**LORNAY**  
ENVIRONMENTAL CONSULTING

# Photo Report

Portion 1 of the Farm 723, Stanford

**August 2025**

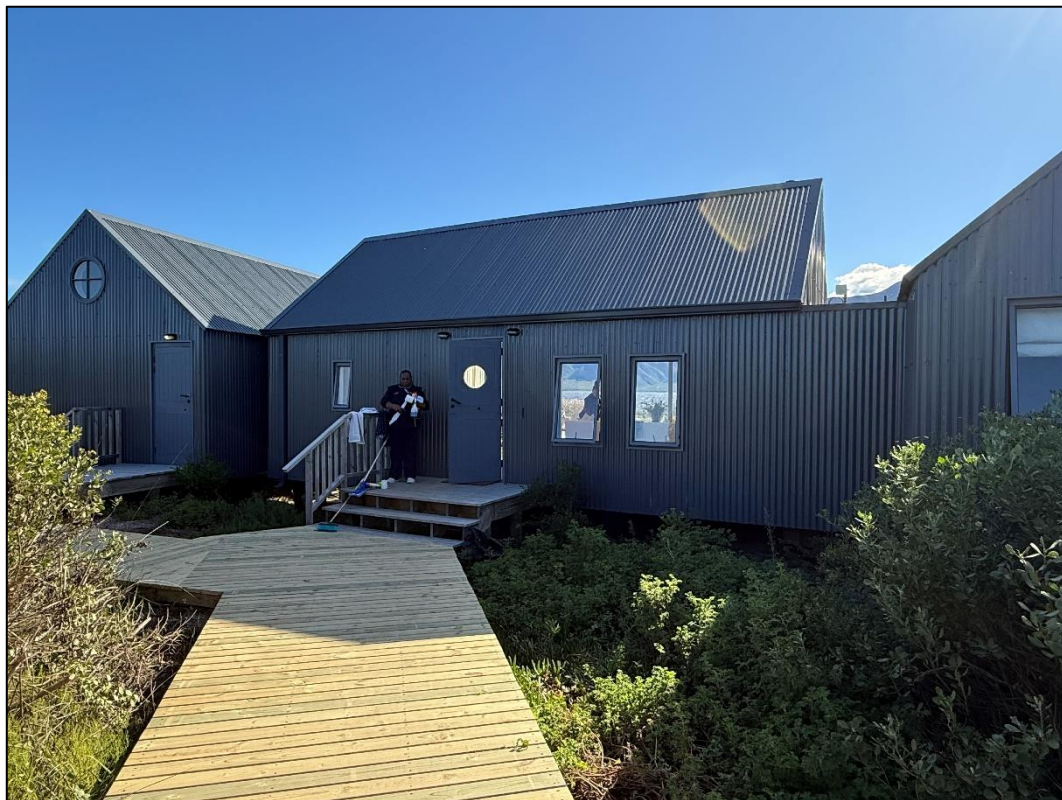
**Photo 1.** Image showing the front of boathouse 1 and a slightly raised boardwalk. (Image taken in July 2025).

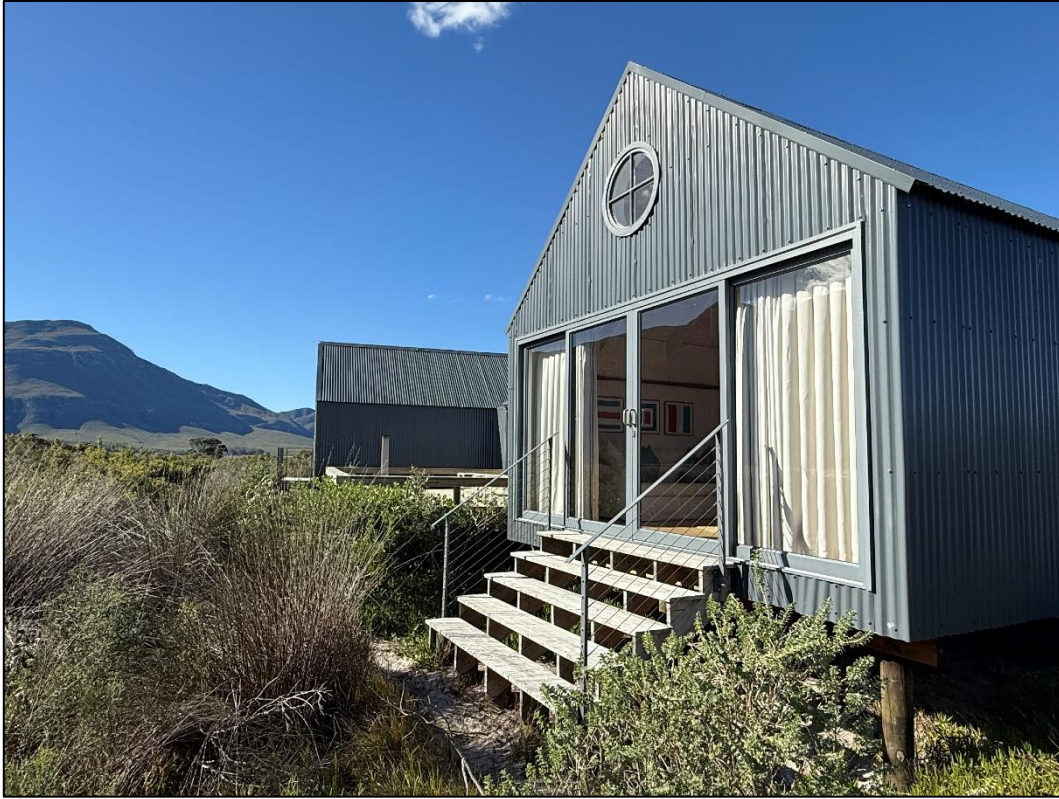
**Photo 2.** Image showing the side view of boathouse 1 constructed on stilts as well as the indigenous vegetation reestablishing underneath the boathouse. *(Image taken in July 2025).*

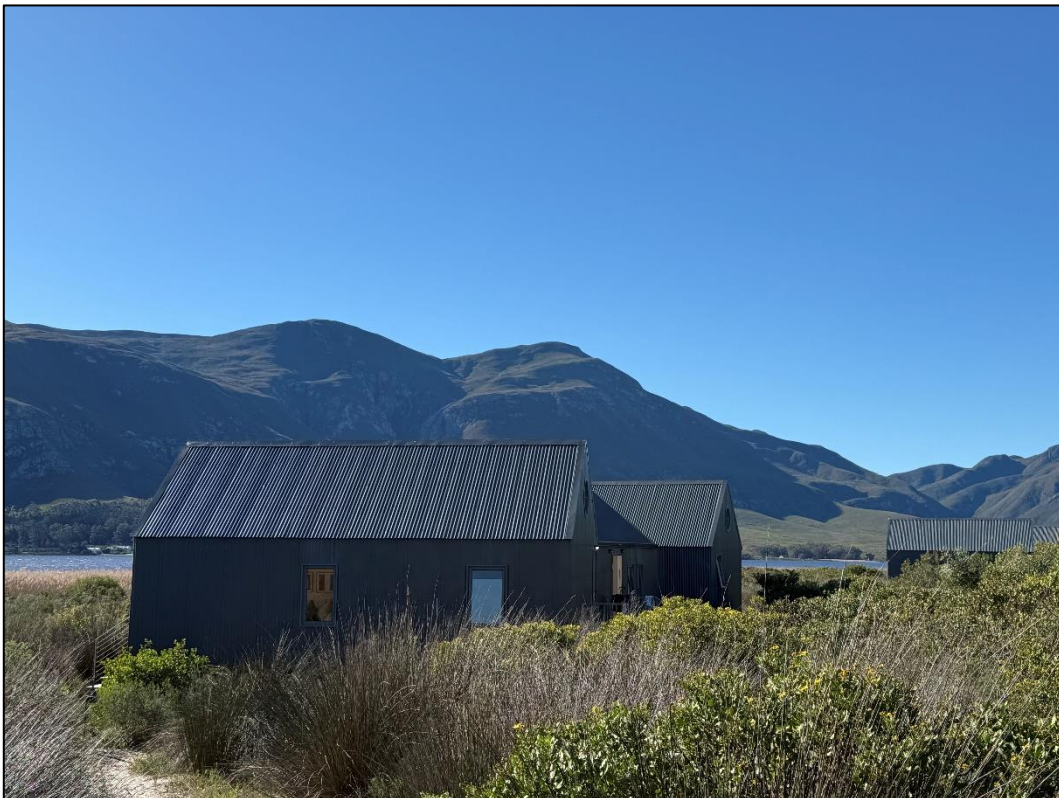
**Photo 3.** Image showing the indigenous vegetation screenig the boathouse 1. *(Image taken in July 2025).*

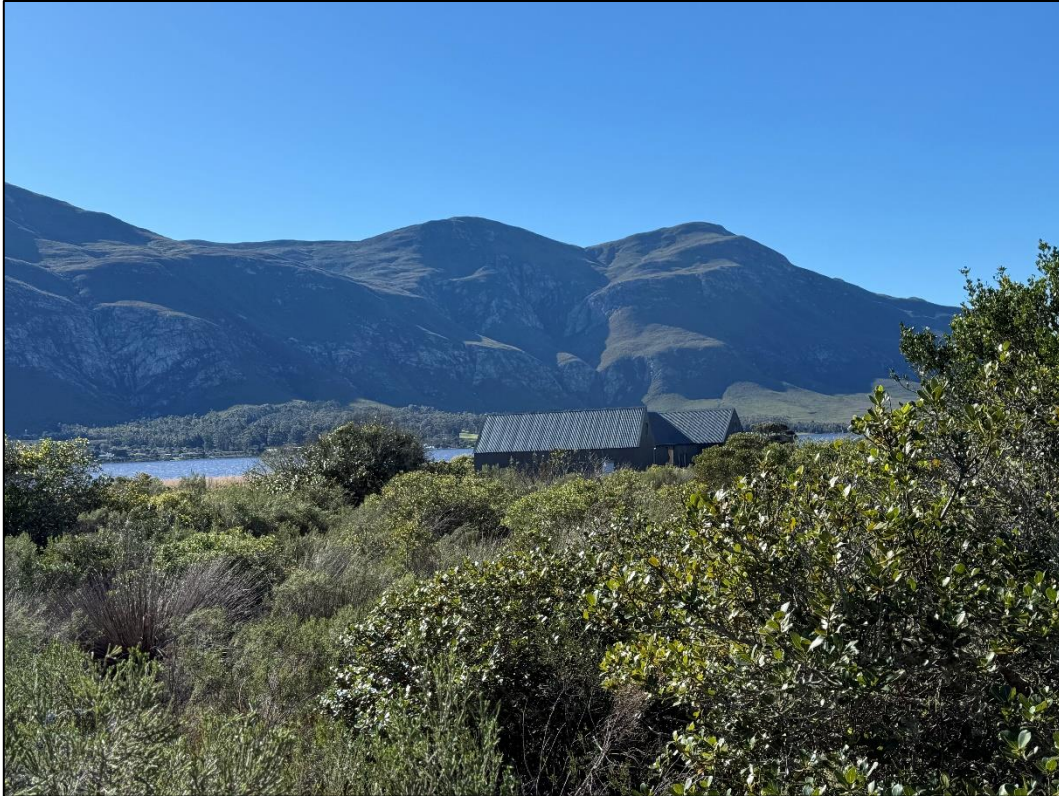
**Photo 4.** Intact indigenous vegetation around boathouse 1 (*Image taken in July 2025*).

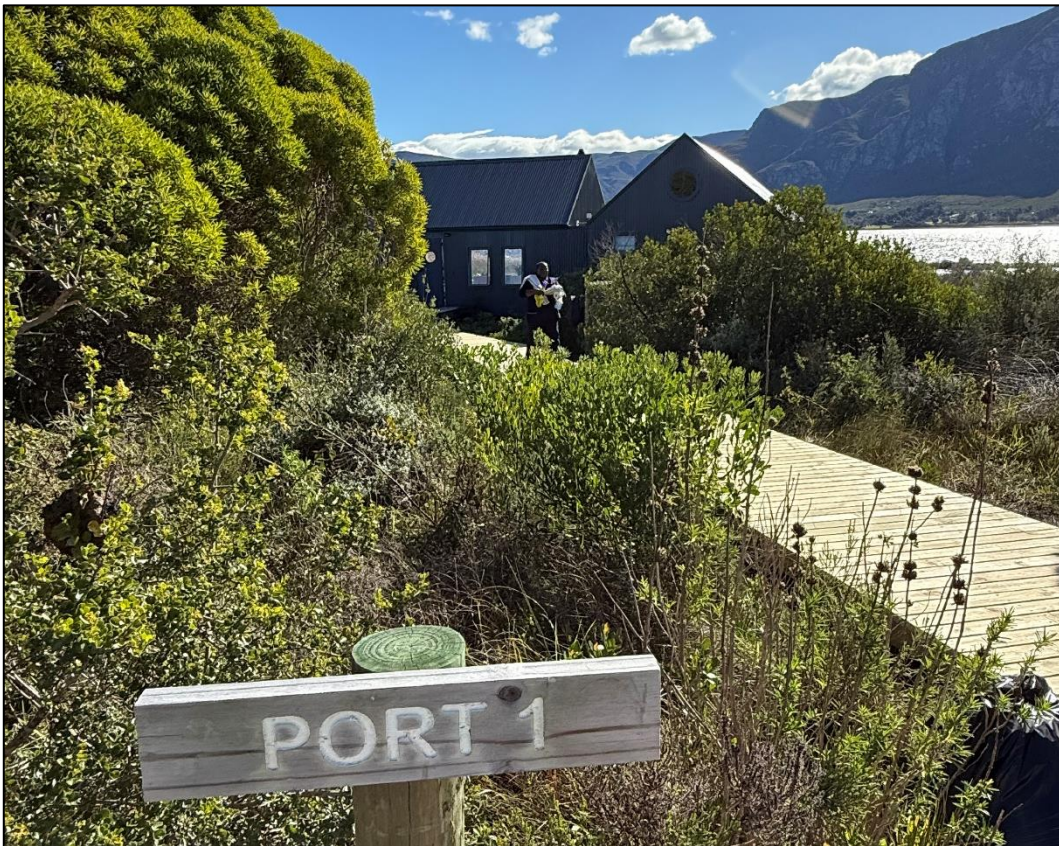
**Photo 5.** Image showing intact indigenous vegetation next to boathouse 1. (*Image taken in July 2025*).

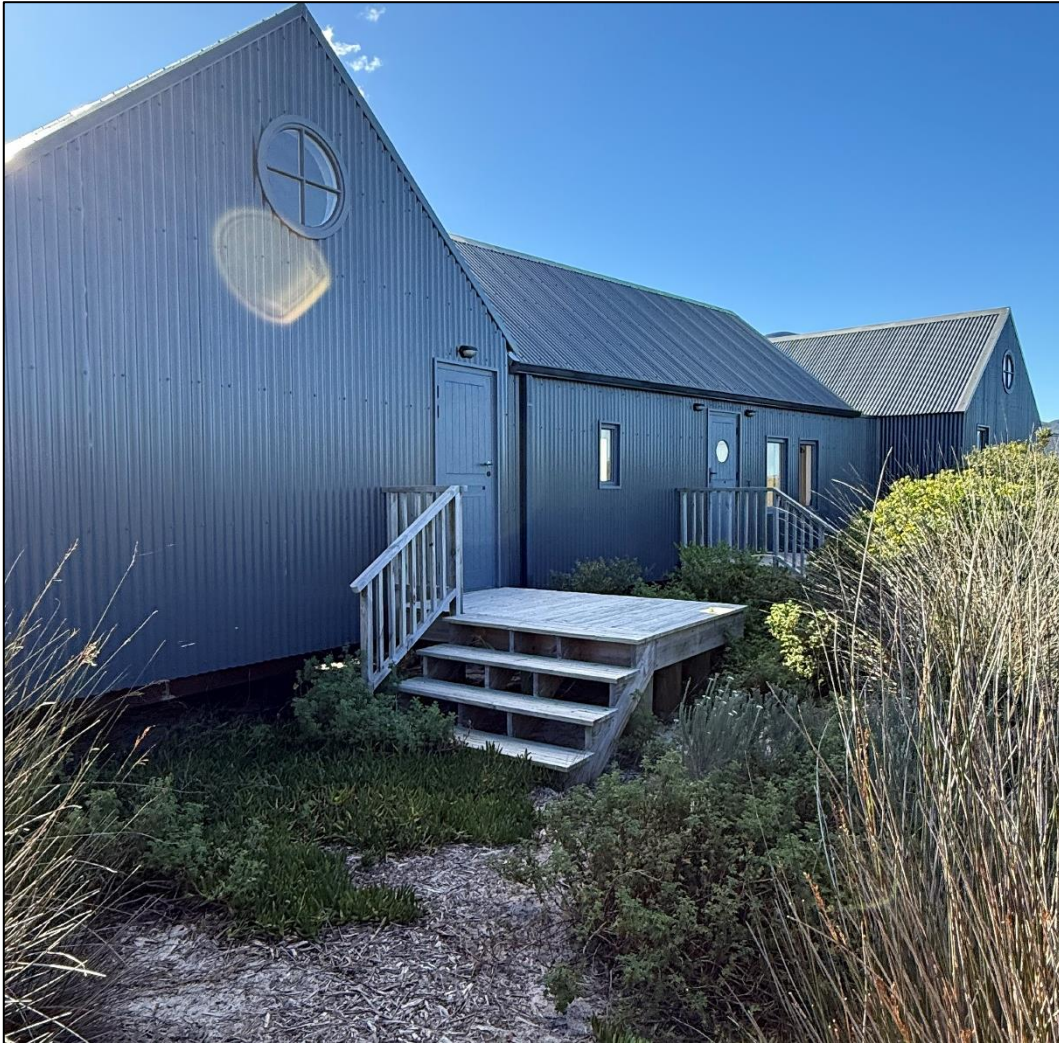
**Photo 6.** Image showing the front view of boathouse 2 along with the indigenous vegetation slightly screening the development. (*Image taken in July 2025*).

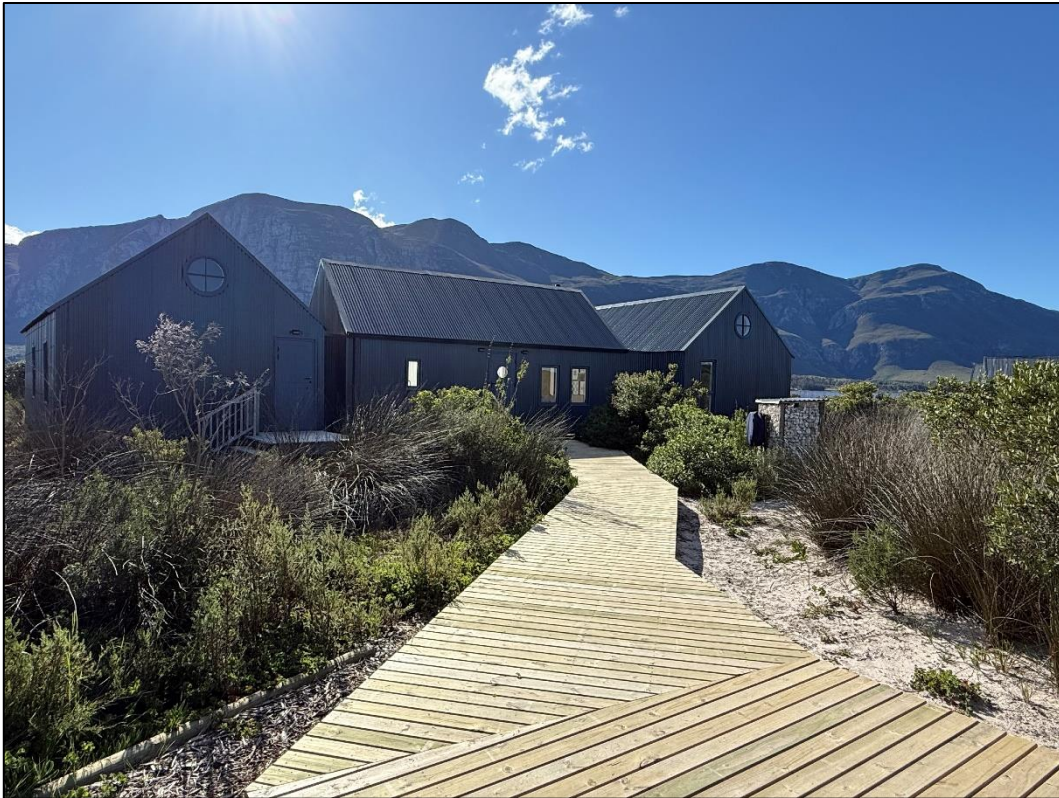
**Photo 7.** View of the boathouse 2 and a slightly raised boardwalk. *(Image taken in July 2025).*

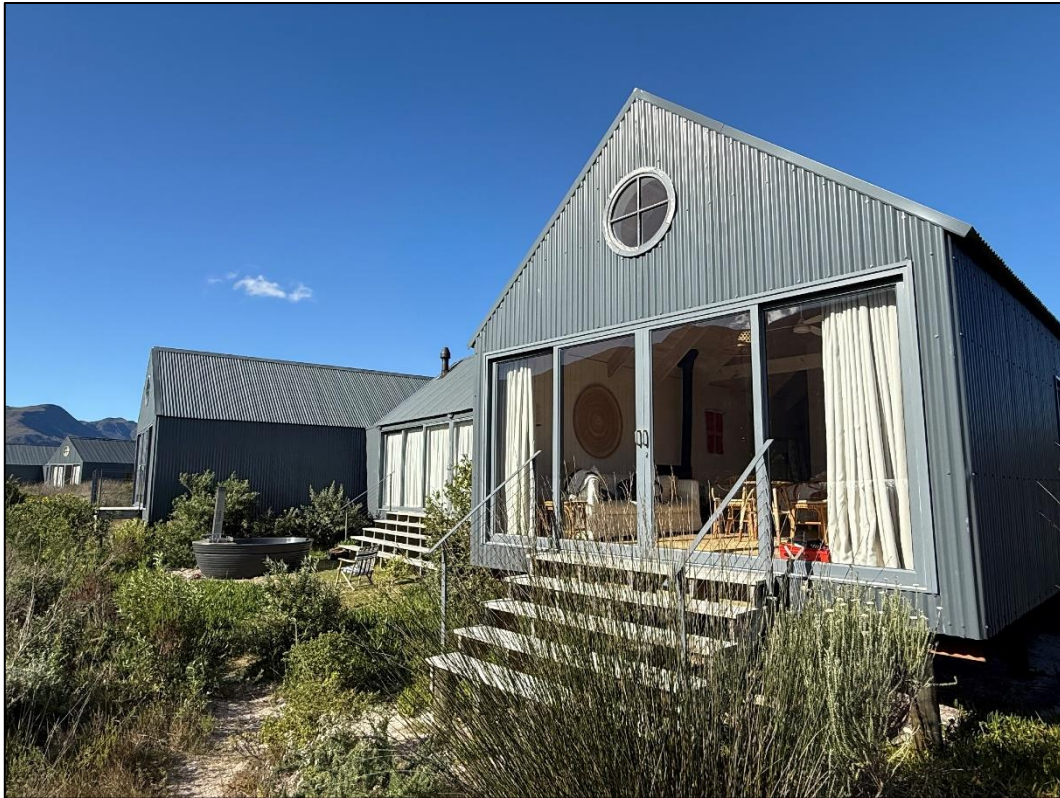
**Photo 10.** Overview of boathouse 3 (*Image taken in July 2025*).

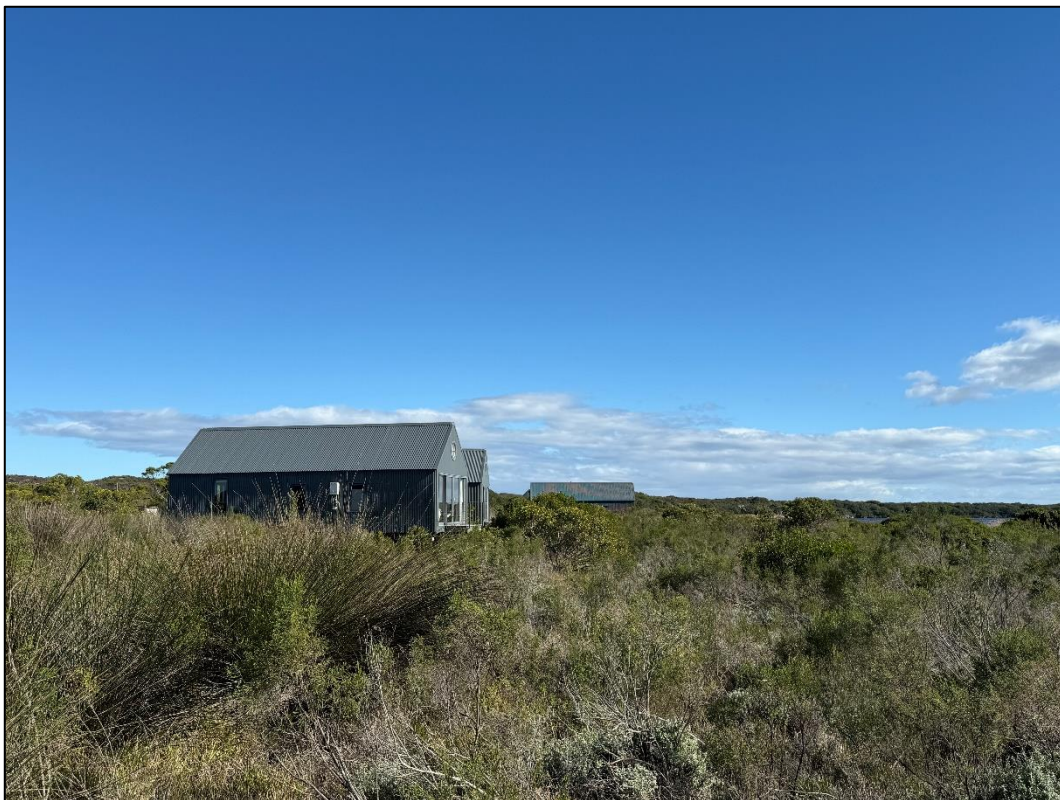
**Photo 11.** View of boathouse 3 as well as indigenous vegetation present adjacent to the boathouse. (*Image taken in July 2025*).

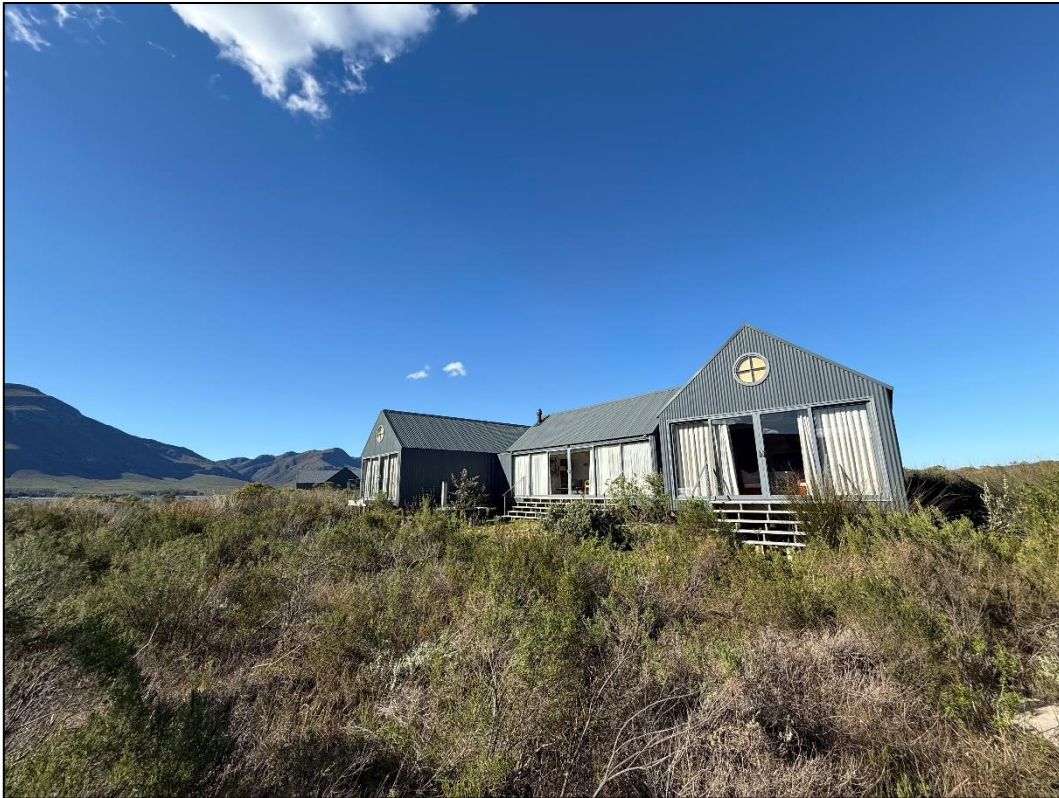
**Photo 12.** Overview of boathouse 3 along with indigenous vegetation. *(Image taken in July 2025).*

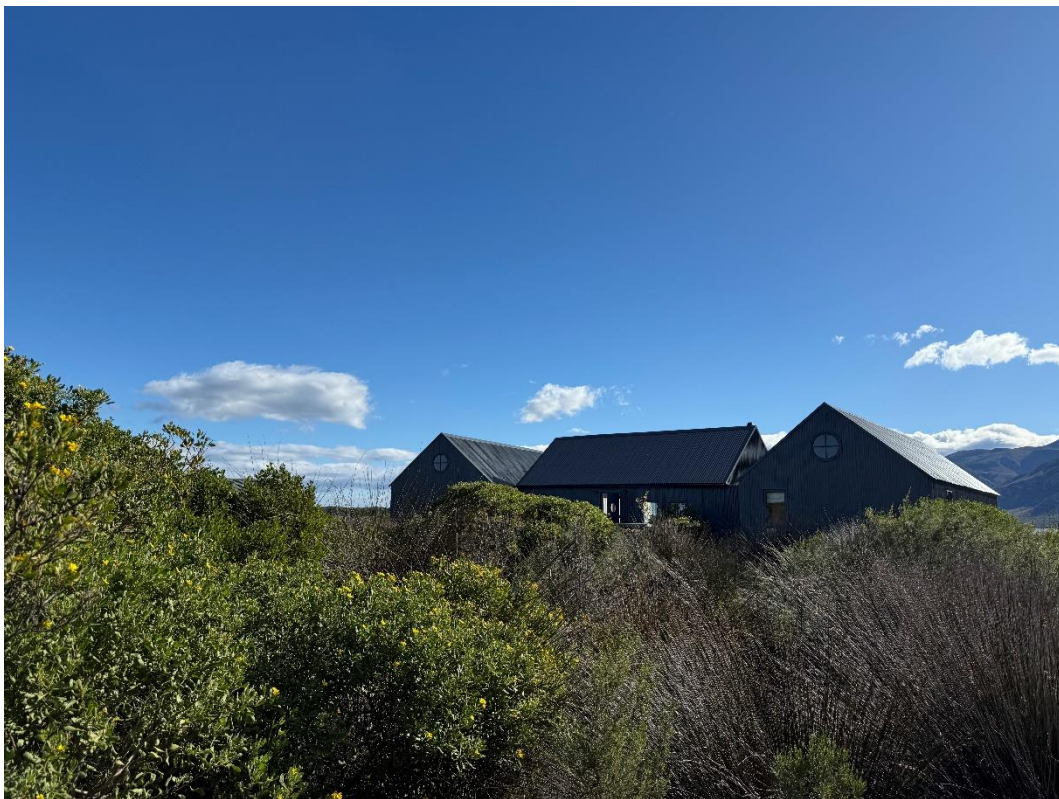
**Photo 13.** Front view of boathouse 3 surrounded by indigenous vegetation. *(Image taken in July 2025).*

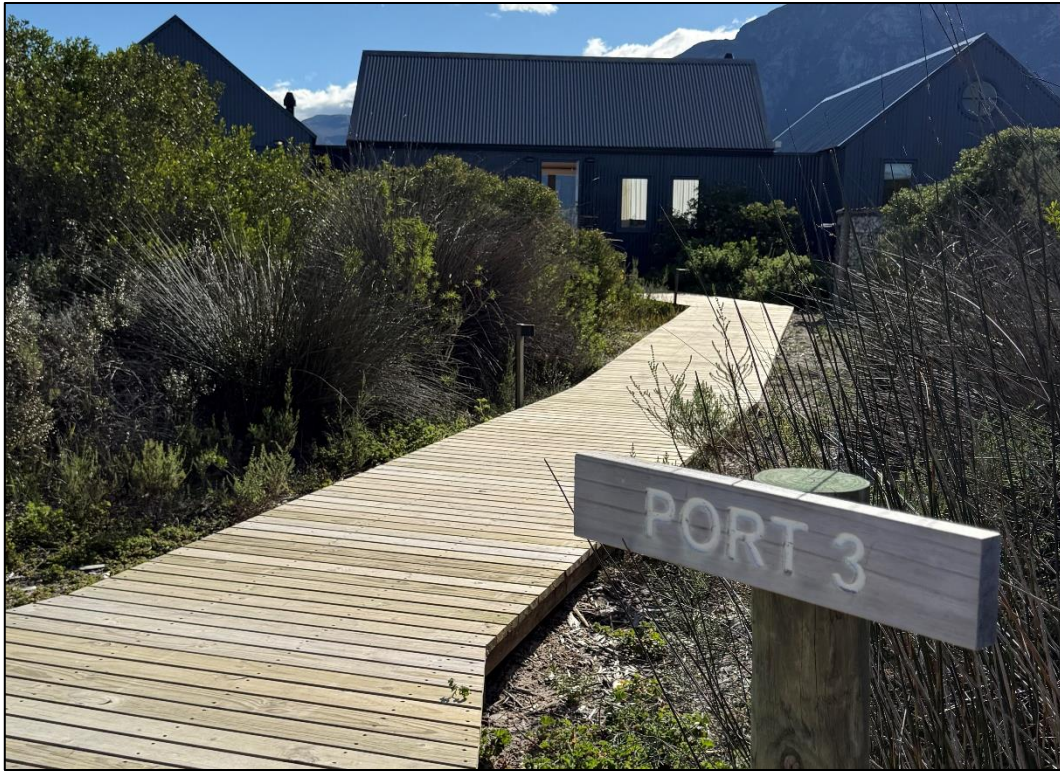
**Photo 14.** Image showing a slightly raised boardwalk providing access to boathouse 3. *(Image taken in July 2025).*

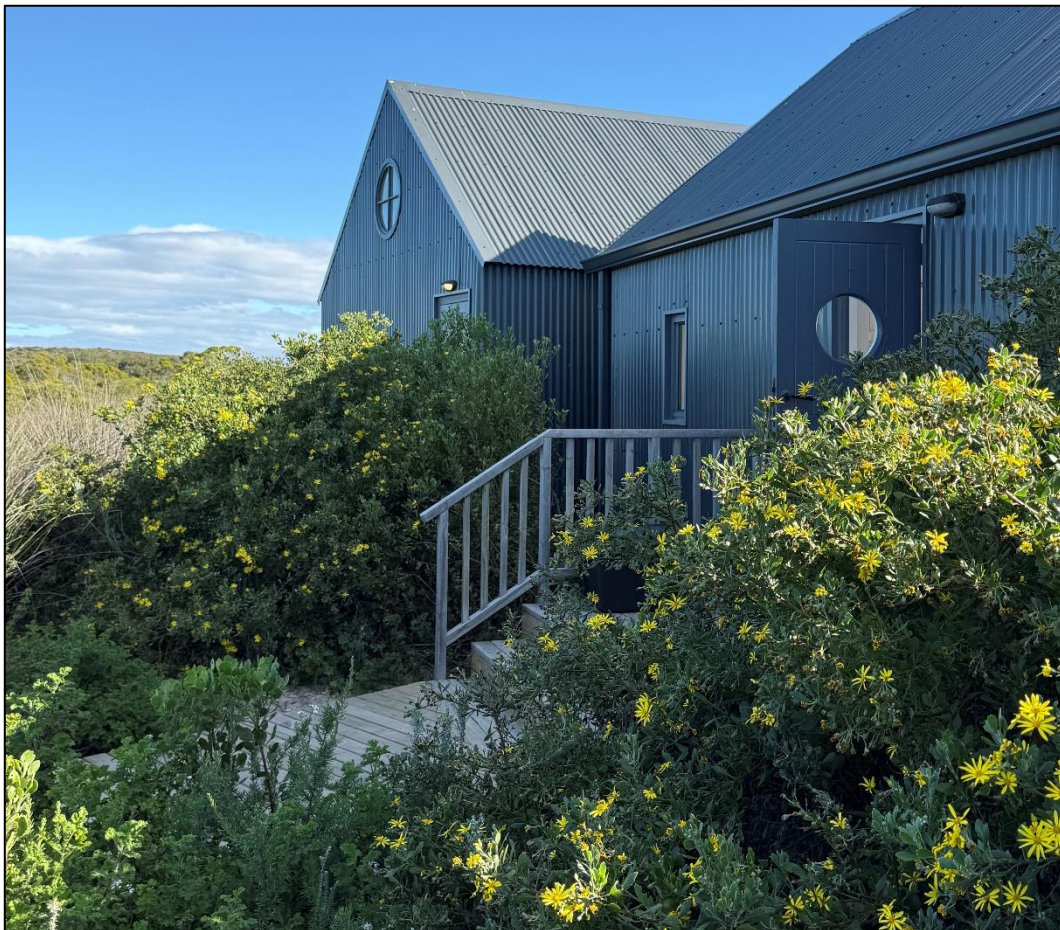
**Photo 15.** Image showing indigenous vegetation screening boathouse 3. *(Image taken in July 2025).*

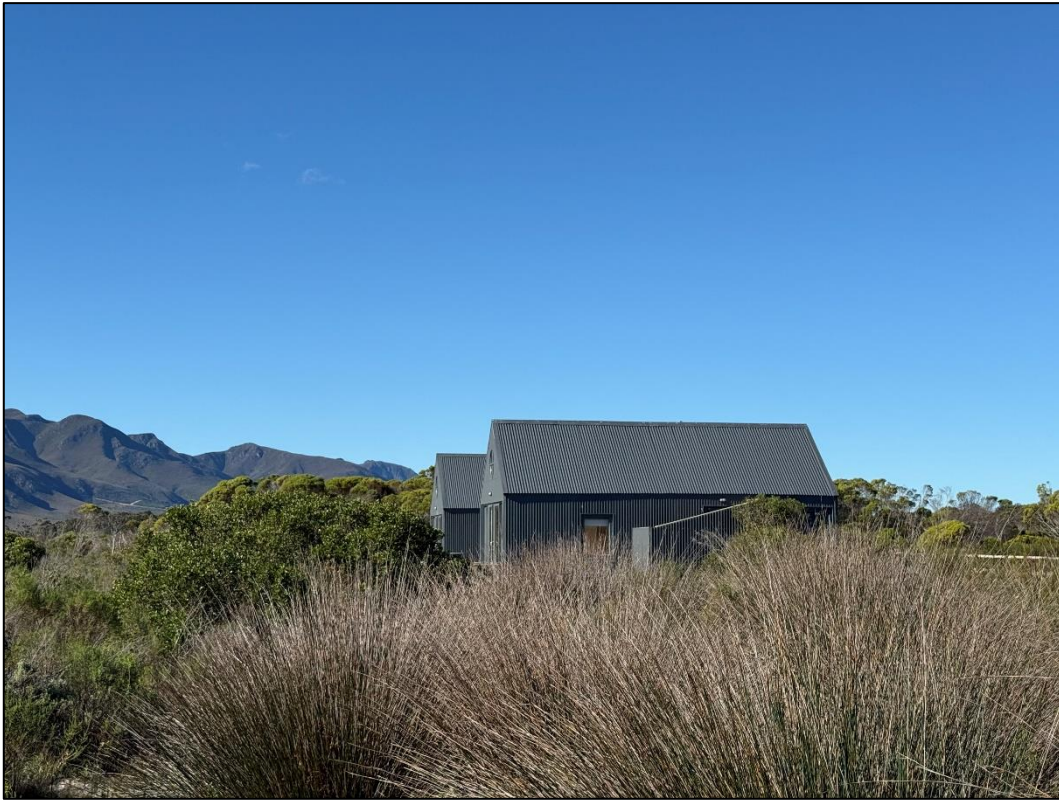
**Photo 16.** Image showing side view of boathouse 4. *(Image taken in July 2025).*

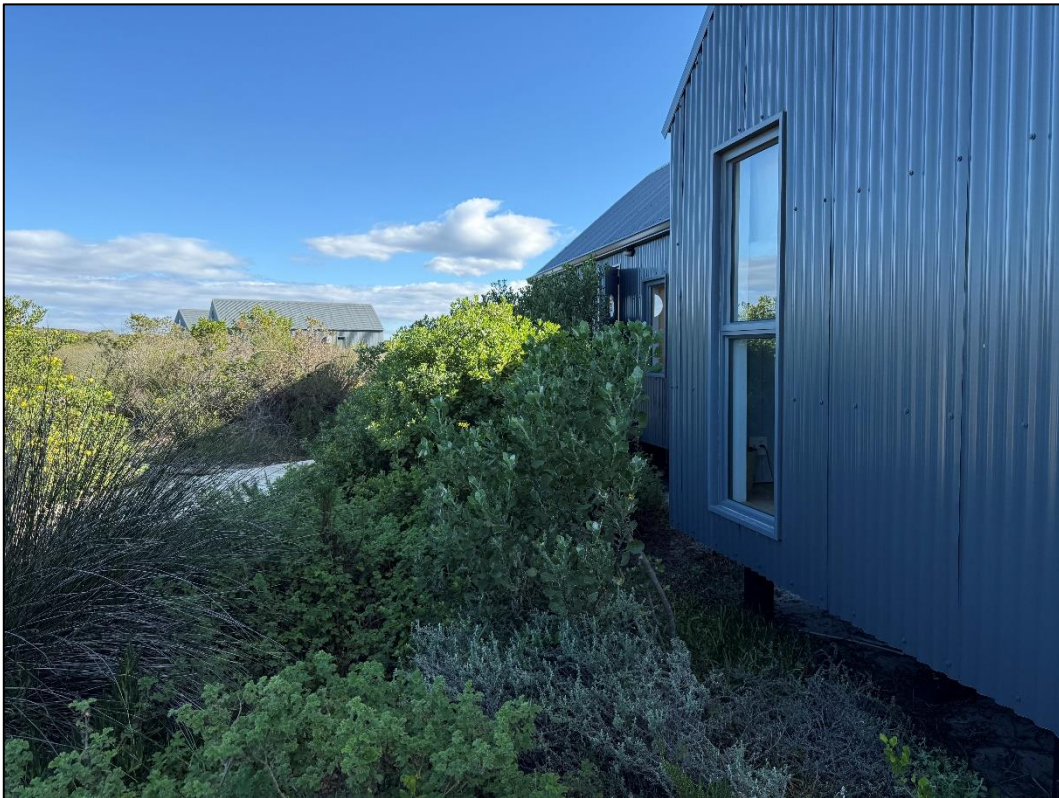
**Photo 17.** View of indigenous vegetation screening boathouse 4. *(Image taken in July 2025).*

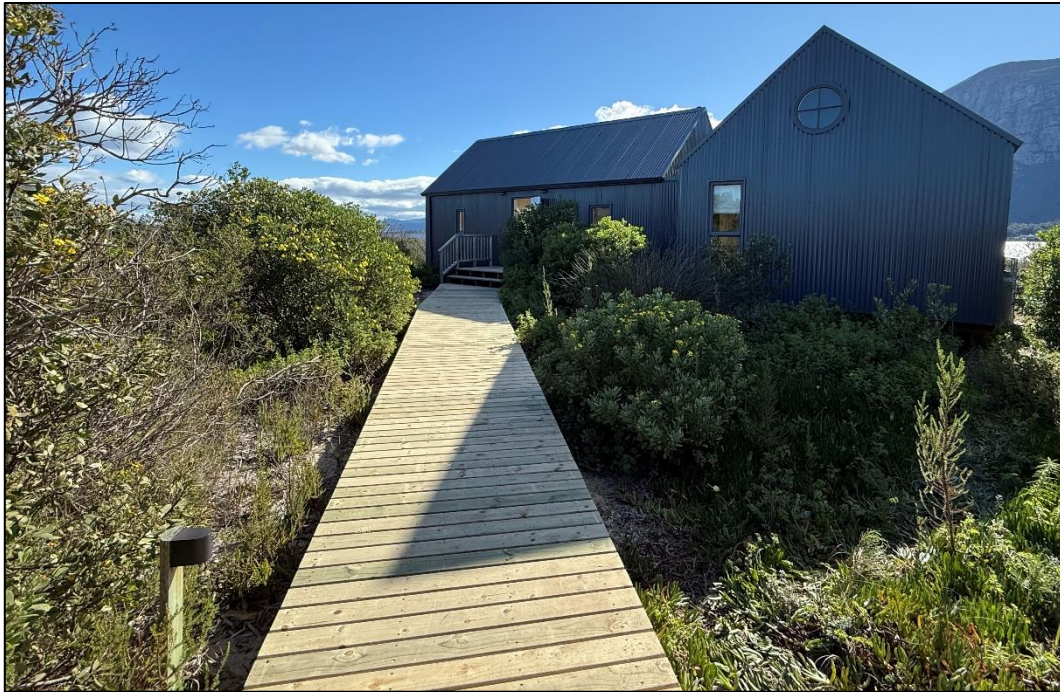
**Figure 18.** Image showing a slightly raised boardwalk which is providing access to boathouse 4. *(Image taken in July 2025).*

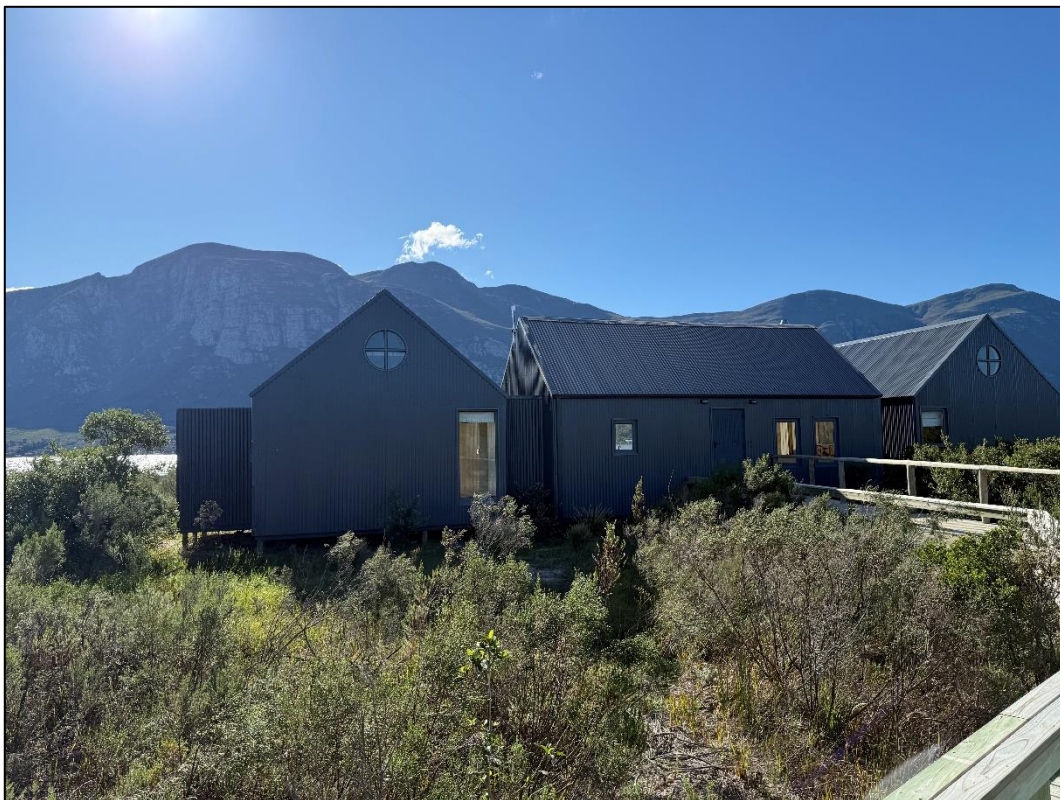
**Photo 19.** Image showing boathouse 5 which was built in 2024. *(Image taken in July 2025).*

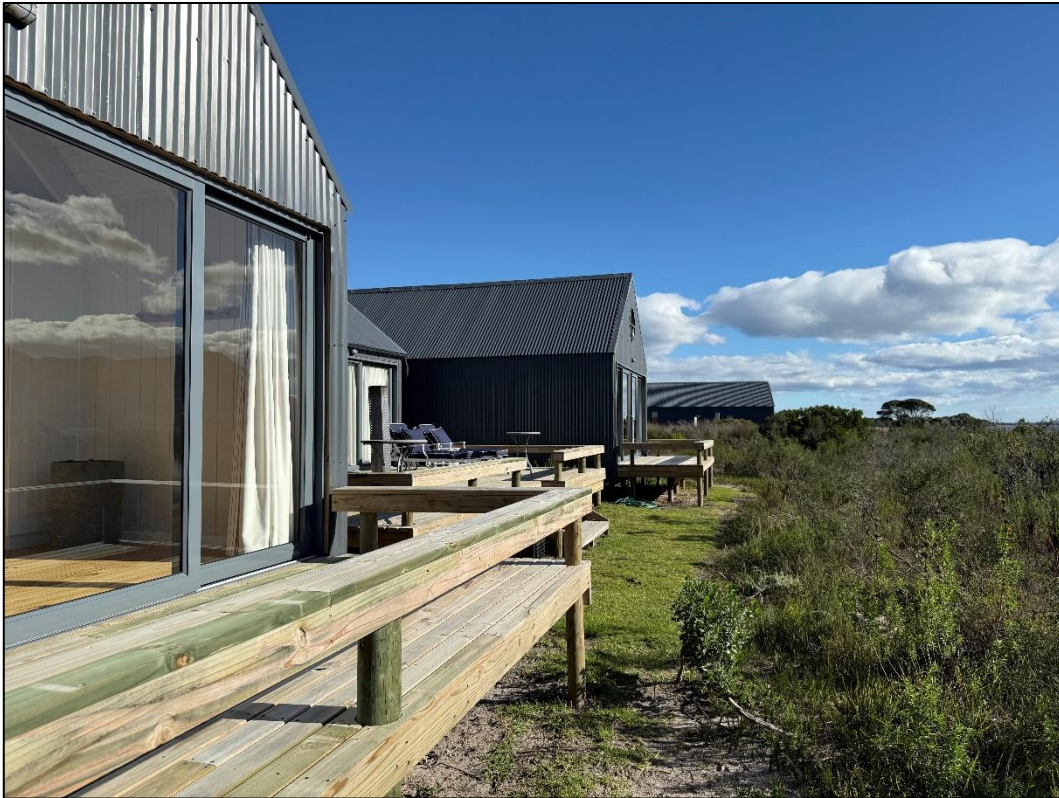
**Photo 20.** Image showing boathouse 5, lawn area and indigenous vegetation. *(Image taken in July 2025).*

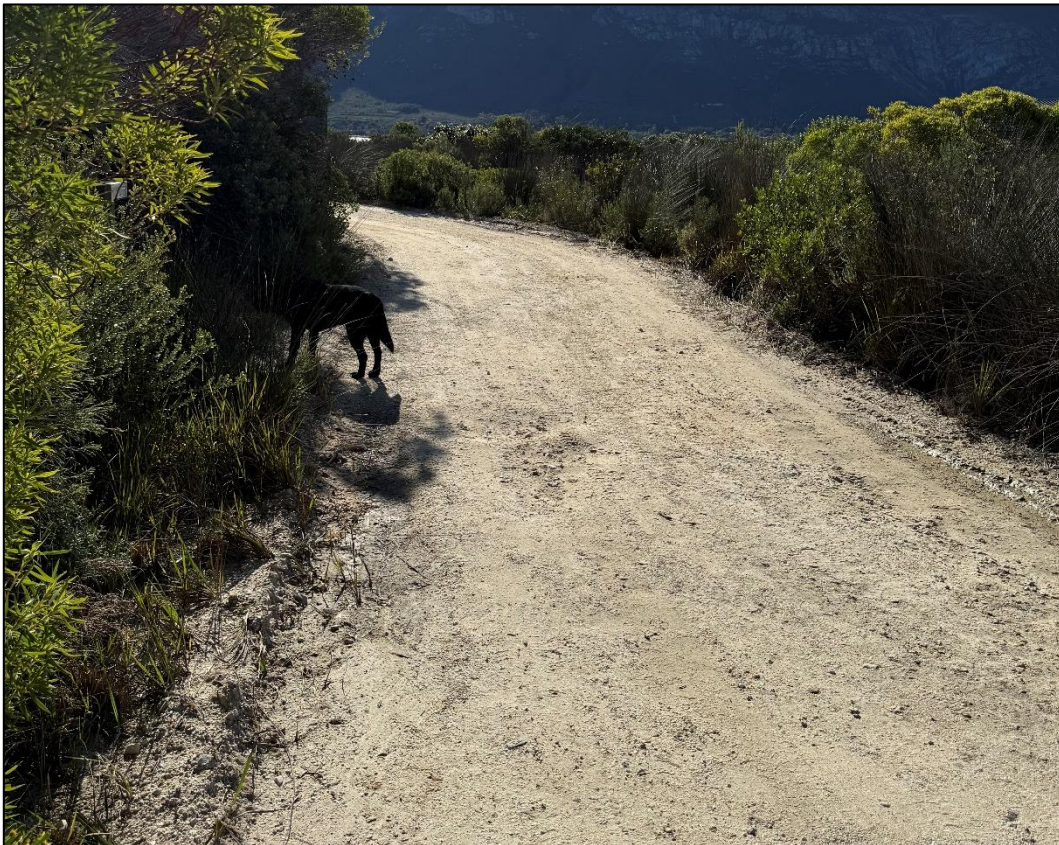
**Photo 21.** Image showing a 3.8 m<sup>2</sup> width dirt roads providing access to the 5 boathouses.

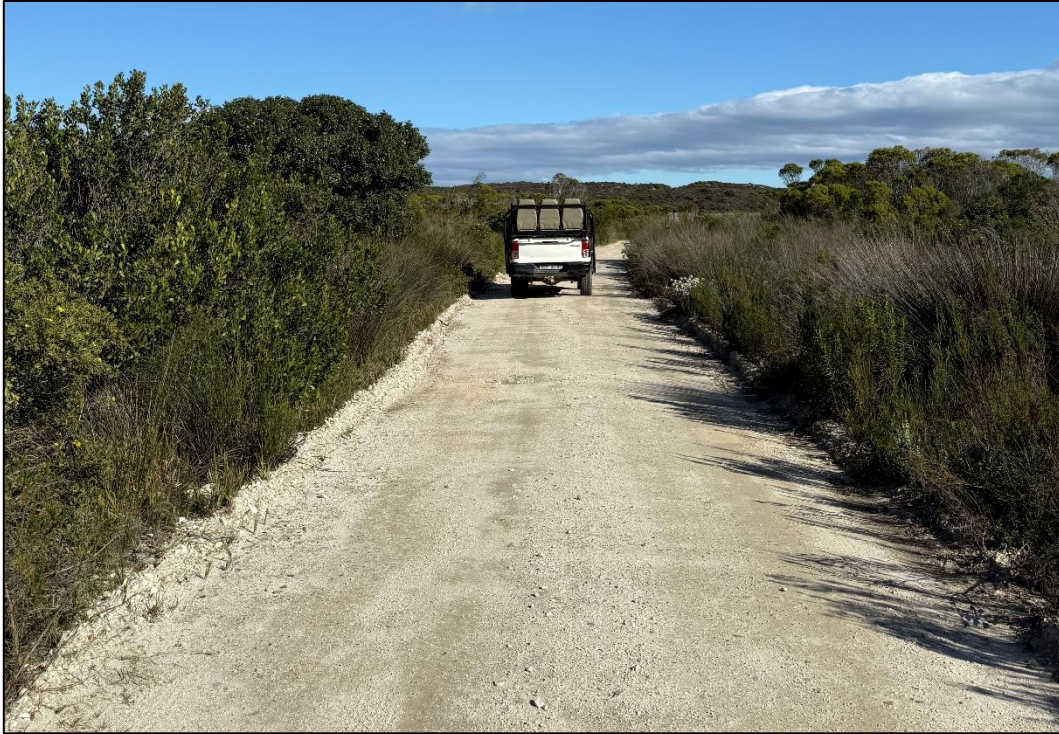
**Photo 22.** Image showing the dirt road and indigenous vegetation on either side of the road.

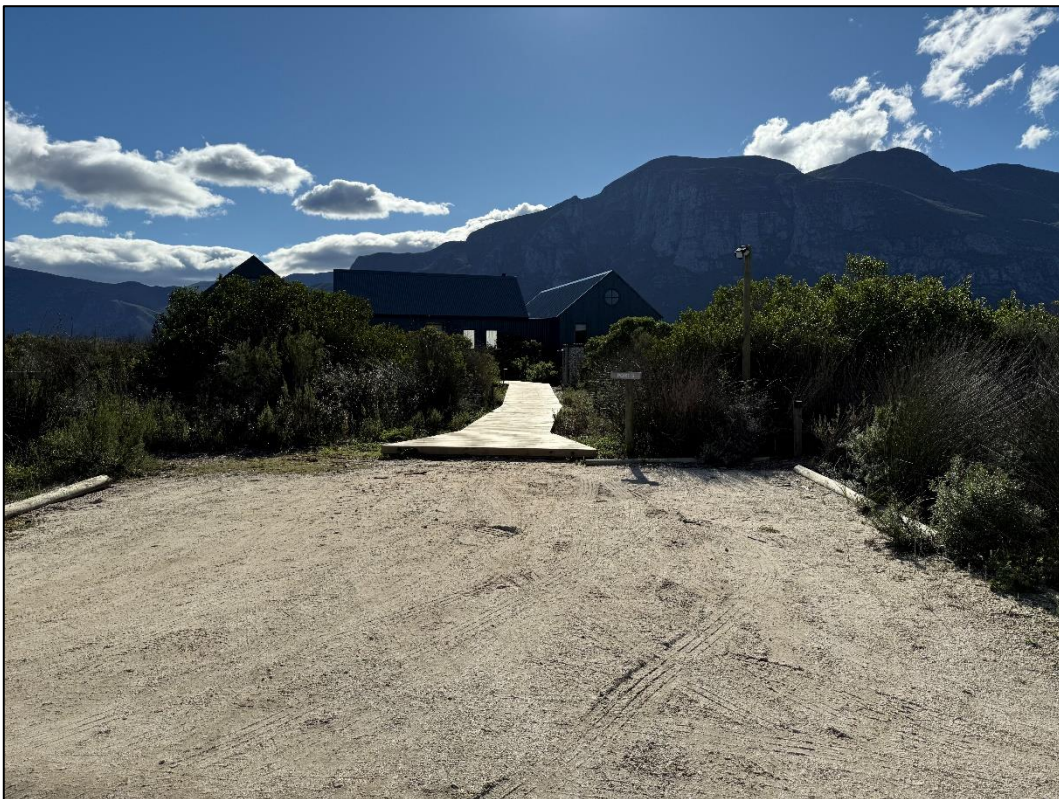
**Photo 23.** Image showing a parking area for one of the boathouses.

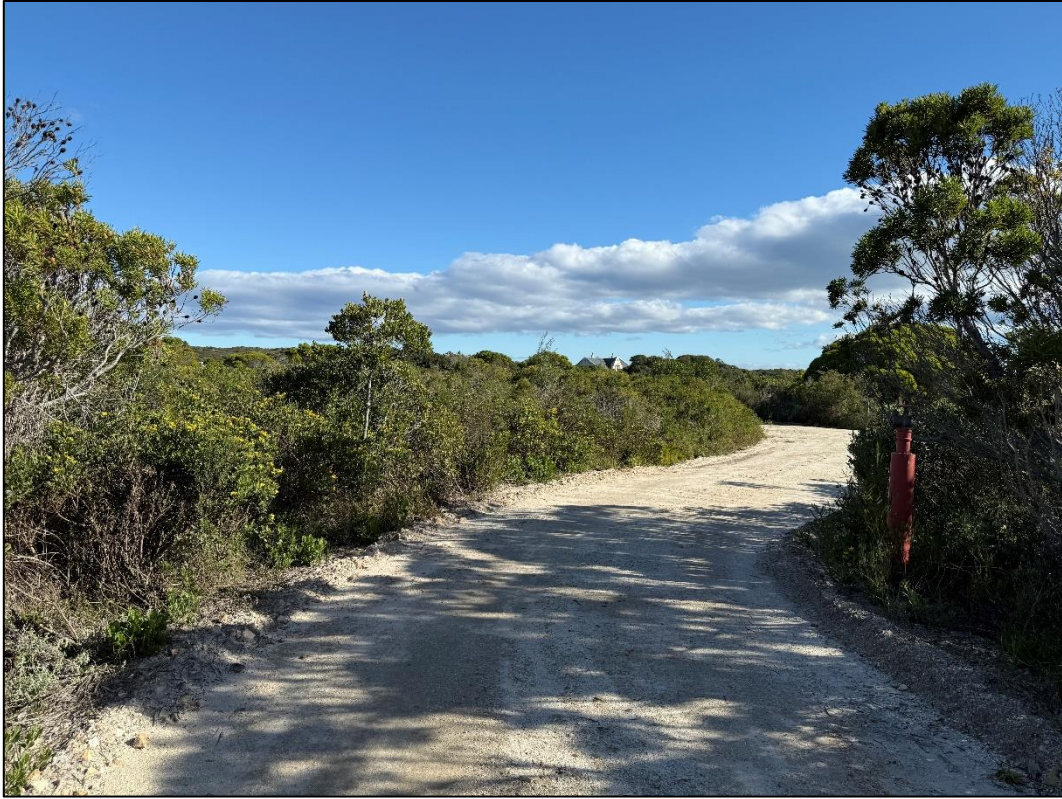
**Photo 24.** Image showing a dirt road established between indigenous vegetation and a fire hydrant.
