LORNAY
ENVIRONMENTAL CONSULTING

PHOTOGRAPHIC REPORT

Portion 2 of the Farm Annex Klein Zout Rivier No. 39, Napier, Bredasdorp
RD

13 March 2026

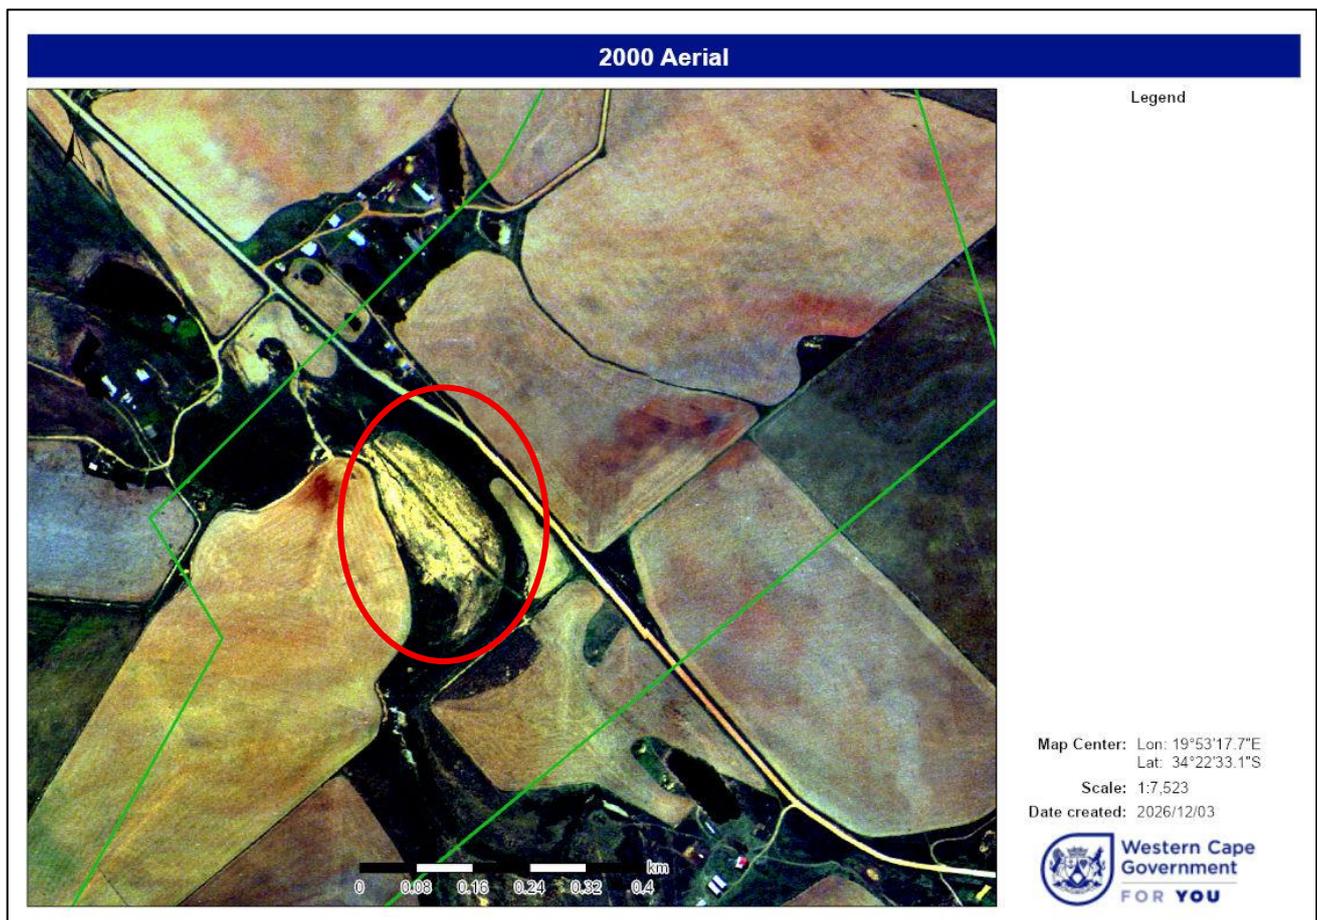
The 2000 aerial image (**Figure 3**) confirms that the southeastern portion of the site, which is the area that was recently cleared, was in a clearly impacted and disturbed state at that time. This disturbance is attributed to historical agricultural activities that previously took place on and adjacent to the subject site, which resulted in soil exposure, erosional scarring, and a loss of natural vegetation cover.

Figure 3: 2000 aerial image shows that the southeastern portion that was recently cleared onsite was in an impacted state.

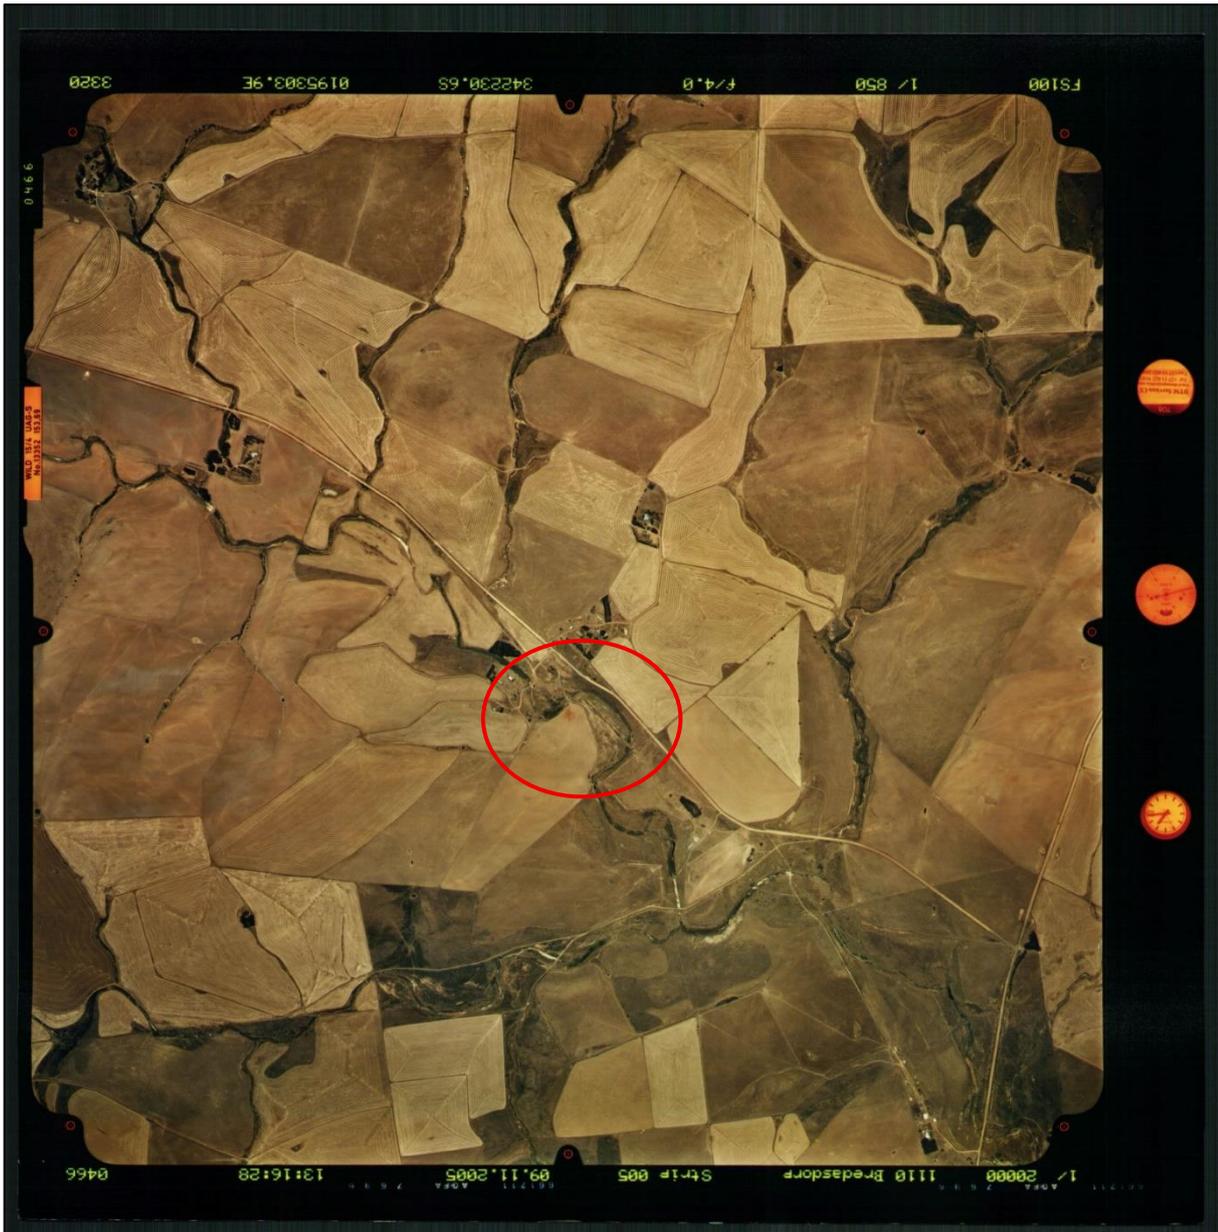
The 2005 aerial image (**Figure 4**) indicates that the site remained in an impacted condition. Although agricultural activities appear to have reduced in intensity, the effects of previous land use are still clearly visible, with limited natural vegetation recovery evident during this period.

Figure 4: The 2005 aerial image shows that the site was impacted.

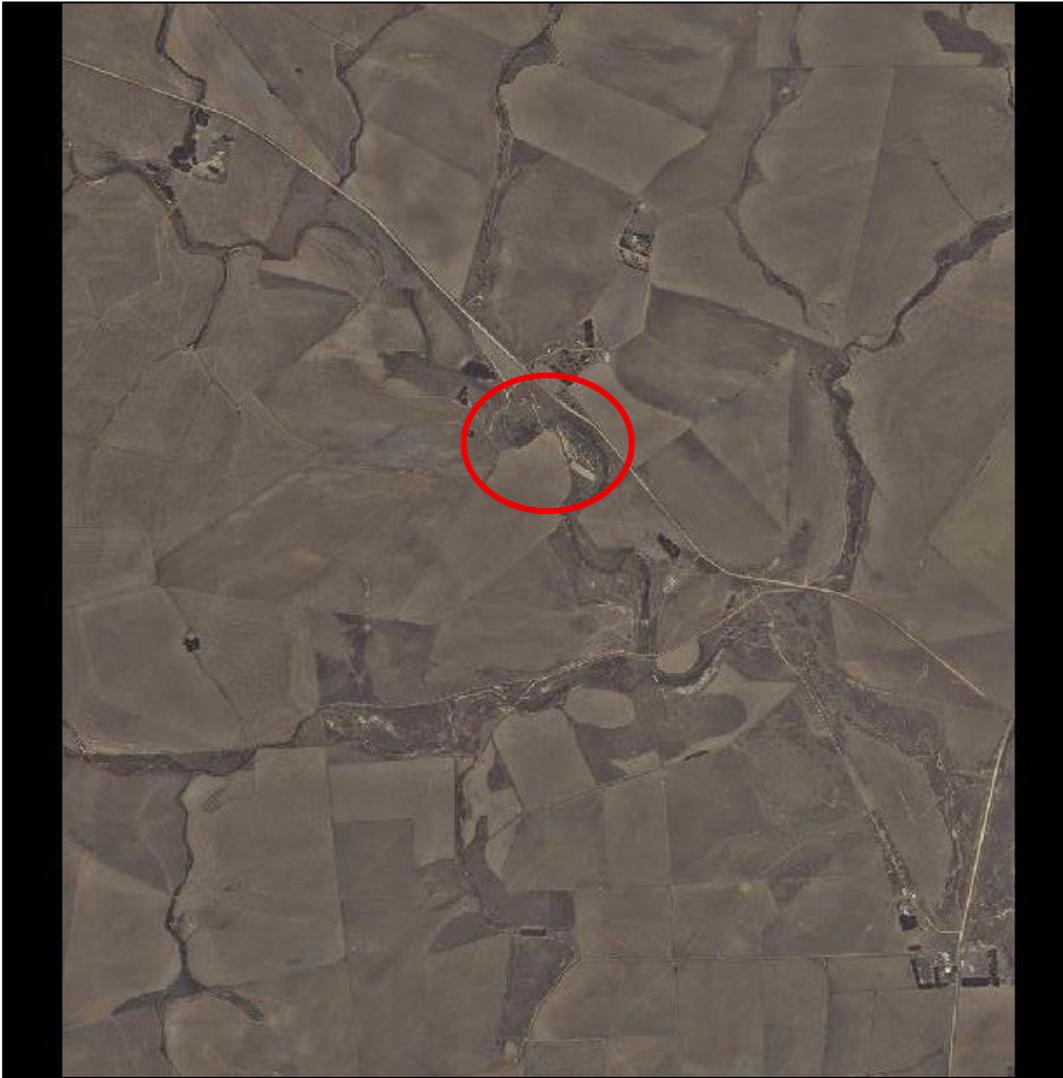
By 2010, as depicted in **(Figure 5)**, the site continued to reflect a slightly impacted condition. However, there are early indications of natural vegetation beginning to re-establish across portions of the site, suggesting that the cessation of active farming was allowing for gradual ecological recovery.

Figure 5: The 2010 image shows that the site was slightly impacted.

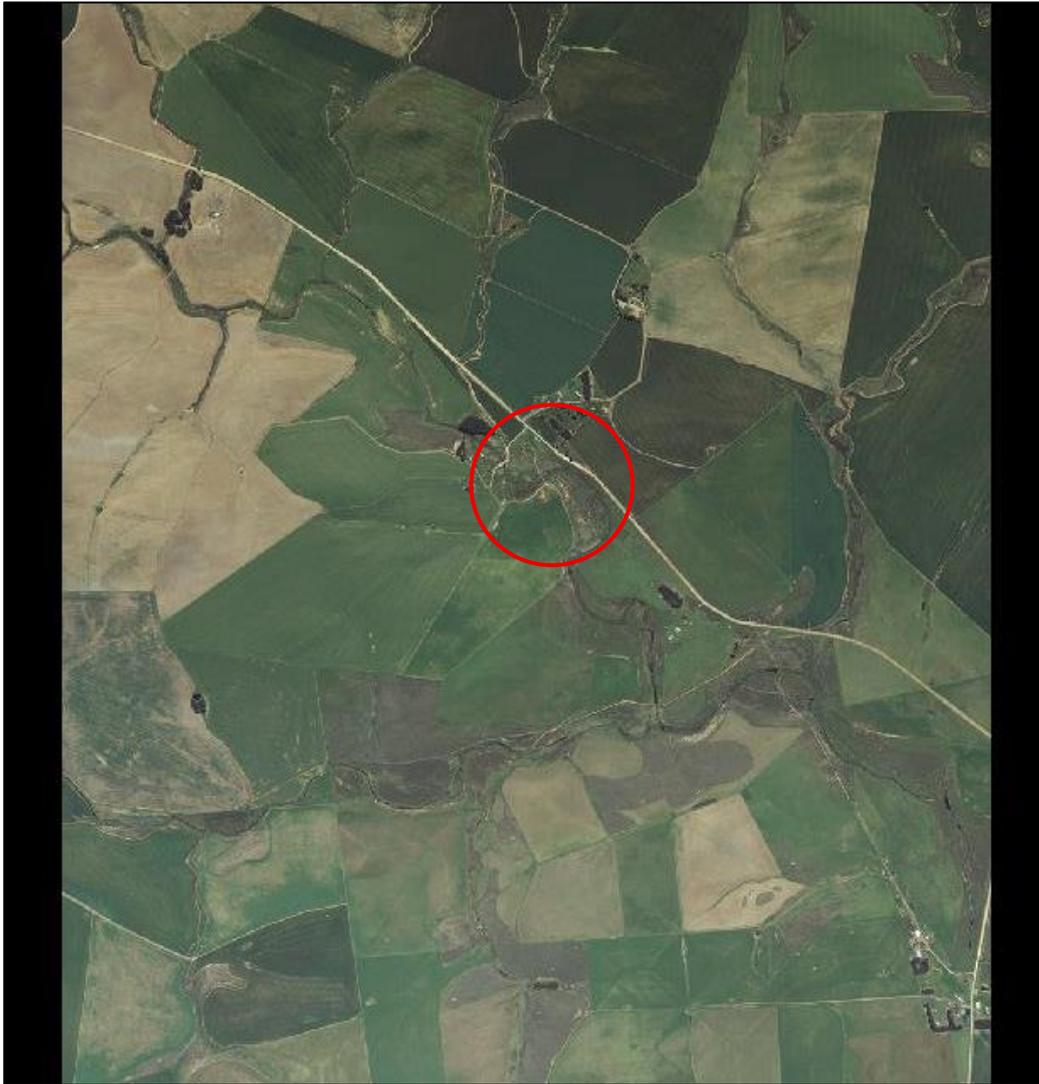
The 2016 aerial image **(Figure 6)** demonstrates a notable improvement in the condition of the site, with visible recovery of vegetation cover compared to earlier imagery. This confirms that the site was in a trajectory of natural recovery following the historical agricultural disturbance, with indigenous vegetation progressively re-establishing over the intervening years.

Figure 6: The 2016 areal image shows that the site was recovering.

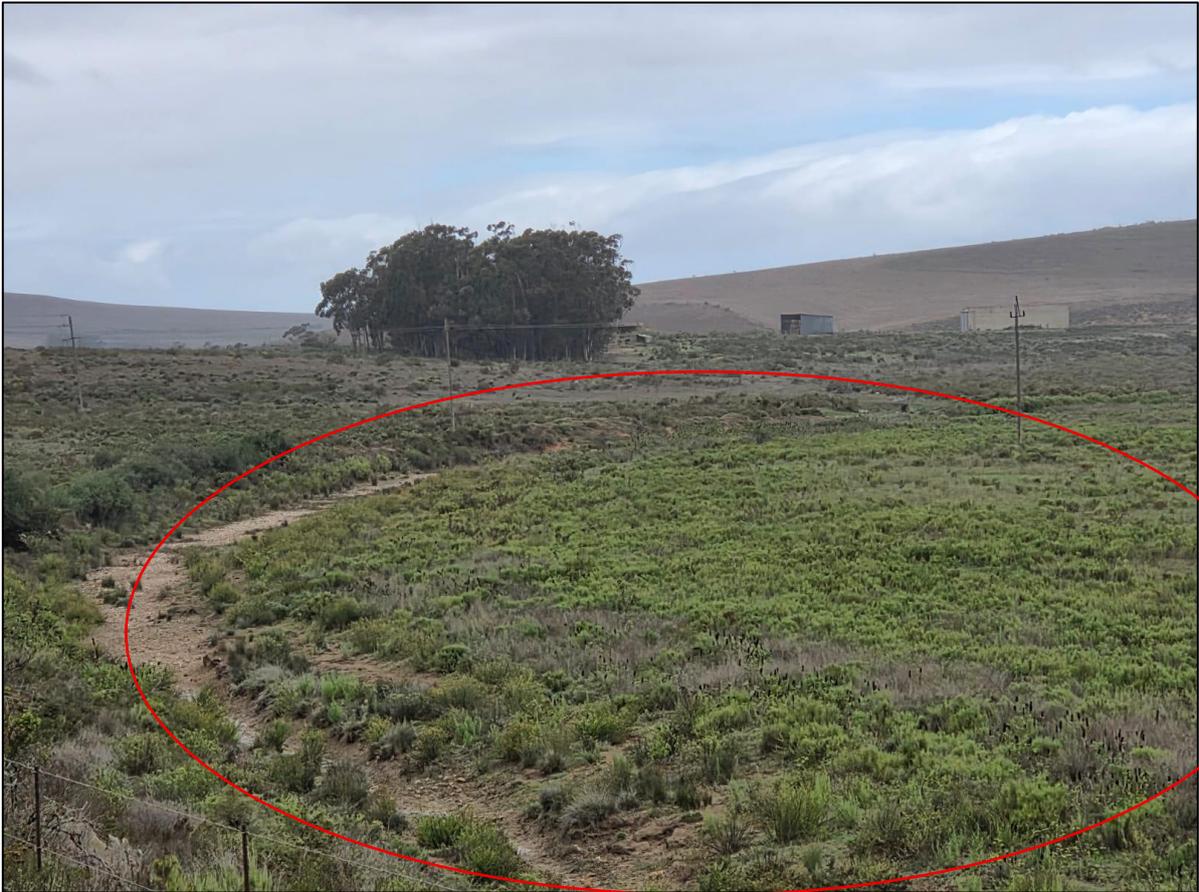
Photo 1. Showing a portion of the cleared area in relation to the non-perennial drainage line traversing between the previously transformed sections of the site. The image illustrates that the clearance activities did not extend into the drainage line or its associated riparian zone.

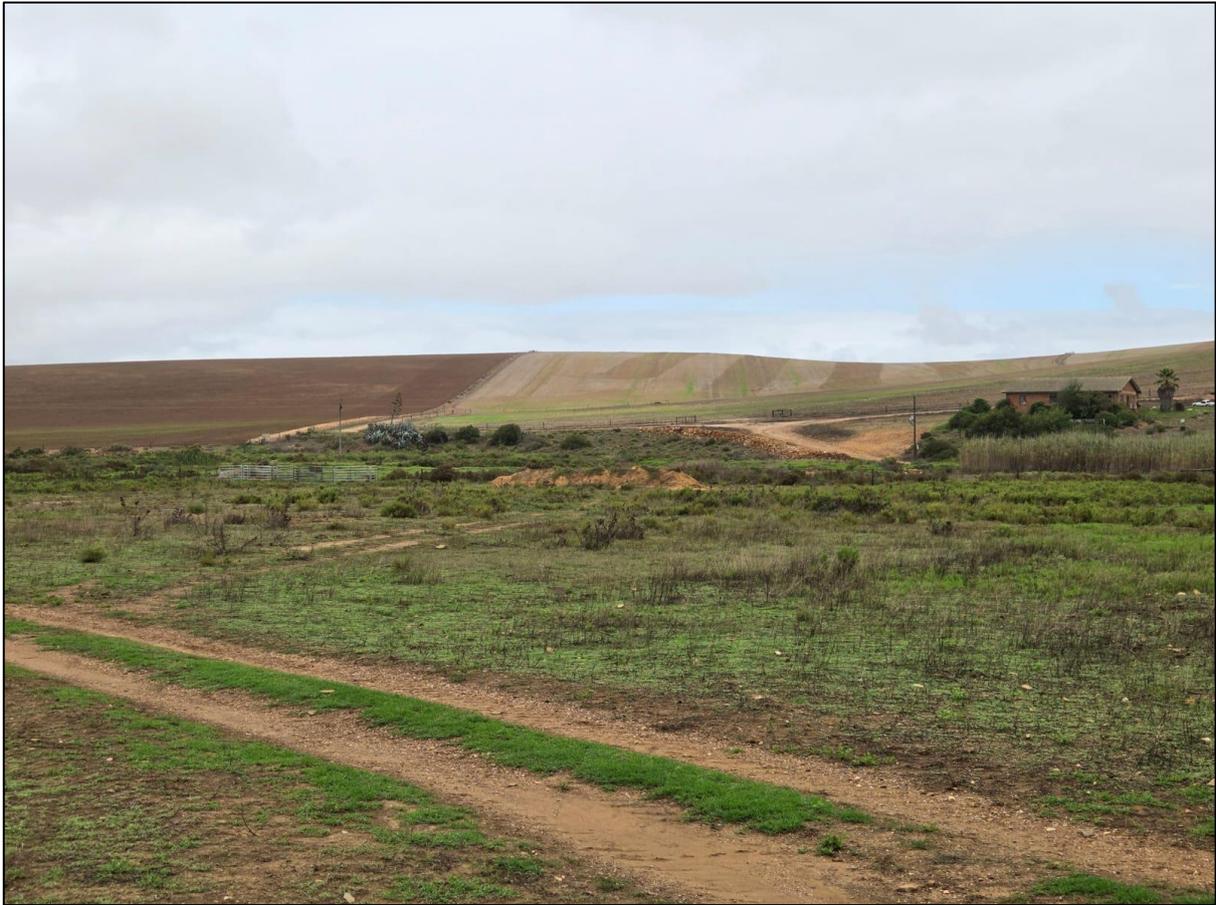
Photo 2. Western portion of the cleared area, including visible jeep tracks associated with agricultural access. The photograph demonstrates the historically disturbed nature of the site and ongoing agricultural land-use practices beyond the site.

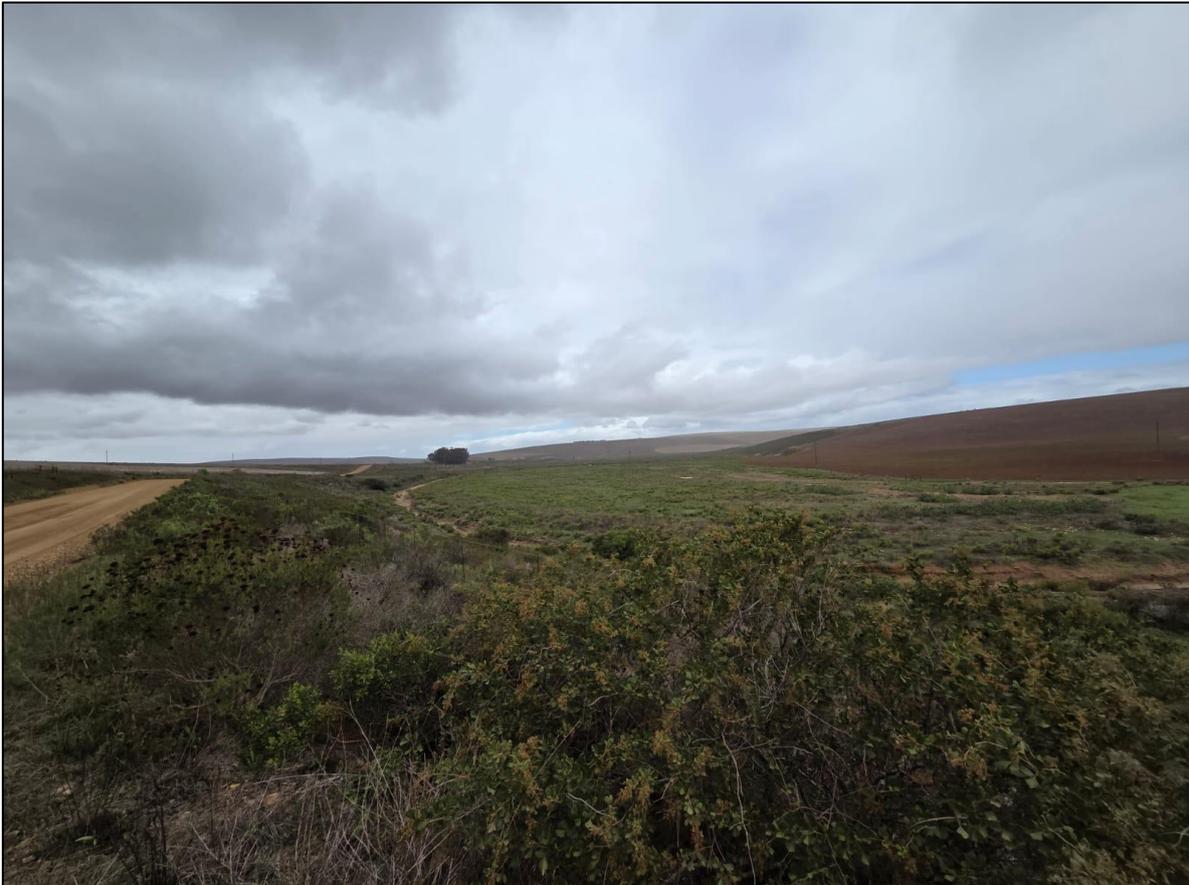
Photo 3. Intact indigenous vegetation visible in the foreground, with the cleared agricultural area in the background. This image highlights the contrast between remaining natural vegetation and the transformed footprint.

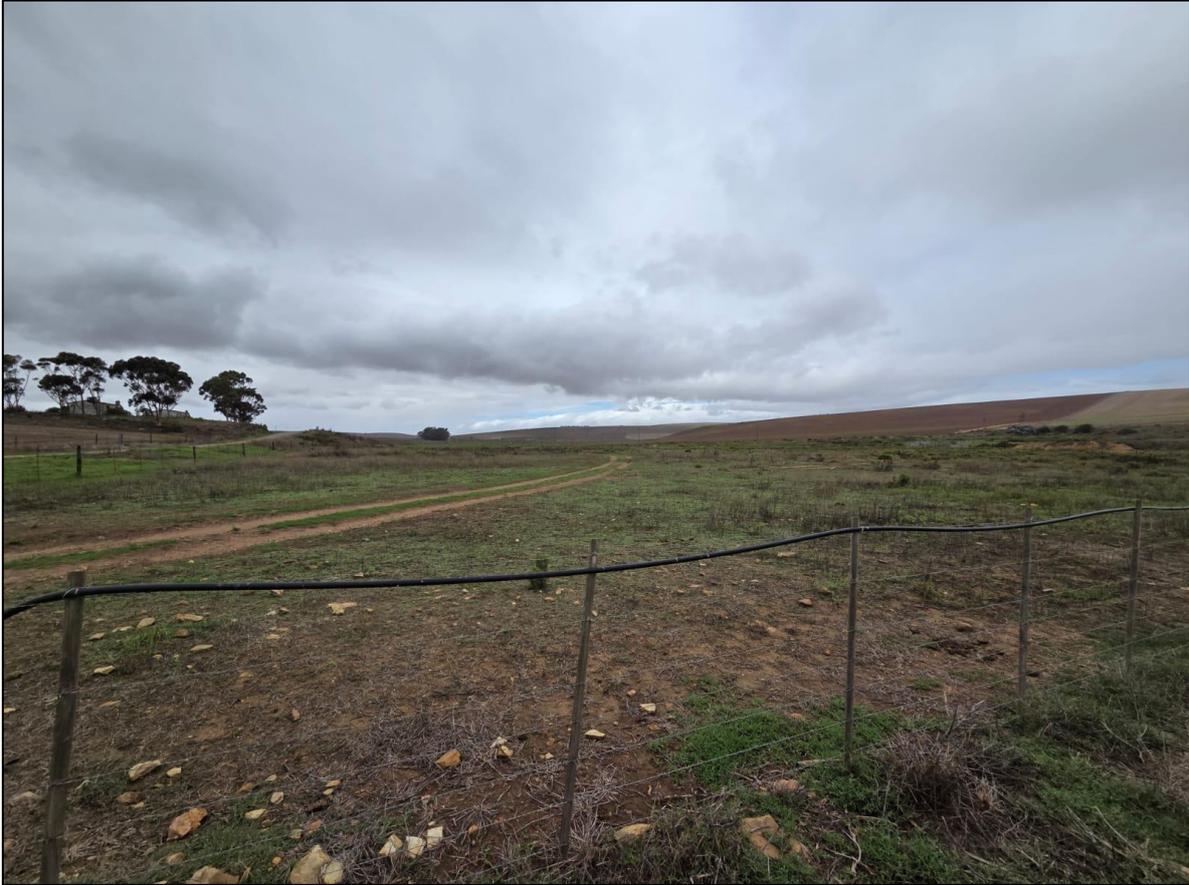
Photo 4. A representative section of the cleared area, illustrating the absence of intact natural vegetation within the cultivated footprint.

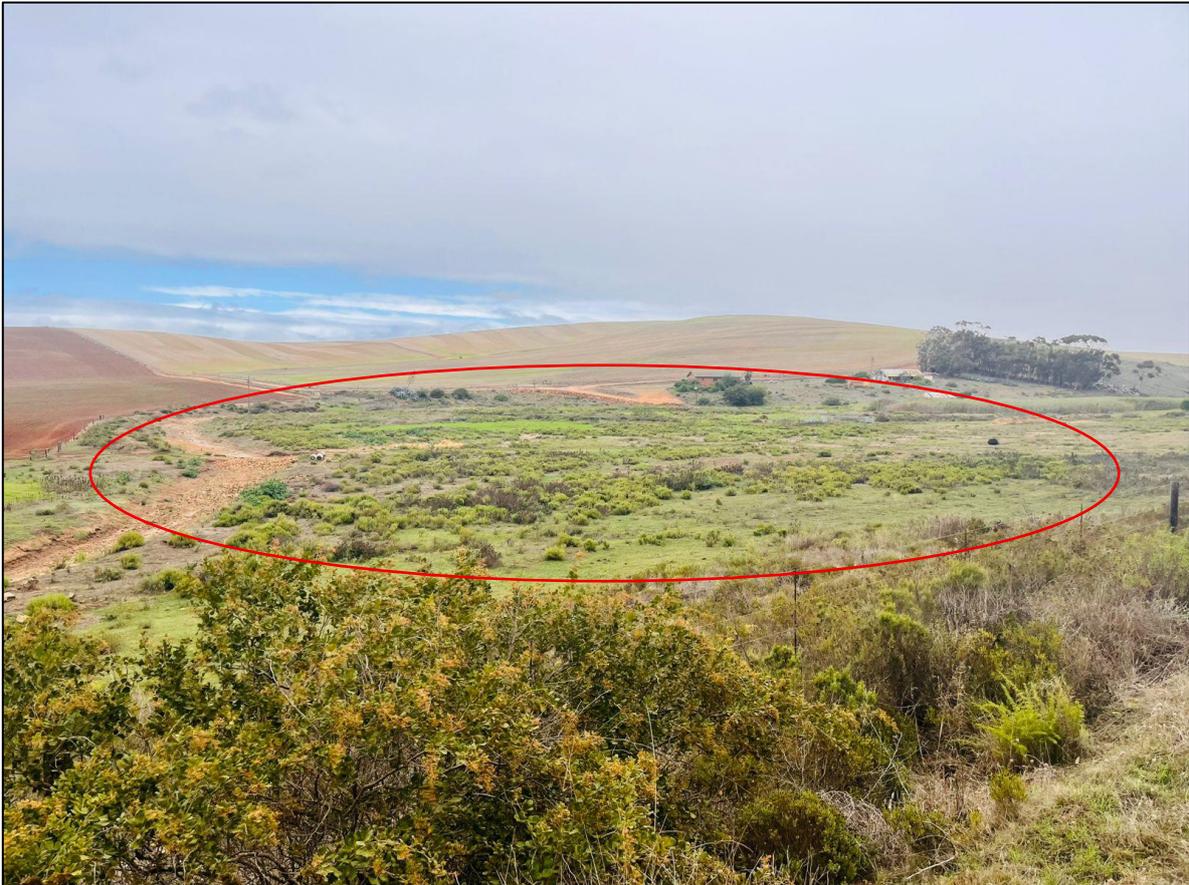
Photo 5. View illustrating the broader agricultural context of the site, demonstrating that the cleared area forms part of a larger transformed landscape.

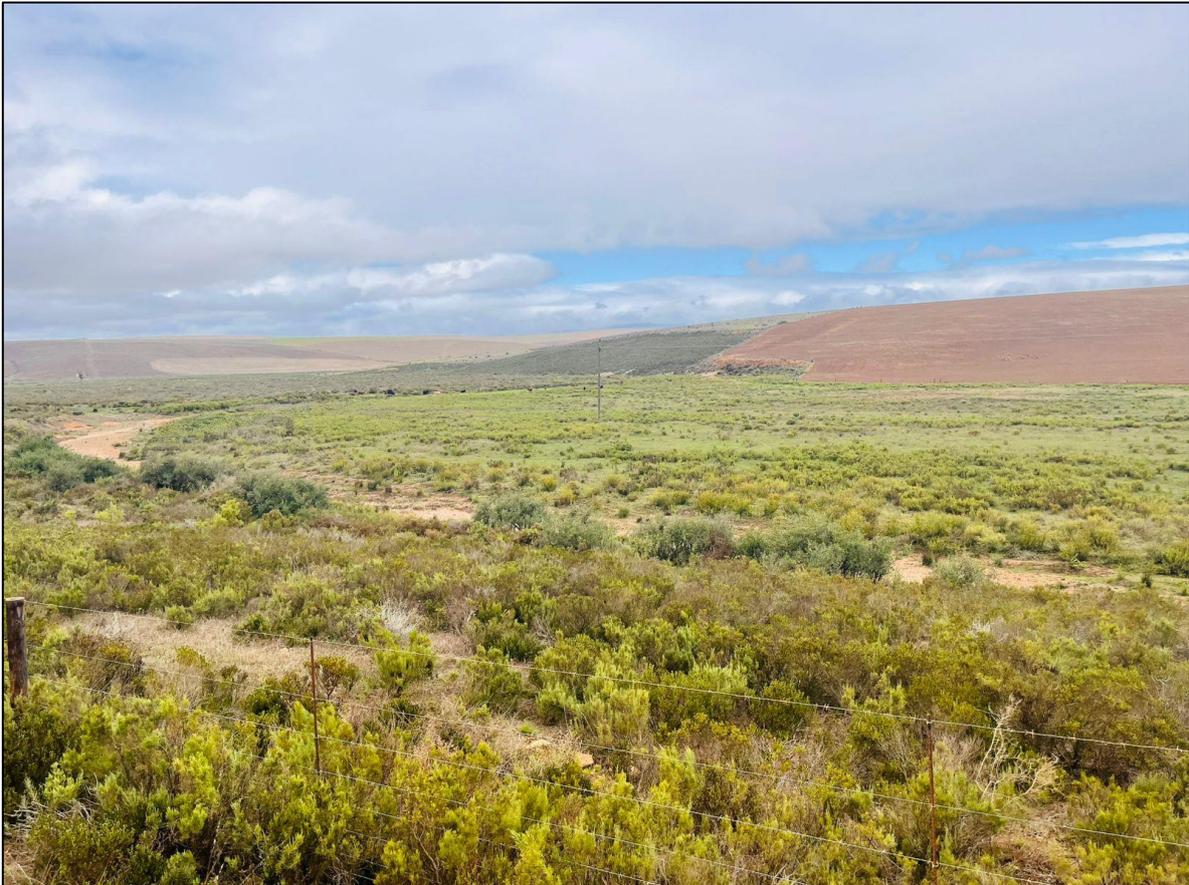
Photo 6. Additional perspective of the cleared footprint, confirming the level of disturbance and the predominance of secondary or transformed vegetation.

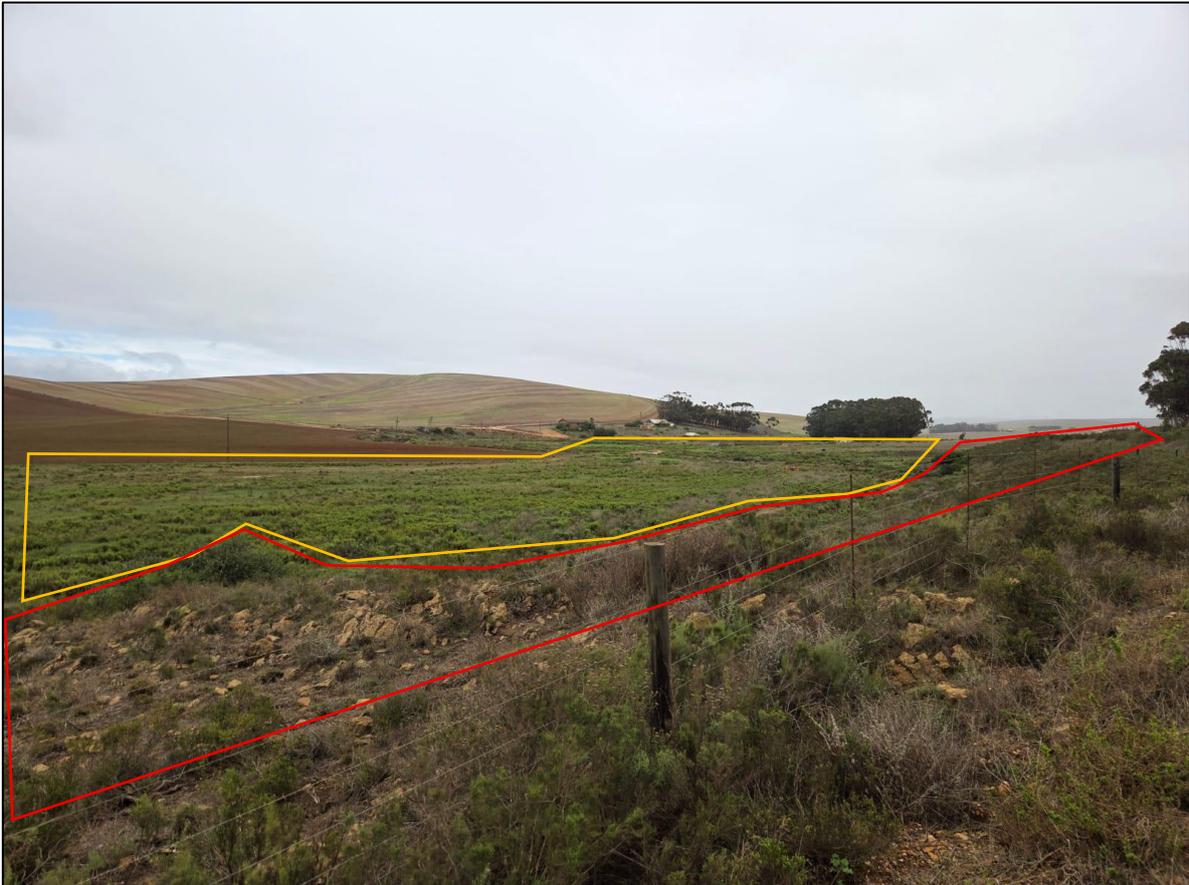
Photo 7. Photograph depicting the boundary between cleared land (Orange) and retained nature (Red).
