LORNAY
ENVIRONMENTAL CONSULTING

Photo Report

Portion 7 of the Farm 116, Bredasdorp

Farm 326, Bredasdorp

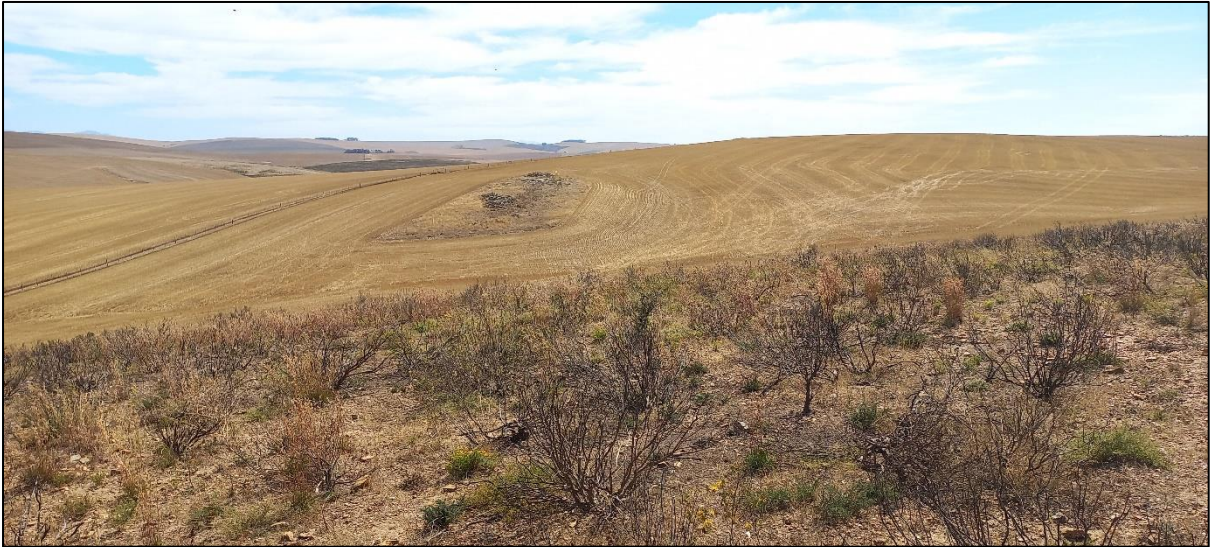
View of the subject property, foreground vegetation indicates the type and state of vegetation typically found in the areas that were cleared. The patch of vegetation in background, is typically what the small patches of cleared areas would have looked like prior to clearance. These patches left between fields have limited biophysical value and are a nuisance to farm operations.

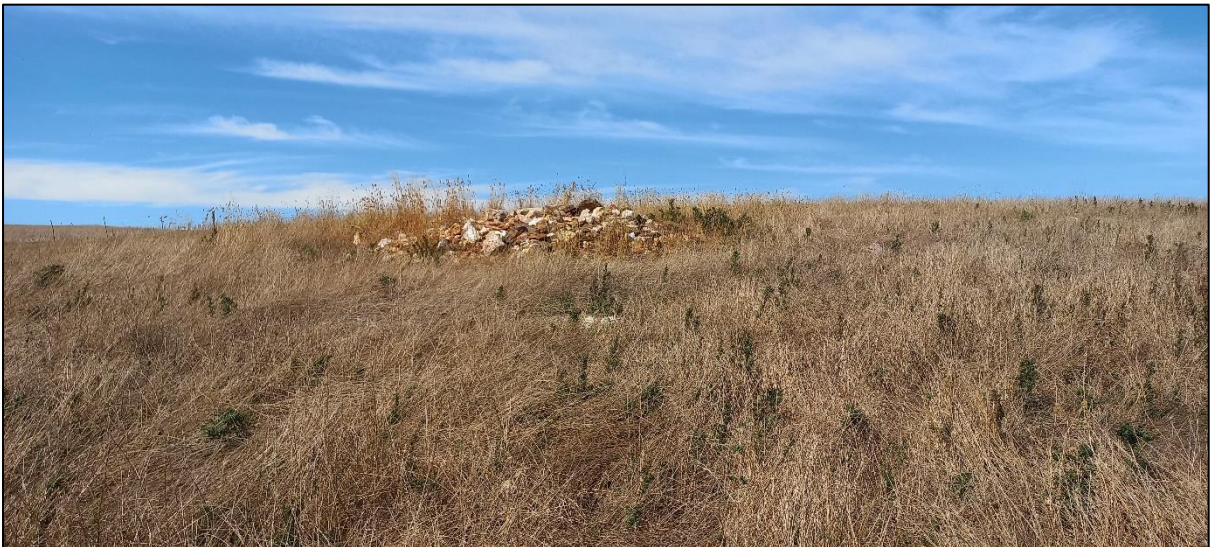
Typical area that would have been cleared. Long since been disturbed by farming practices over the years.

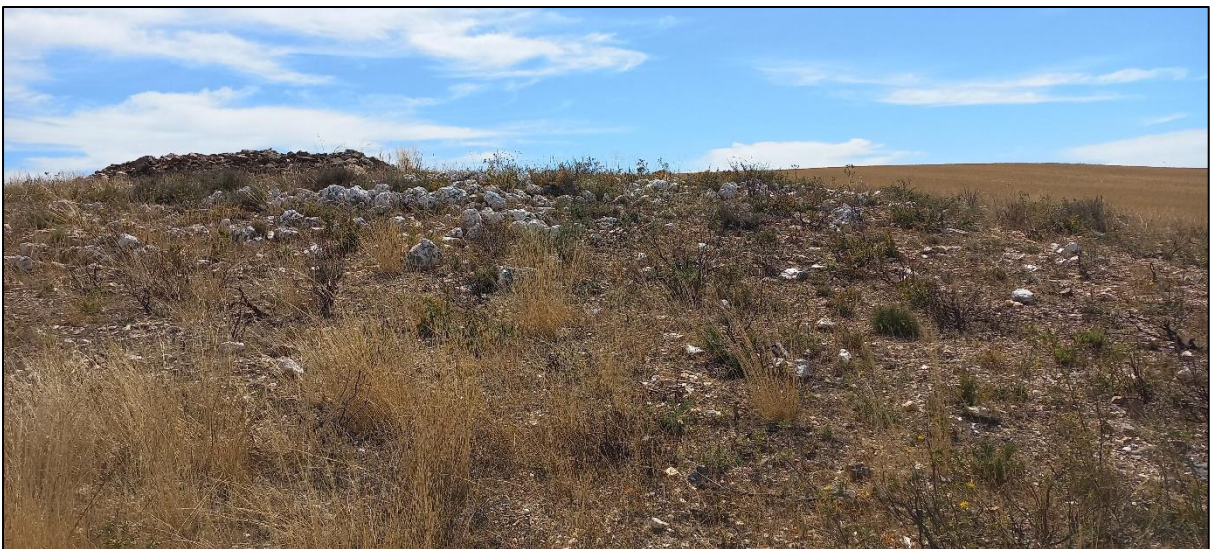
Typical area that would have been cleared. Long since been disturbed by farming practices over the years.

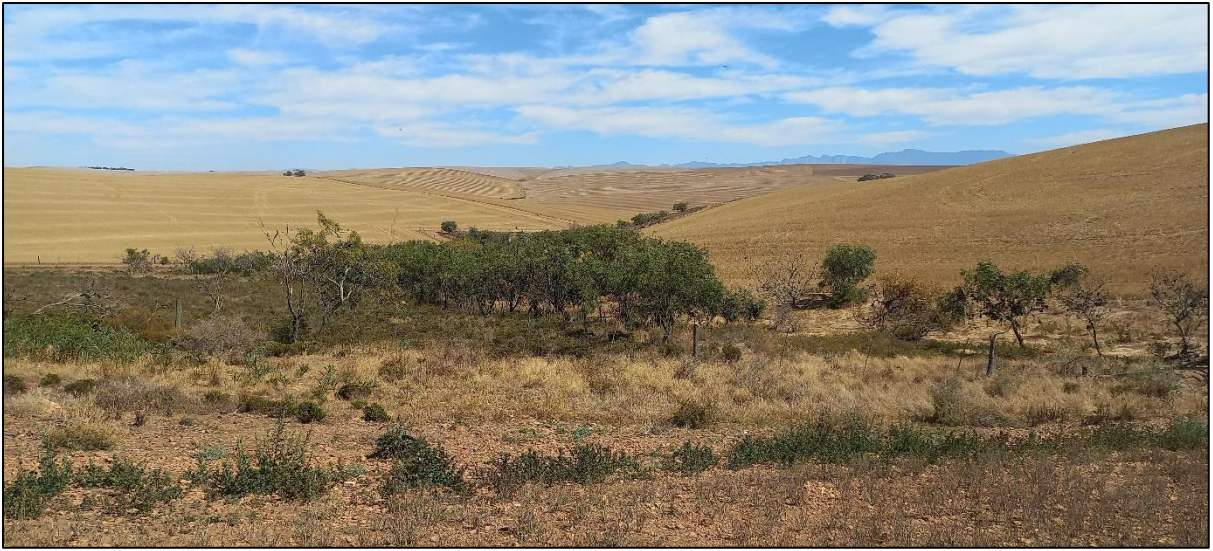
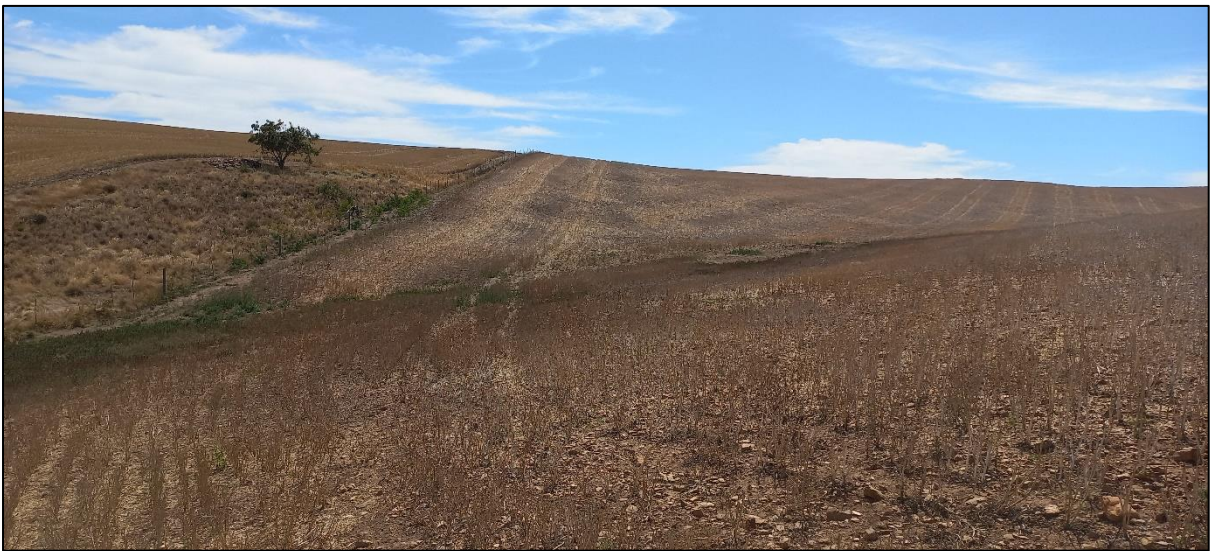
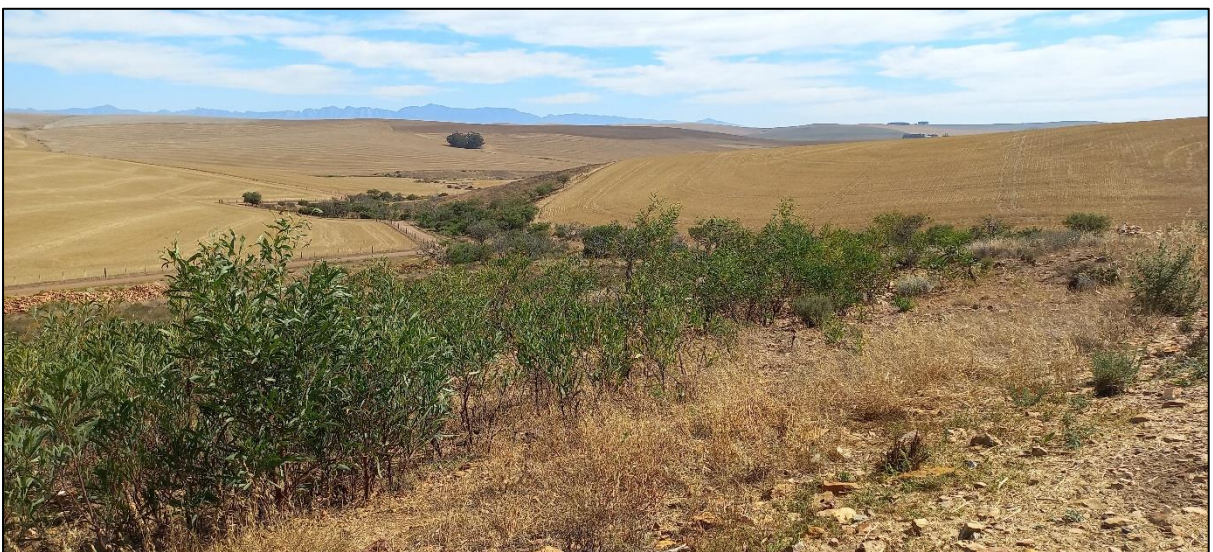
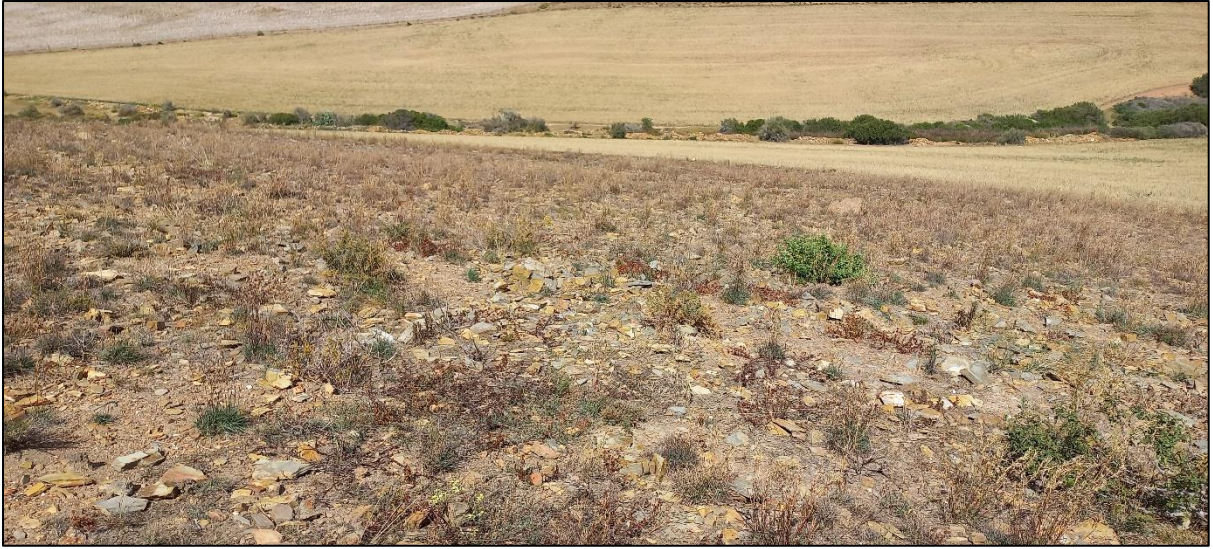
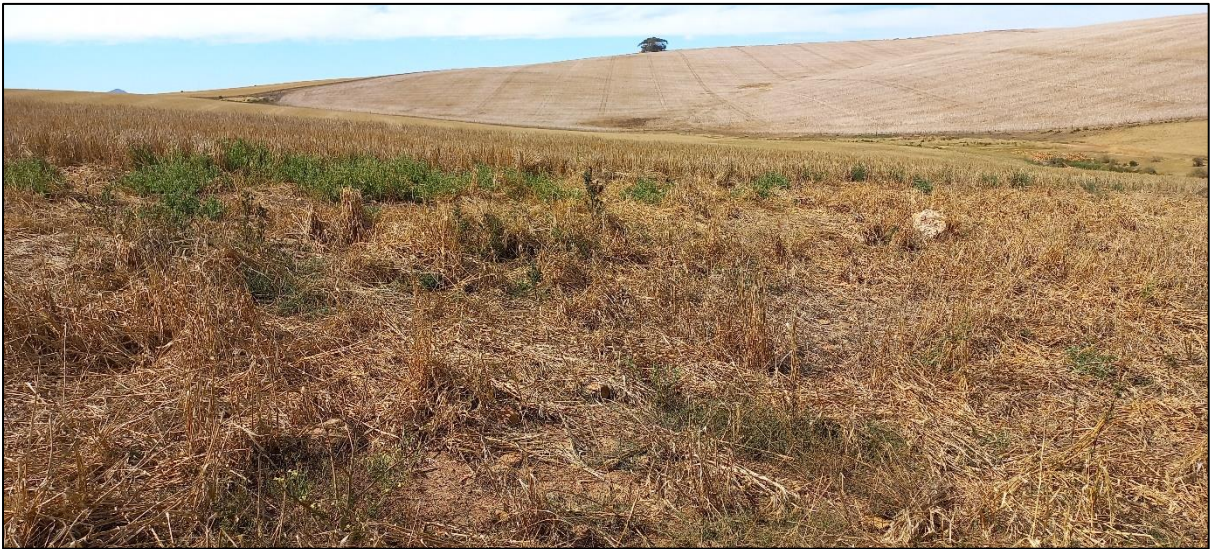
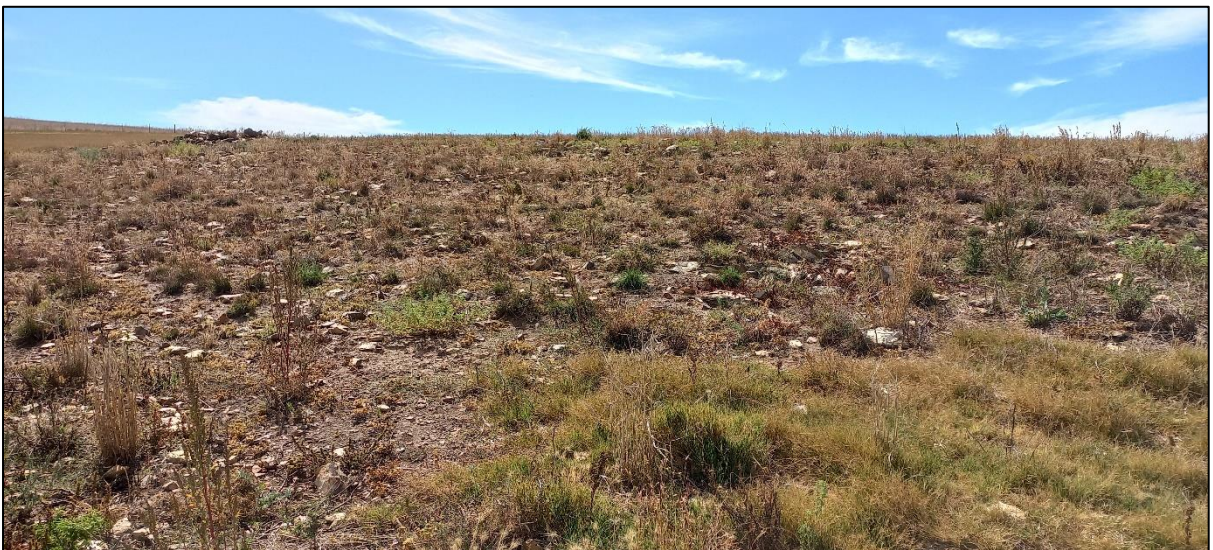
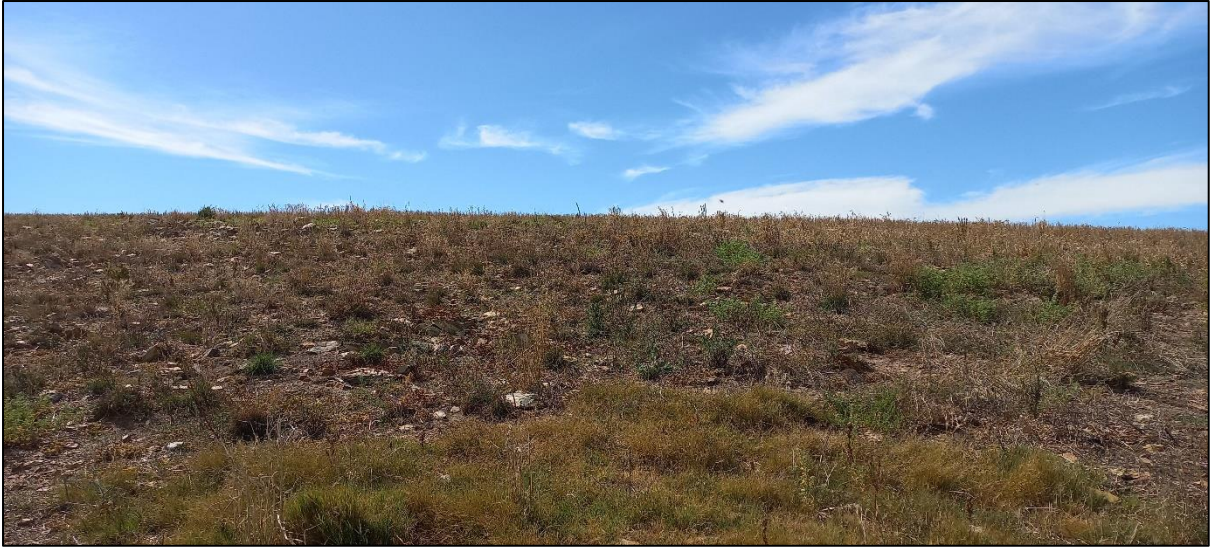
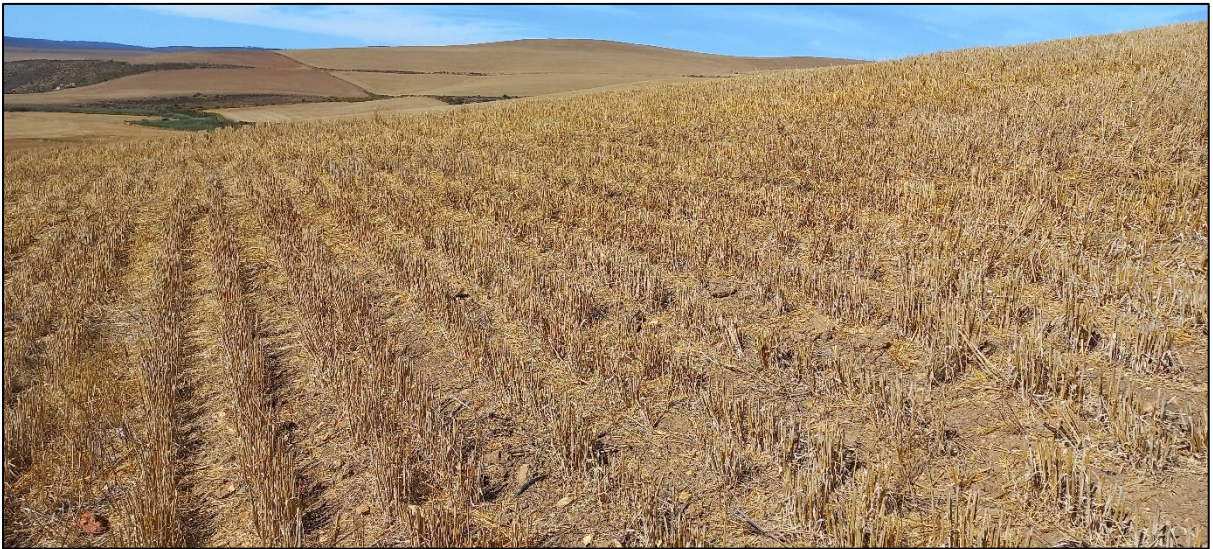
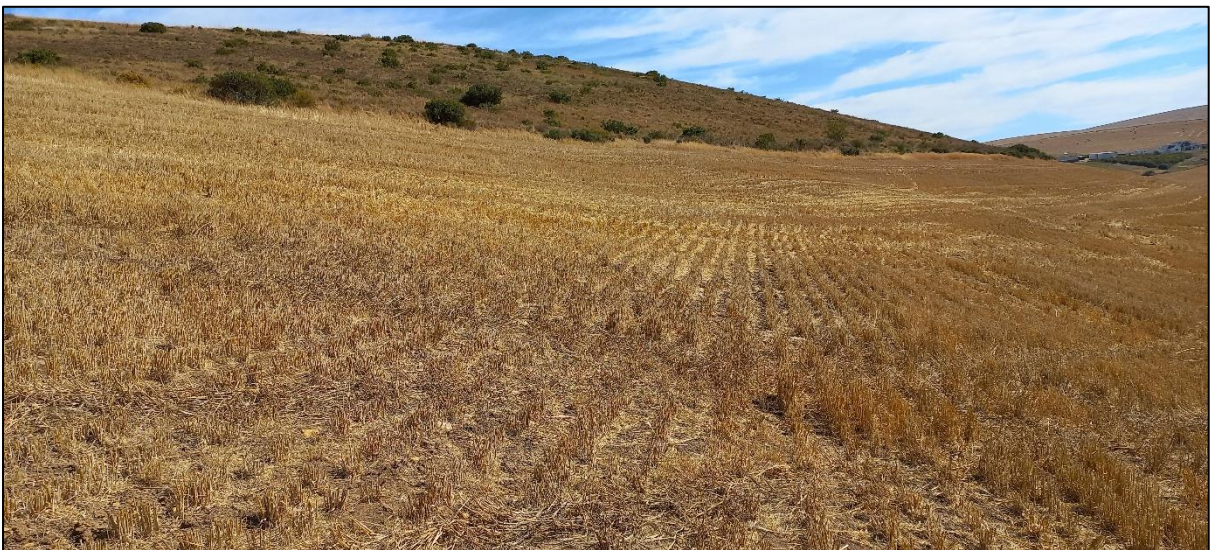
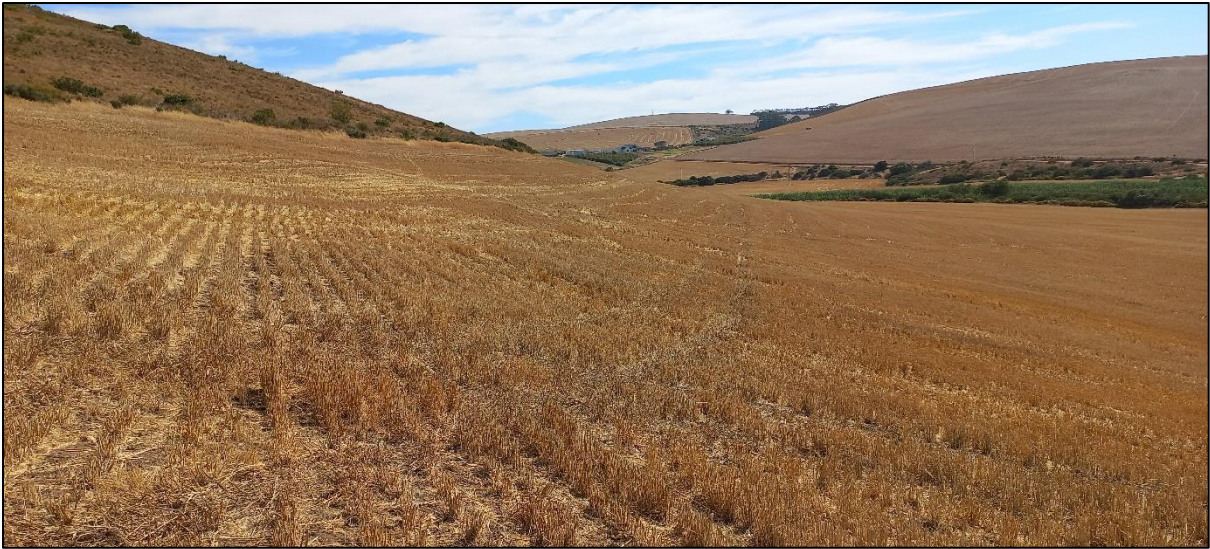
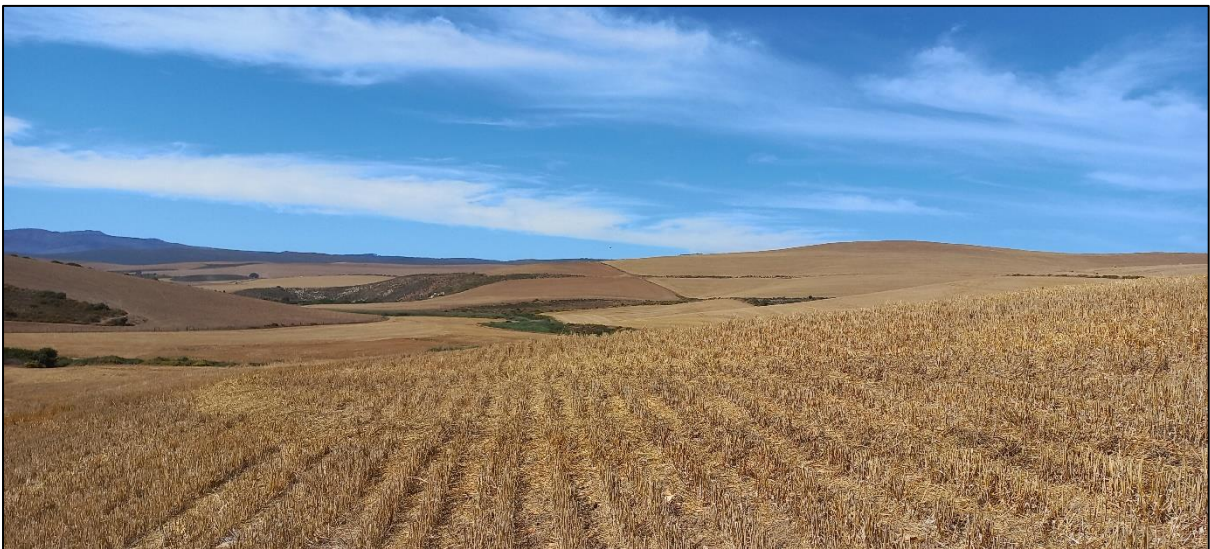
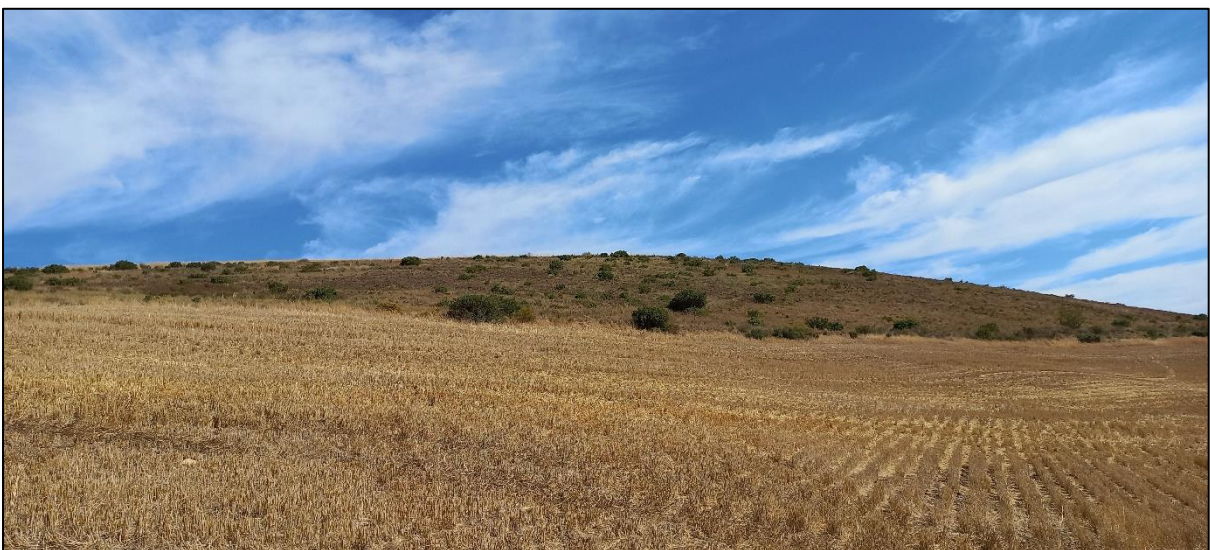
The photos above show various areas across the subject farms. The photos also show the state of the fringe pockets of vegetation and indicate that these small pockets are highly disturbed and do not represent the typical Central Ruens Shale Renosterveld. The intact and remaining larger pockets on the site, in particular Farm 326, have not been disturbed and serve as habitat amongst the cultivated areas.
