Aquatic Biodiversity Impact Assessment

Proposed Apartment Building on Erf 4439, Simons Town, Cape Town

For: Lornay Consulting

August 2024

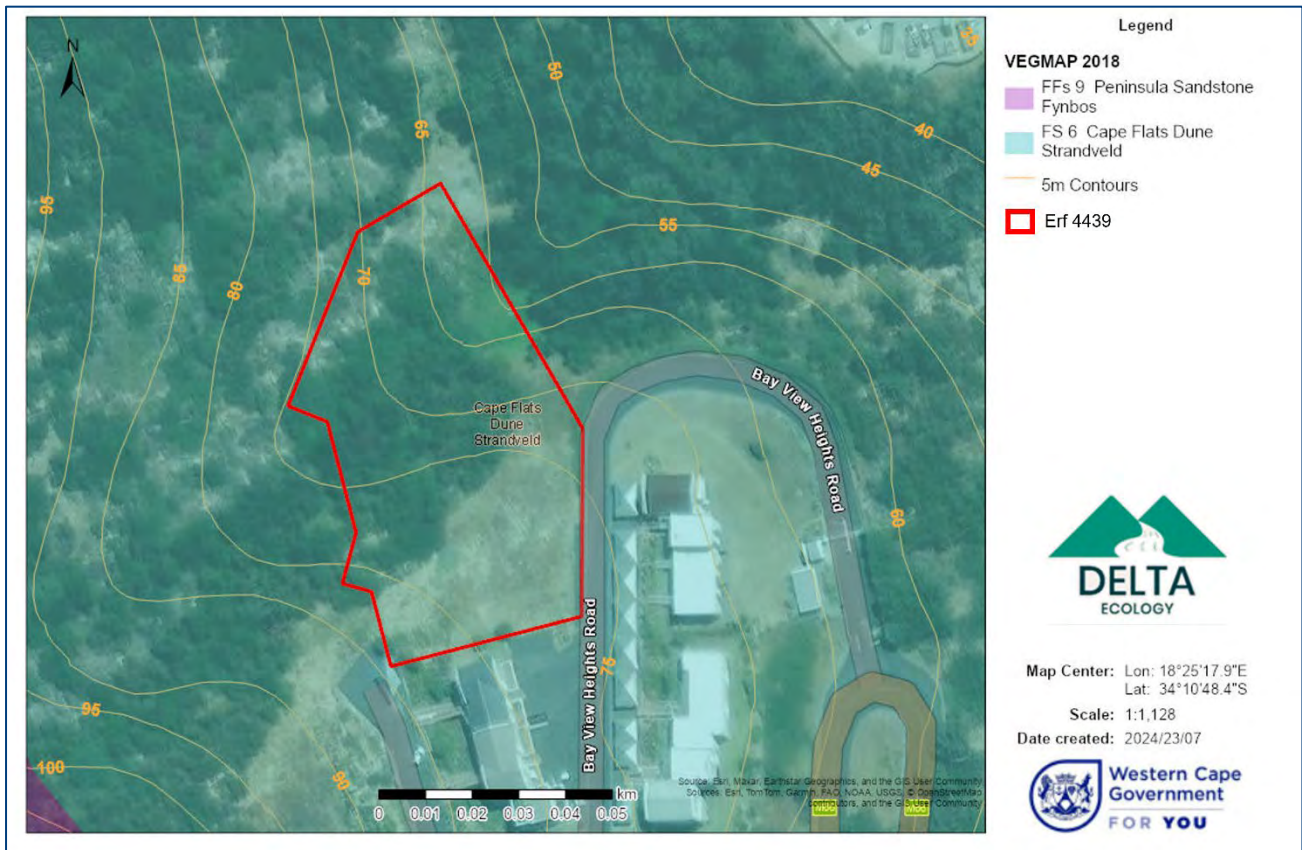
Figure 4-1: Vegetation and topography map.

The proposed site is located on steeply sloped terrain. The site falls from approximately 75 m.a.s.l in the southeast to 52 m.a.s.l in the east with an average gradient of 22% across the site (**Figure 4-1**).

According to the SANBI Vegetation Map (2018), the natural vegetation in this area consists of Cape Flats Dune Strandveld which is listed as Endangered (EN) and Moderately Protected (MP) (**Figure 4-1**). According to the NFEPA spatial dataset (SANBI, 2011), this area corresponds to the Southwest Sandstone Fynbos wetland vegetation type (where wetlands are present) which is also listed as Critically Endangered (CR) and ranges from Zero Protection (ZP) to MP depending on the wetland type.

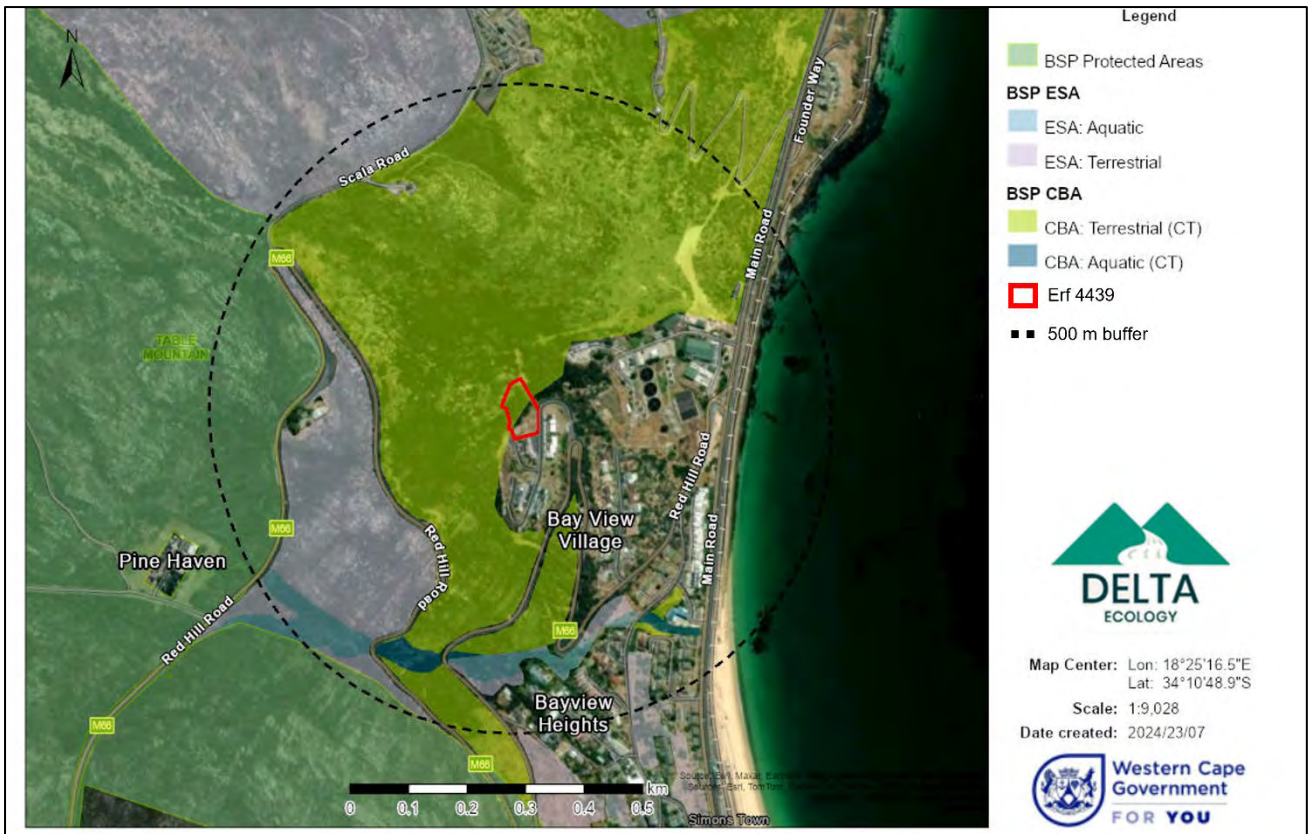
Figure 4-3: CBAs, ESAs and protected areas indicated by the WCBS (2017).

The WCBSP (2017) indicates the presence of a terrestrial Critical Biodiversity Area 1 (CBA 1) within the northern section of the site (**Figure 4-3**). The WCBSP also identifies aquatic CBAs, aquatic Ecological Support Areas (ESA 1), terrestrial CBAs, terrestrial ESAs, and the Table Mountain National Park within the regulated proximity of the site (**Figure 4-3**). This would indicate that the northern portion of the site is of high biological value for conserving terrestrial biodiversity and maintaining ecosystem functioning.

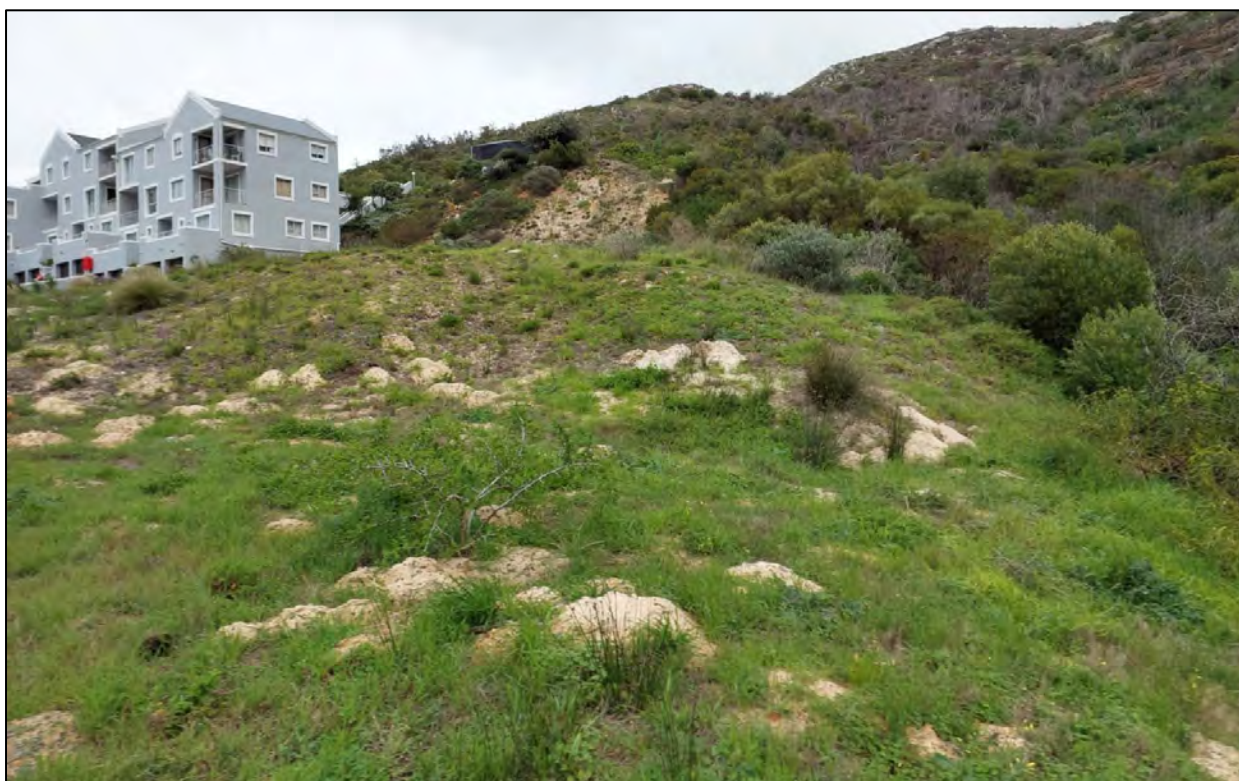
Figure 5-1: Overview of the development area.

The proposed development area is situated in the southern portion of the site, where historical vegetation clearing has occurred, resulting in sparse natural vegetation coverage (**Figure 5-1**). Upon assessment of the site, a non-perennial drainage line was identified within a steep valley located in the north of the proposed development footprint. This drainage line traverses the site in a west to east direction (**Figure 5-2 - Figure 5-5**).

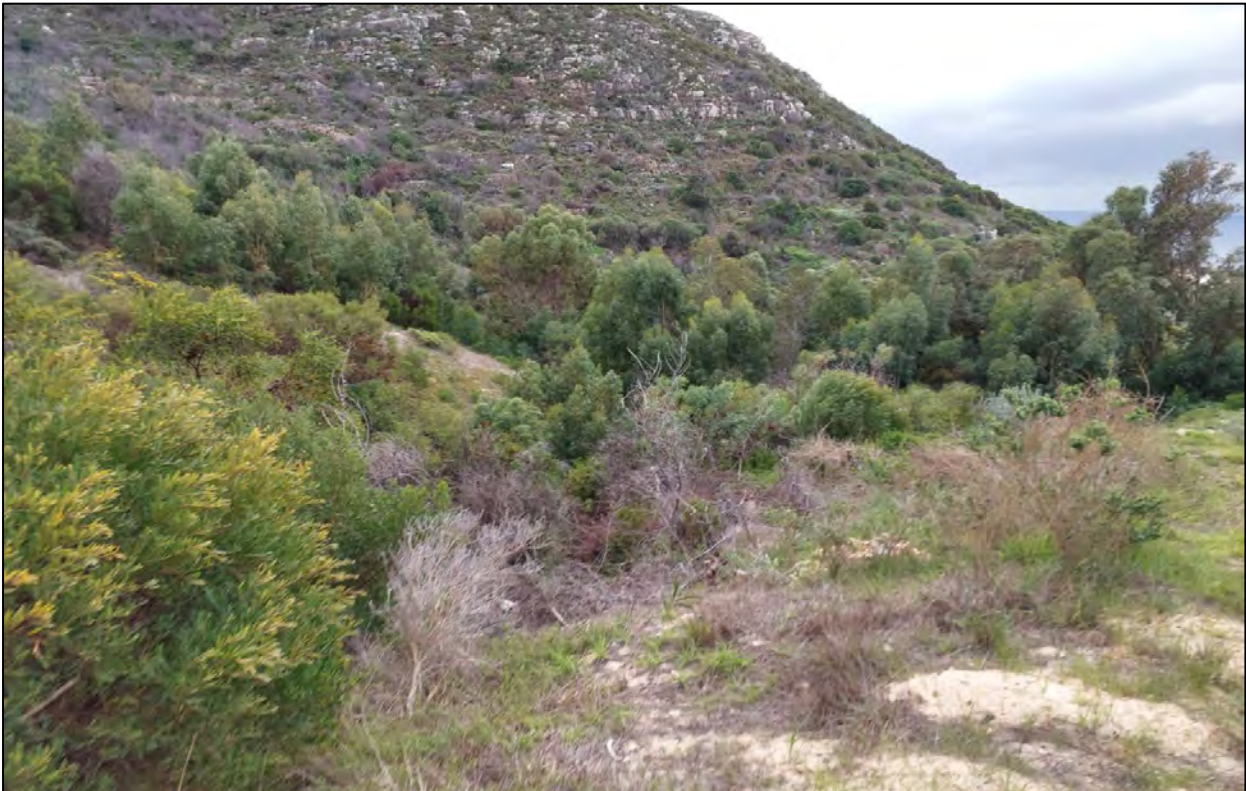
Figure 5-2: The valley within which the non-perennial drainage line flows.

The drainage line comprises a narrow active channel (approximately 0.5 - 1 m wide), with a relatively shallow bed dominated by sand (approximately 0.5 m deep). The drainage line is a non-perennial system which only contains natural surface water flow during the wet season and is fed by direct rainfall and interflow. The riparian area of the drainage line is dominated by alien *Eucalyptus* spp (**Figure 5-6**), interspersed with *Acacia saligna* (Port Jackson) and *Cenchrus clandestinus* (Kikuyu Grass).

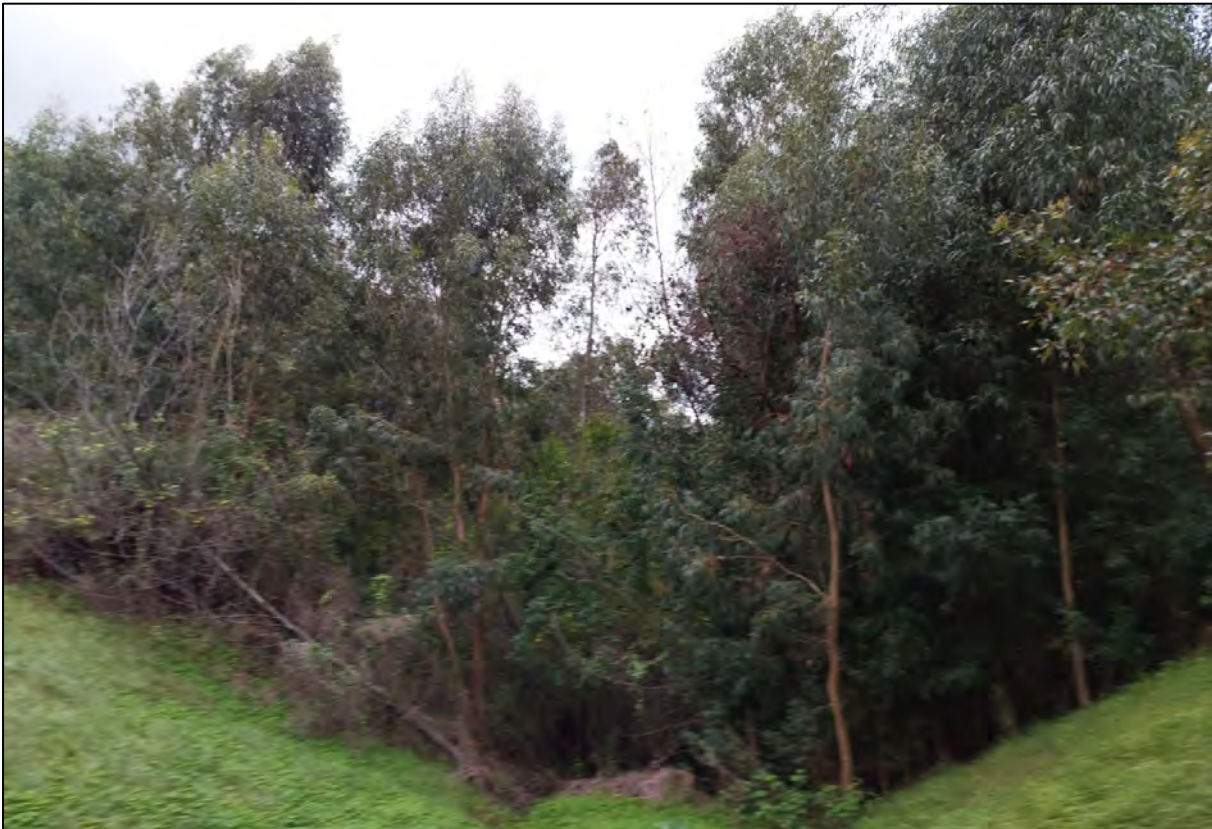
Figure 5-6: *Eucalyptus* trees dominating the steep valley and riparian area of the non-perennial drainage line.

- There is no direct abstraction from the watercourse for domestic use. However, *Eucalyptus* trees within the riparian area would use a significantly greater volume of water when compared to natural vegetation.
- Water quality impairment, including nutrient loading and toxicant supply, tend to favour dense growth of alien invasive species, as observed throughout the watercourse.

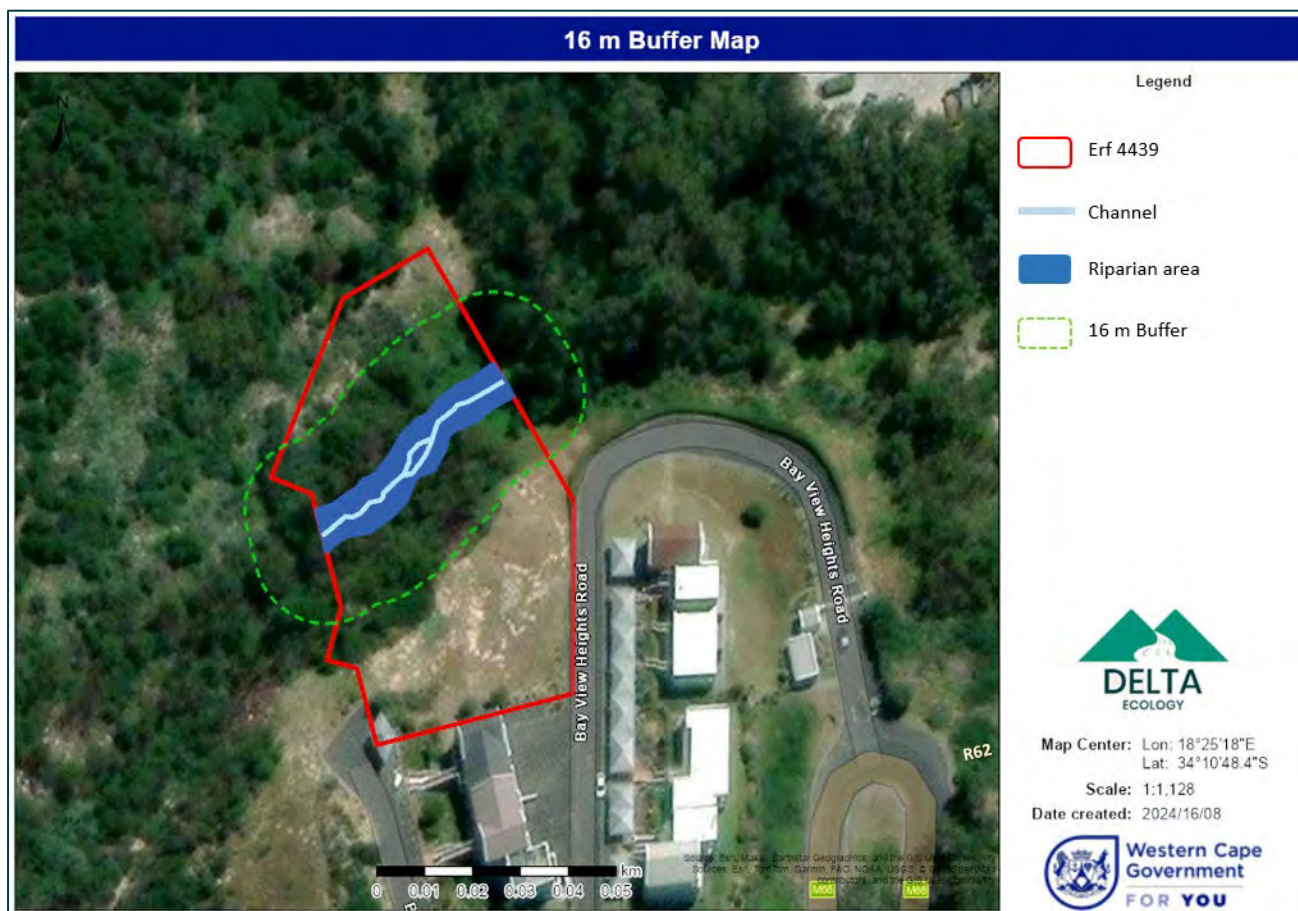
Figure 6-1: Buffer area of 16 m surrounding the non-perennial stream.

An appropriate buffer of 16 m for the drainage line, during the construction and operational phases of the proposed development, has been determined using the method described in the Buffer Zone Guidelines for Rivers, Wetlands and Estuaries (Macfarlane and Bredin, 2016). The recommended buffer is shown in **Figure 6-1** below. It is noted that the complete avoidance of the buffer area will not be possible, as the proposed apartment building encroaches into the buffer zone. It is recommended that all non-essential construction and operational related activities must be strictly prohibited within the 16 m buffer (e.g. construction camps, laydown areas, mixing of cement, stockpiling of soils, ablution facilities etc).
