Aquatic Biodiversity Impact Assessment

Portion 36 of Farm Franche Kraal 708, Overberg

For: Lornay Environmental Consulting

August 2024

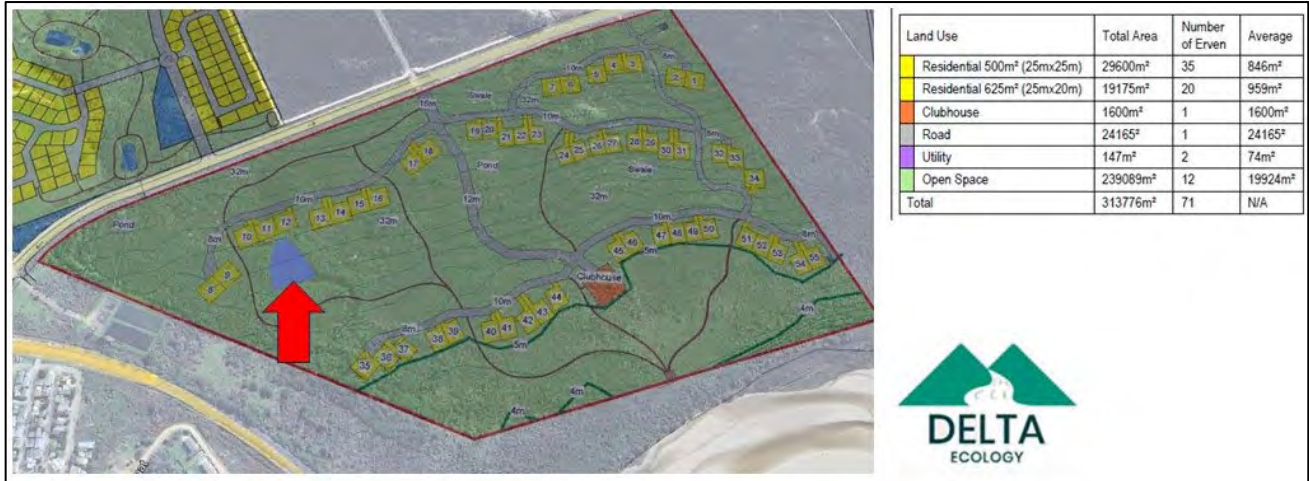
Figure i: Wetland area to be conserved and rehabilitated.

It is recommended that the relatively natural portion of the seep wetland indicated by the red arrow in **Figure i** below is avoided by construction activities, and maintained within a likely larger area to be rehabilitated during the Offset process:

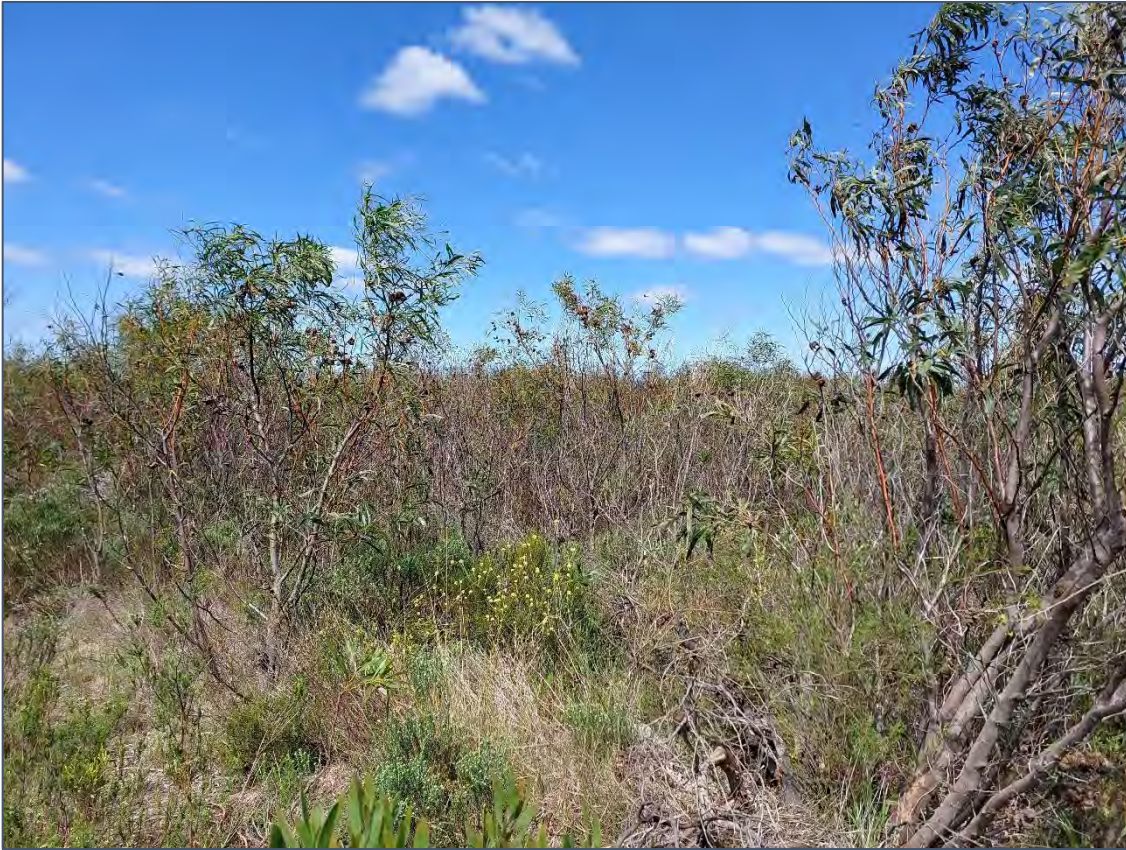
Figure 5-1: Dense stands of alien invasive *Acacia saligna*.

The majority of the site is considered to be highly degraded, consisting of dense stands of alien invasive *Acacia saligna* (Port Jackson) which competes with and replaces indigenous vegetation (**Figure 5-1**). Indigenous wetland vegetation was therefore lacking across much of the site. The alien plant *Myoporum insulare* (Common Boobialla) and *Cenchrus clandestinum* (Kikuyu grass) was also noted onsite (**Figure 5-2** and **Figure 5-7**).

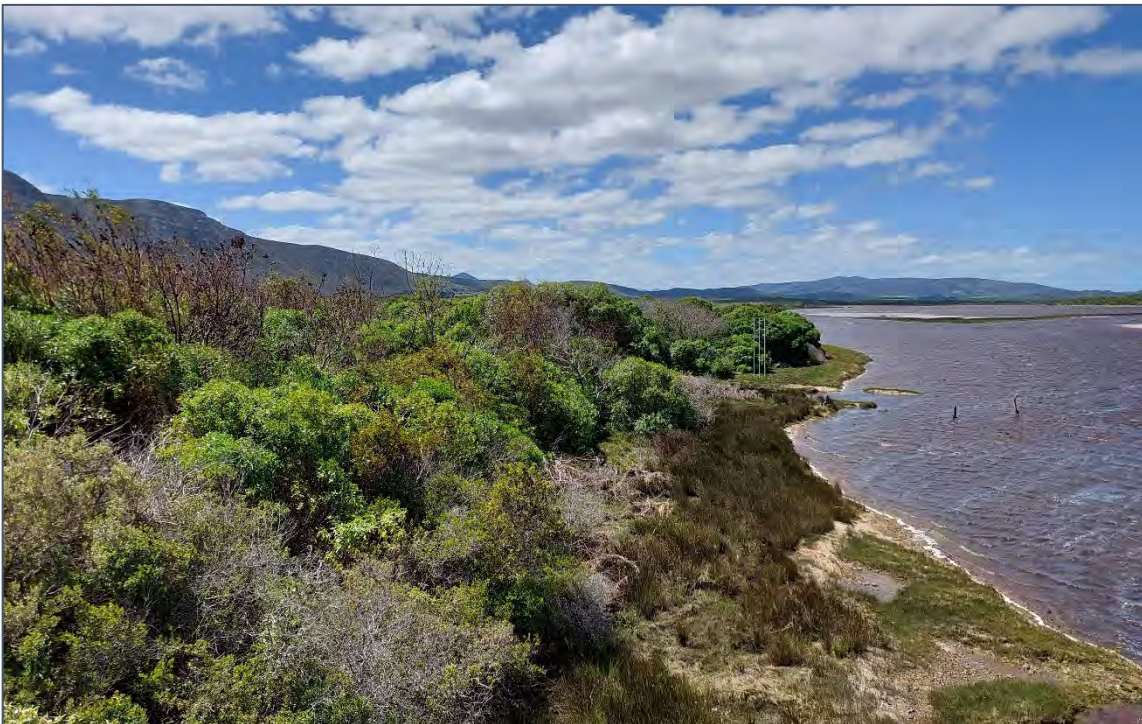
Figure 5-12: Uilkraals Estuary and associated estuarine functional zone.

The majority of the site exhibited wetland indicators, and was subsequently classified as a seep wetland, apart from a small terrestrial portion in the north of the site (**Figure 5-13**). The Uilkraals Estuary and associated estuarine functional zone borders the site to the south - southeast (**Figure 5-12** and **Figure 5-13**).

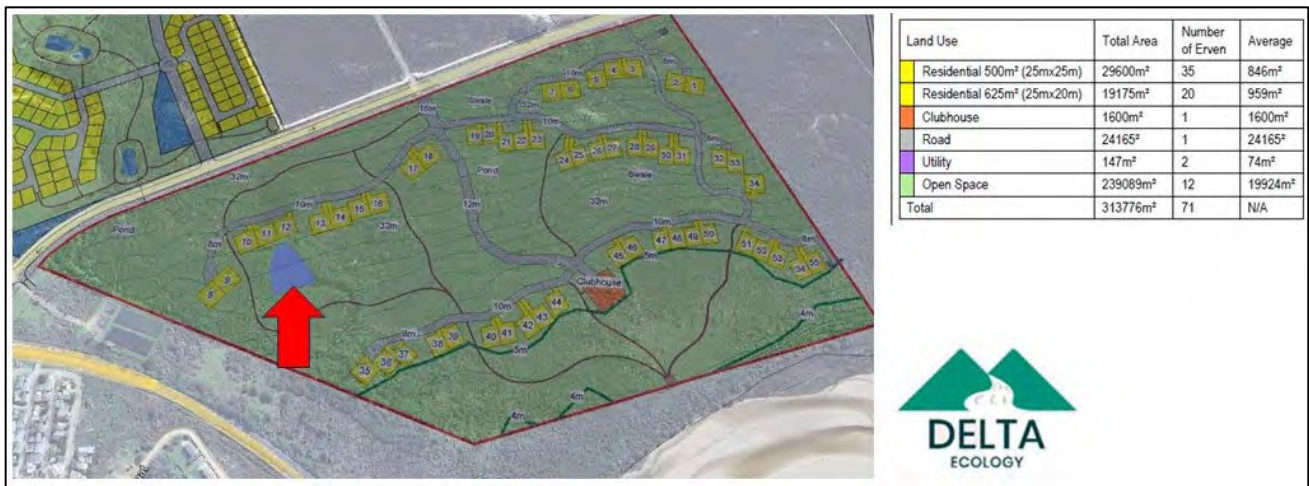
Figure 10-1: Wetland area to be conserved and rehabilitated.

It is recommended that the relatively natural portion of the seep wetland indicated by the red arrow in **Figure 10-1** below is avoided by construction activities, and maintained within a likely larger area to be rehabilitated during the Offset process:

In particular, Layout Alternative 2 is supported as it ensures that flow is maintained to the downstream Uilkraals Estuary along the western Rehabilitated wetland area and in the central area of the site. The relatively natural portion of the seep wetland indicated by the red arrow in **Figure 10-1** is avoided and maintained within a larger area to be rehabilitated during the Offset process. Additionally, Layout Alternative 2 includes a buffer area surrounding the Uilkraals Estuary of more than 75 m (as recommended) during construction and operation of most essential aspects of the estate.
