EnviroSwift

Freshwater Ecological Assessment:

Proposed development of tourism accommodation facilities at Rusty Gate Mountain Retreat comprising Farm No. 824, Remainder Farm No. 826 and Farm No. 887, Caledon, Theewaterskloof Municipality

Date: 19.02.2024

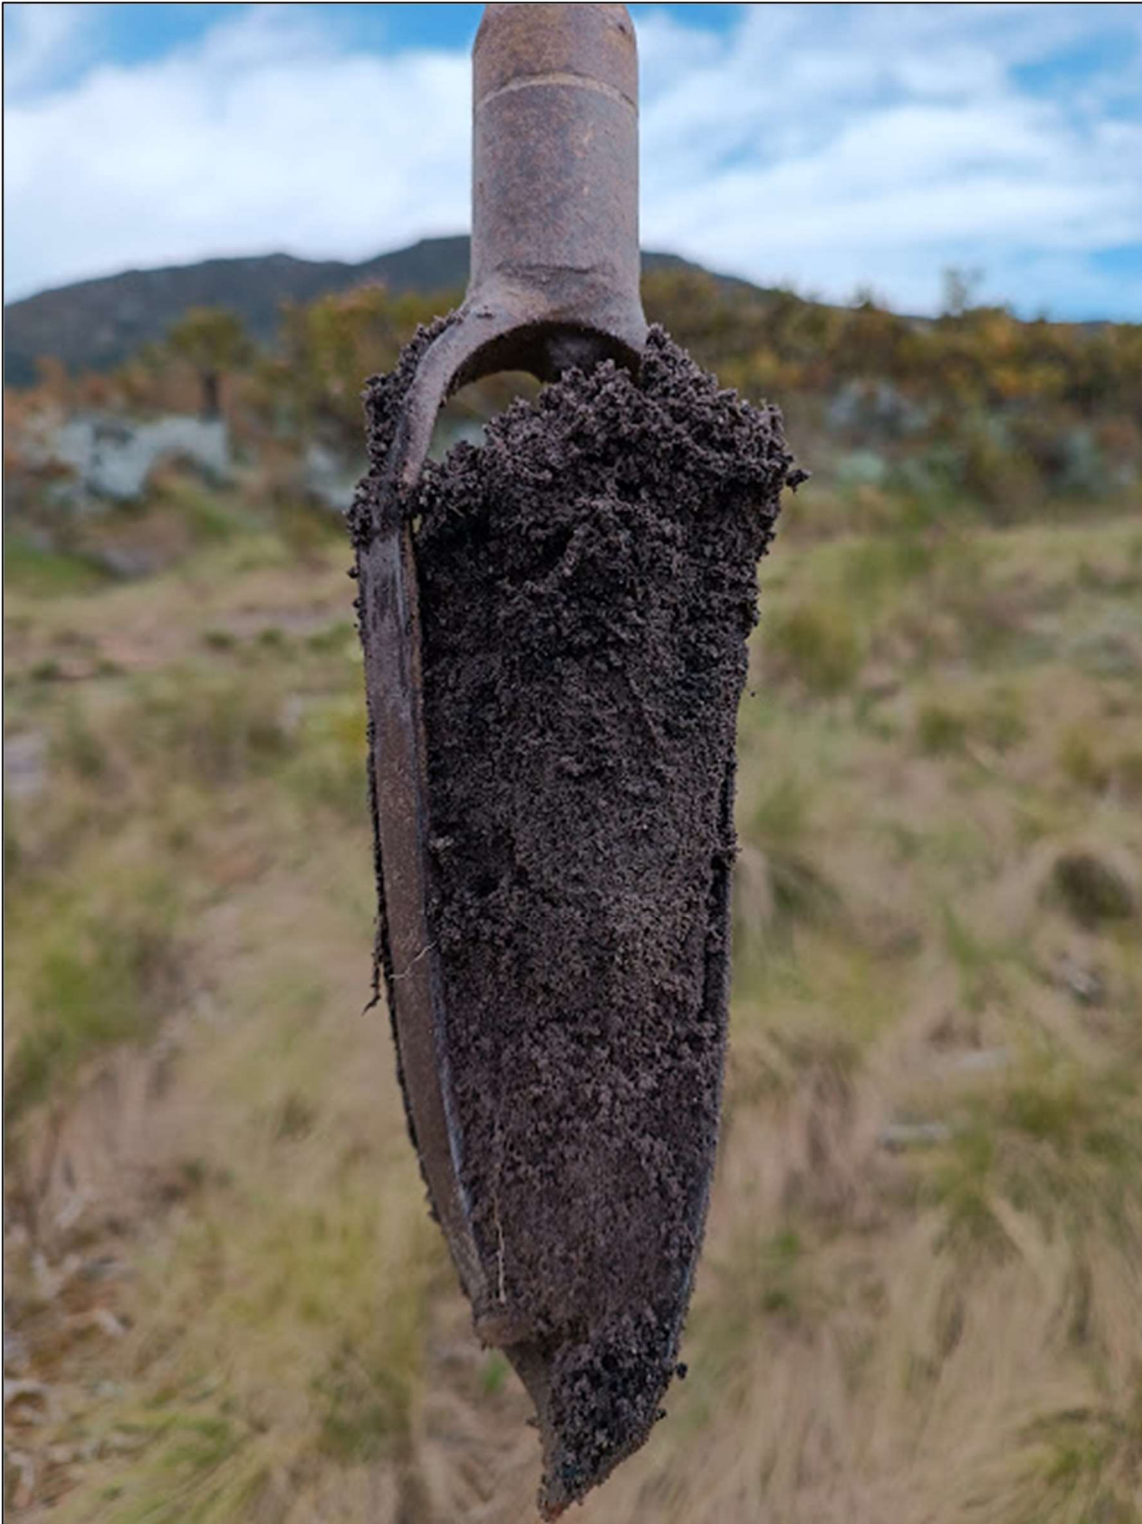
Figure 9: Soil auger sample taken from within the seep identified at Site 27. The dark, low chroma and high organic content is characteristic of wetland soils in quartzitic sands.

Augering across Rusty Gate Mountain Retreat revealed two distinct soil types. In the extreme west near Sites 26 and 27 the soils were found to be quartzitic with a low clay content. The seeps identified in this area were characterised by dark, low chroma soils with a high organic content (see Figure 9). The soils augered from the central part of the site in the vicinity of the proposed campsite (Site 3A) were reddish indicative of a high clay content (see Figure 10). These two soil types are largely aligned with the two differing areas of underlying geology *viz-a-viz* quartzitic sandstone and shale as indicated in Table 6.

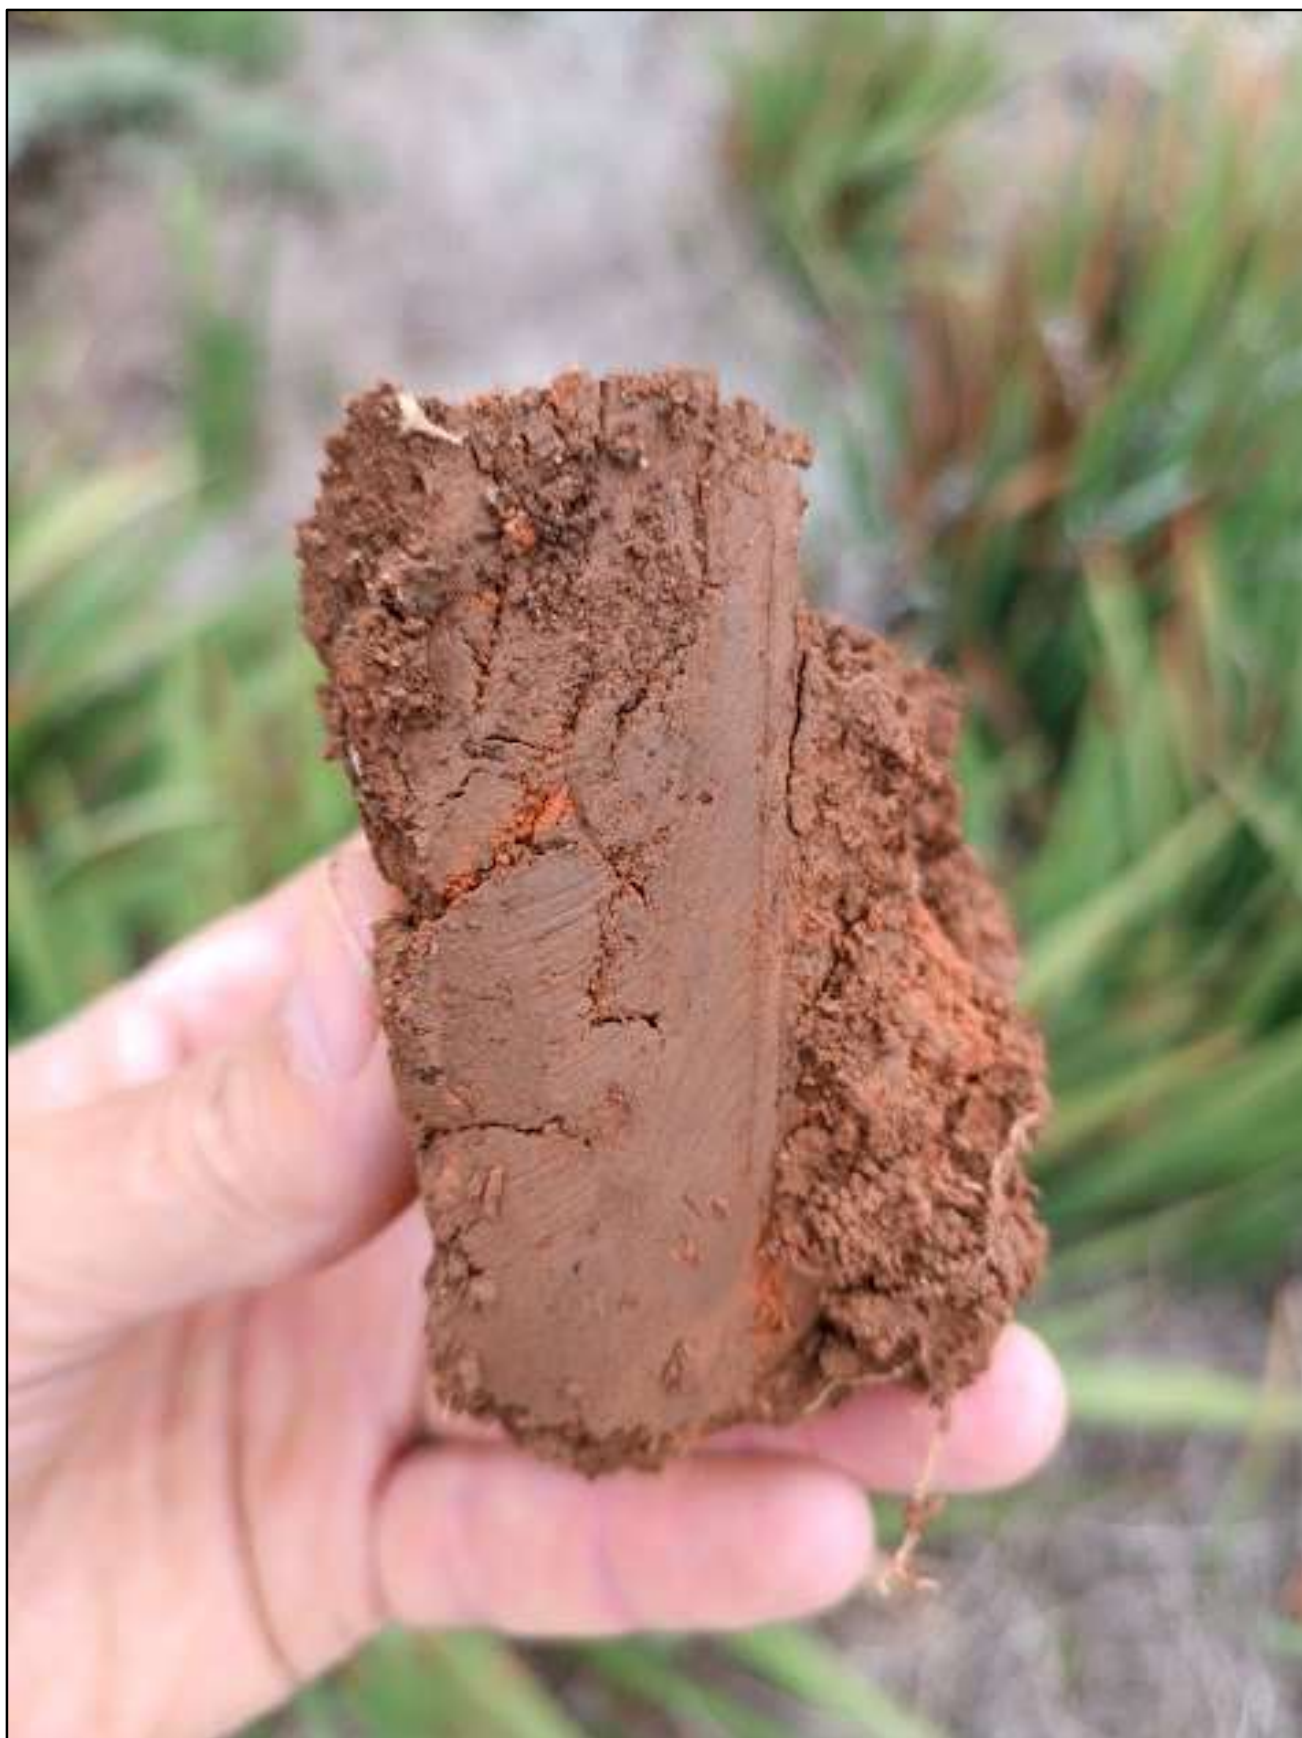
Figure 10: Reddish soils with a high in clay content as augered near Site 3A.

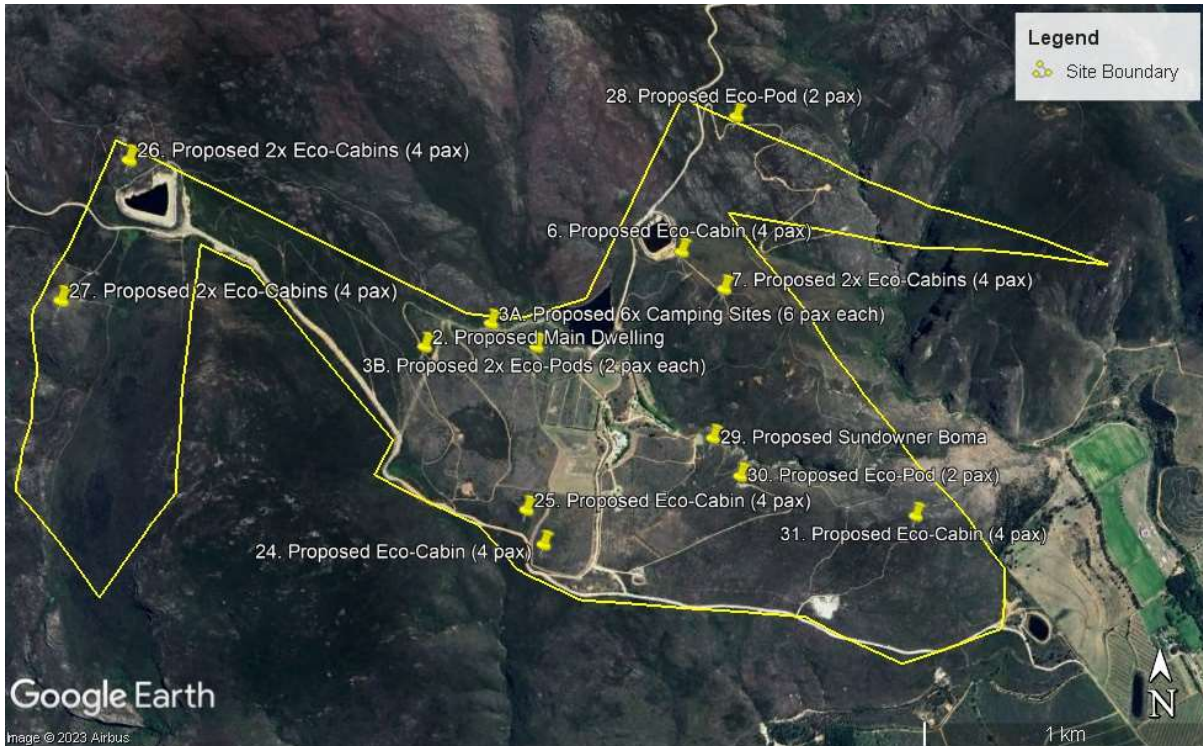
Figure 12: Proposed location of new accommodation units and the new campsite.

Given that single or double unit accommodation units are proposed in various locations across the site which is extensive and includes several minor catchments, it is considered appropriate to provide a brief description of the each proposed site with specific reference to the presence of wetlands and drainage lines. Note that only the directly affected aquatic feature is discussed, if any. The various sites proposed for development are shown in Figure 12 below.

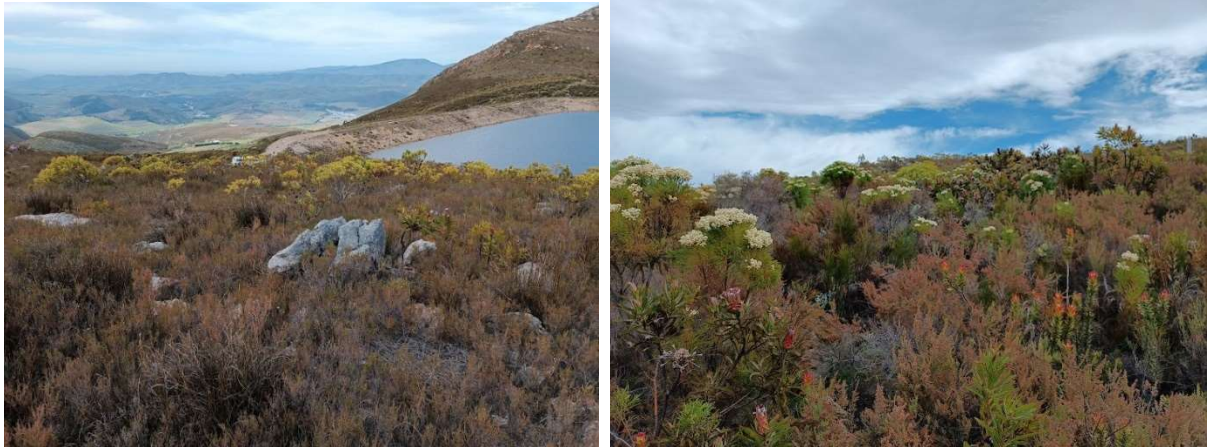
Figure 14: Photos of the proposed site for 2 Eco Cabins (left) and the seep which lies downslope from the site indicated by the presence of *Berzelia lanuginosa*.

Two Eco Cabins are proposed at Site 26 which is positioned to the north of and overlooking a dam (see Figure 13). A hillslope is situated between the proposed cabin site and the dam. The presence of the wetland obligate *Berzelia lanuginosa* was the primary informant in determining the existence of the seep (see Figure 14).

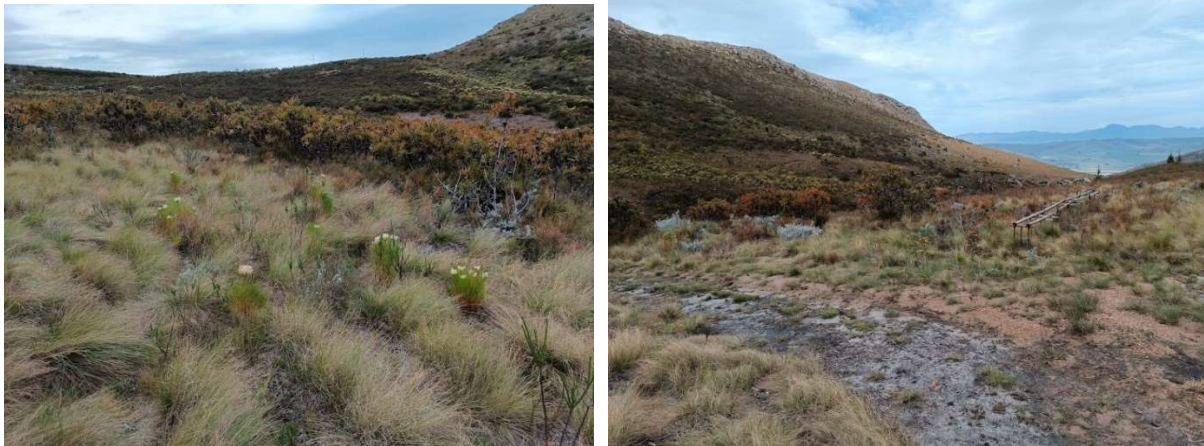
Figure 16: Photos of the wetland seep indicated by various grasses interspersed with *Berzelia lanuginosa*.

Two Eco Cabins are proposed as Site 27 which is located on the east-facing side of a small valley that contains a mapped non-perennial drainage line that flows in a southerly direction. A significant part of the drainage line extending up and down the valley from the proposed site was determined to comprise a hillslope seep (see Figure 15) which becomes an unchannelled valley bottom wetland as the valley drops off to the south. Vegetation including the presence of *B. lanuginosa*, *Pteridium* sp. (bracken) and the grass *Pennisetum macrourum* (see Figure 16) as well as auger samples which revealed dark soils high in organic matter and very wet (see Figure 9) were the primary informants in confirming the existence of the seep.

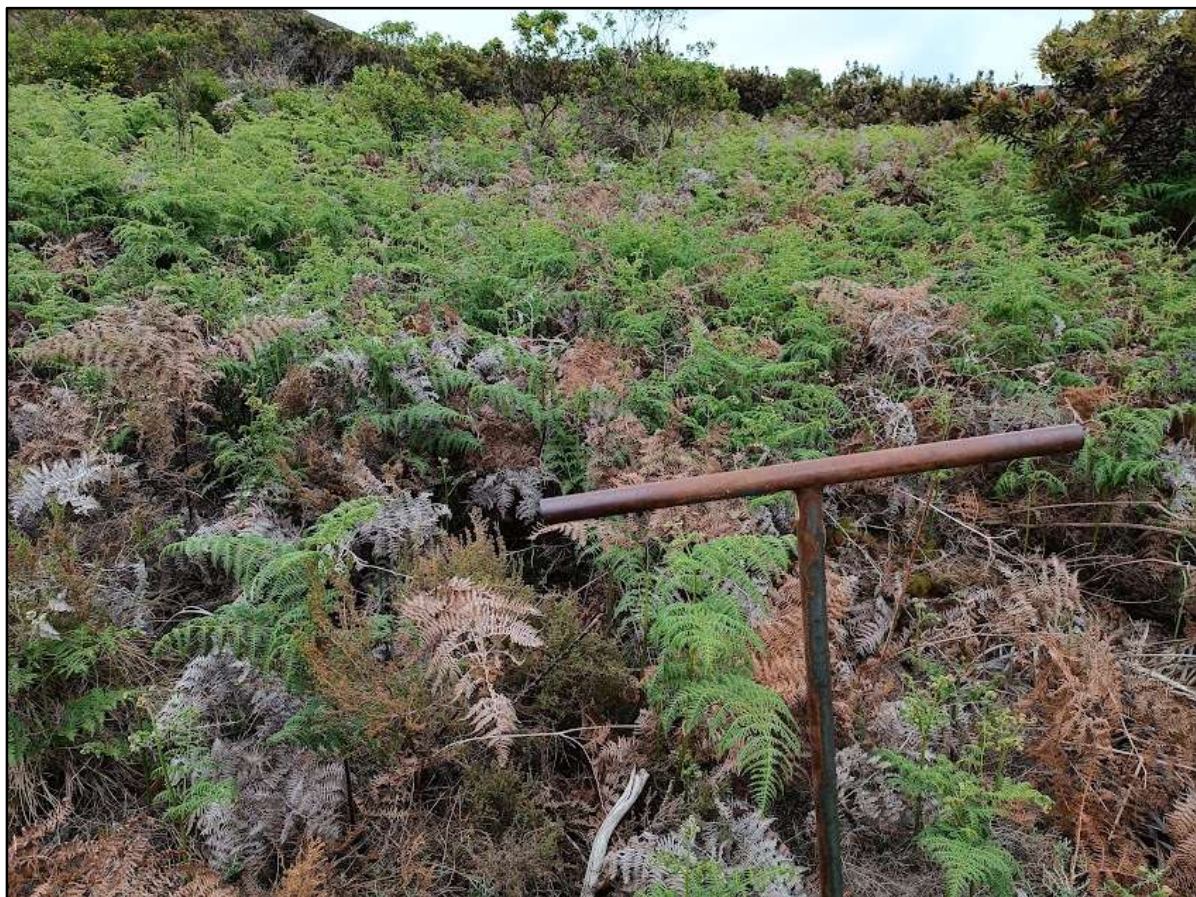
Figure 17: Bracken-dominated seep identified near the proposed location of the new primary dwelling (Site 2).

Site 2 is the proposed location of a new residence for the landowner. A bracken-dominated hillslope seep was identified approximately 25m south east of the site (see Figure 17) and extending down the slope towards the proposed campsite site (Site 3A). This seep comprises the upslope part of the large hillslope seep that is identified in the NWM5 Map (see Figure 7).

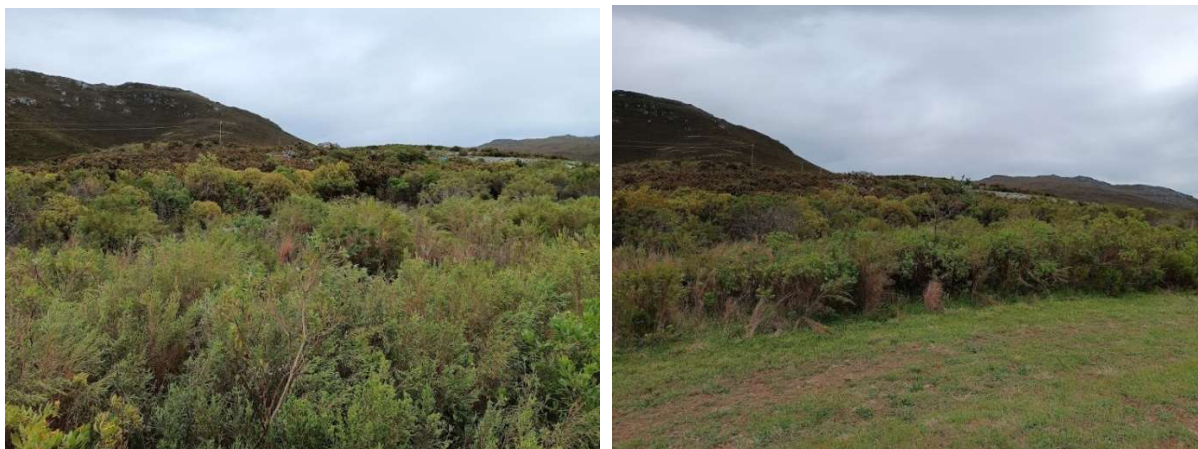
Figure 18: Photos of the proposed location of Site 25 showing the terrestrial habitat that comprises the site and its immediate surroundings.

Site 25 is the proposed location of a single Eco Cabin. The site and its immediate surroundings showed no signs of the presence of aquatic habitat (see Figure 18). Utilisation of this site presents no risks to aquatic habitat.

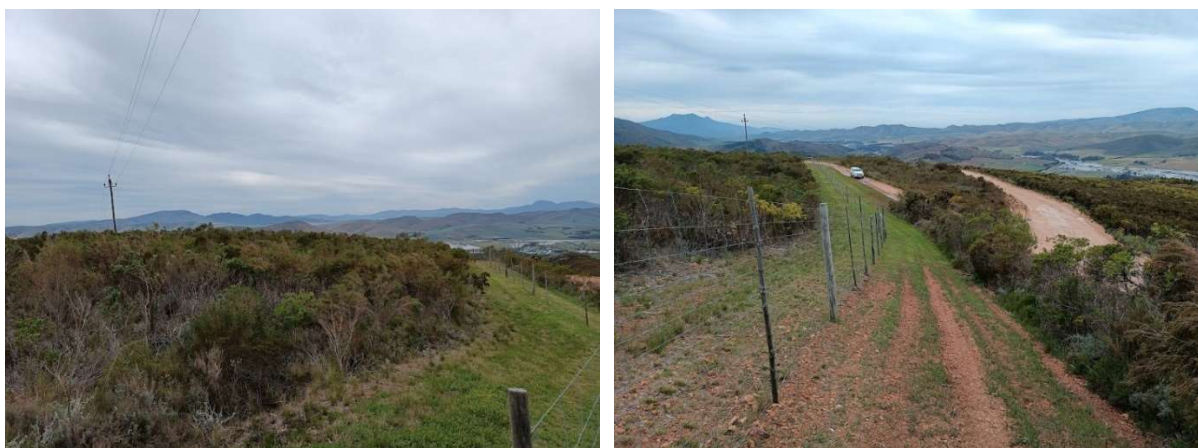
Figure 19: Photos of the proposed location of Site 24 showing the terrestrial habitat that comprises the site and its immediate surroundings.

A single Eco Cabin is proposed at Site 24 which is located on the upper slope of a valley which falls away to the south from the proposed site. The site and its immediate surrounds were confirmed to comprise only terrestrial habitat (see Figure 19). The nearest aquatic habitat is located beyond the property boundary approximately 110m to the south west. Utilisation of this site presents negligible risks the buffering effect of the $\pm 110\text{m}$ set-back from the watercourse, the intact indigenous vegetation present in the set-back area and also the small footprint of the proposed unit at Site 24 which is limited a single Eco Cabin ($\pm 120\text{ m}^2$).

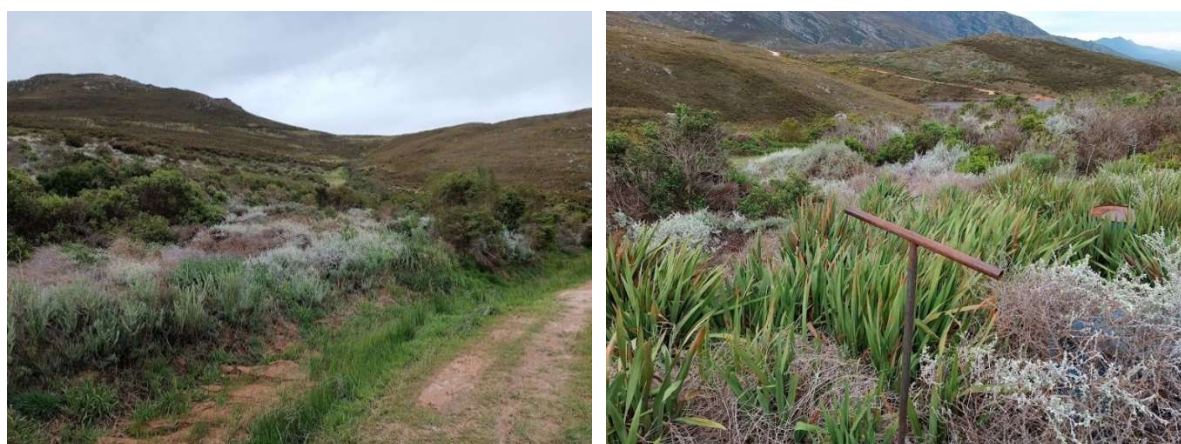
Figure 21: Photos of the campsite (Site 3A). Note *Watsonia barbonica* in the photo on the right.

in this area comprised *Pennisetum macrourum*, *Pteridium* sp (bracken), *Restio panniculatus*, *Plecostachys serpyllifolia* and *Watsonia barbonica*. (see Figure 21).

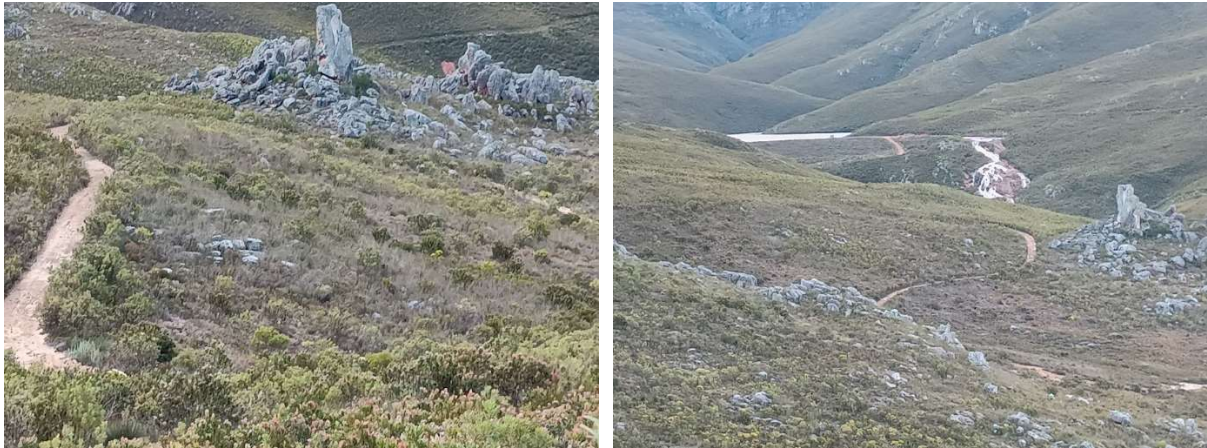
Figure 22: Photos of Site 28 indicating the terrestrial nature of the site and its immediate surroundings.

Two new Eco Pods are proposed at Site 28 which lies on a ridge just upslope of a distinct finger-like rock structure. The site itself and the surrounding area showed no signs of the presence of aquatic habitat (see Figure 22). The nearest watercourse comprises a non-perennial drainage line which lies approximately 220m to the south west. The perennial Elands Kloof River which is mapped as an unchannelled valley bottom wetland on the NWM5 is located approximately 360m to the east of the proposed site and in a separate catchment (i.e. utilisation of this site presents negligible risk to aquatic habitat).

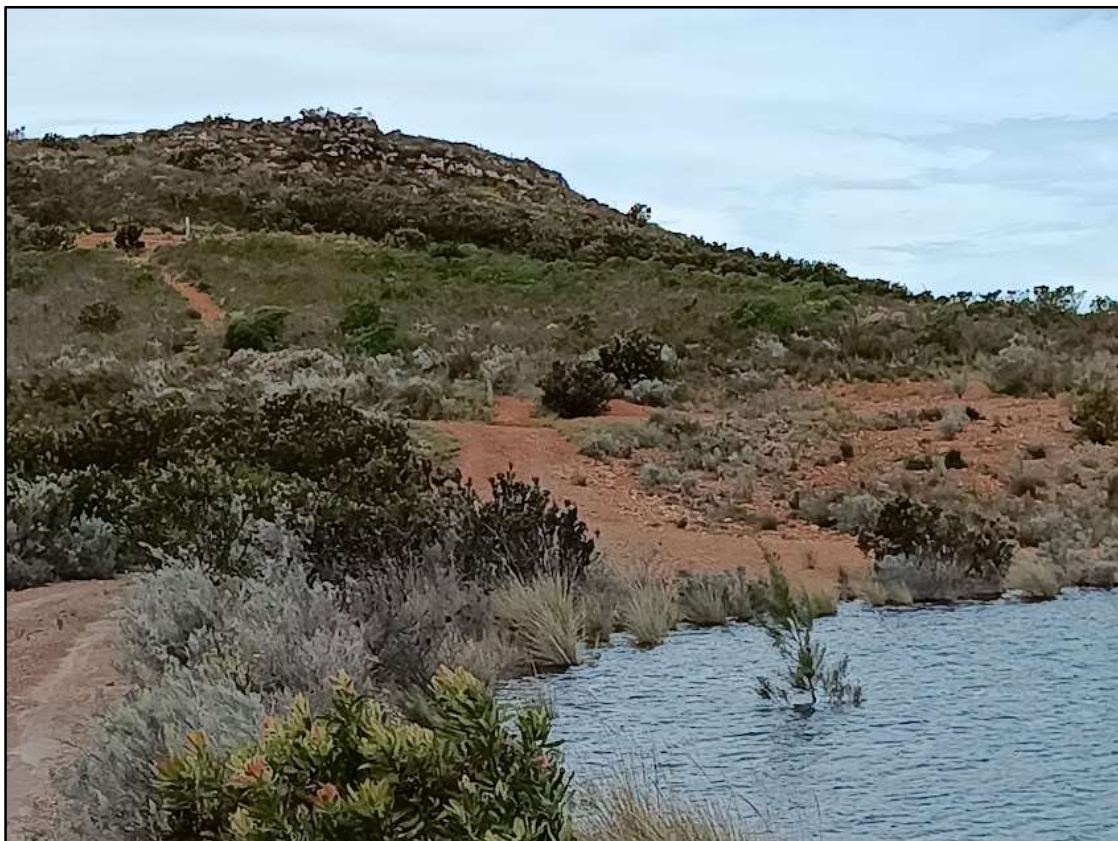
Figure 23: Photo of the dam with Site 6 located beyond and upslope of the dam. The site and its immediate surroundings comprise terrestrial habitat and the dam is an off-stream dam and as such is not deemed to be a watercourse.

Site 6 comprises the proposed site for a new Eco Cabin. The site is north-facing and overlooks a small off-stream dam which shows no signs of any aquatic habitat within or near the site (see Figure 23). The nearest watercourse is a non-perennial drainage line approximately 130m north east of the proposed site. Utilisation of this site presents negligible risk to any aquatic habitat.

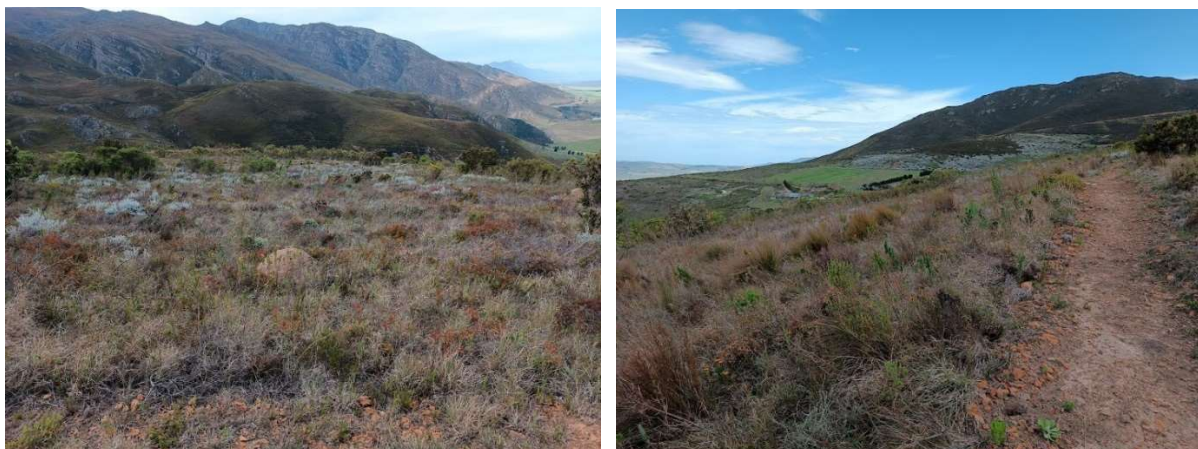
Figure 24: Photos of Site 7 which exists on the top of a hillock and contained indigenous terrestrial grasses and shrubs.

Site 7 is the site of two new Eco Cabins. It lies approximately 200m south east of Site 6 on a hillock with east-facing views. The site contains no signs of aquatic habitat near or immediately down-slope of the site (see Figure 24). Utilisation of this site presents zero risk to any aquatic habitat.

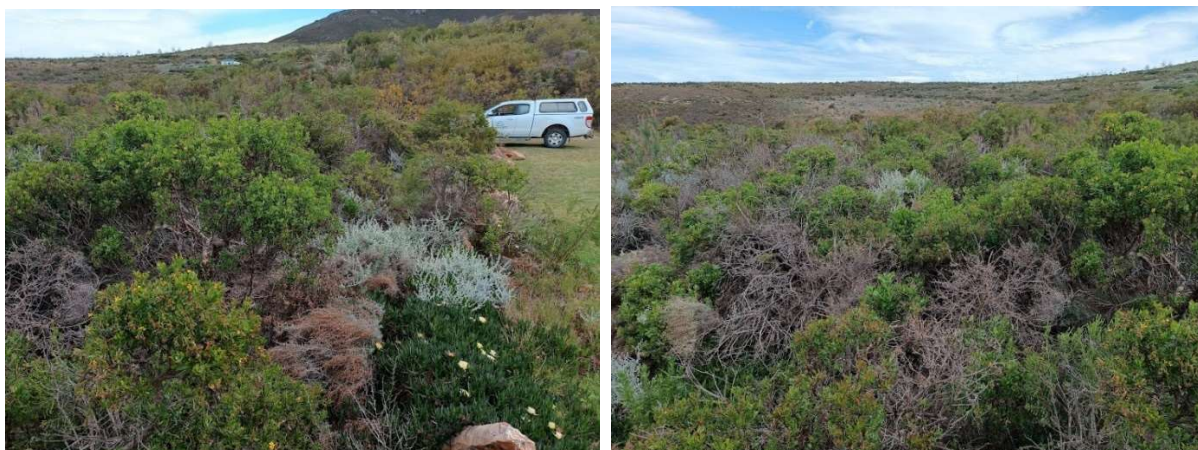
Figure 25: Photos of the proposed site of the sundowner boma and fire pit. All vegetation growing in and near the site comprises terrestrial species.

A new sundowner boma and fire pit is proposed at Site 29. The site lies adjacent and to the south east of a levelled, lawned area which is used for events. Site 29 revealed no signs of aquatic habitat as the vegetation on the site and immediate surrounds is dominated by terrestrial species (see Figure 25). The utilisation of this site presents zero risk to any aquatic habitat.

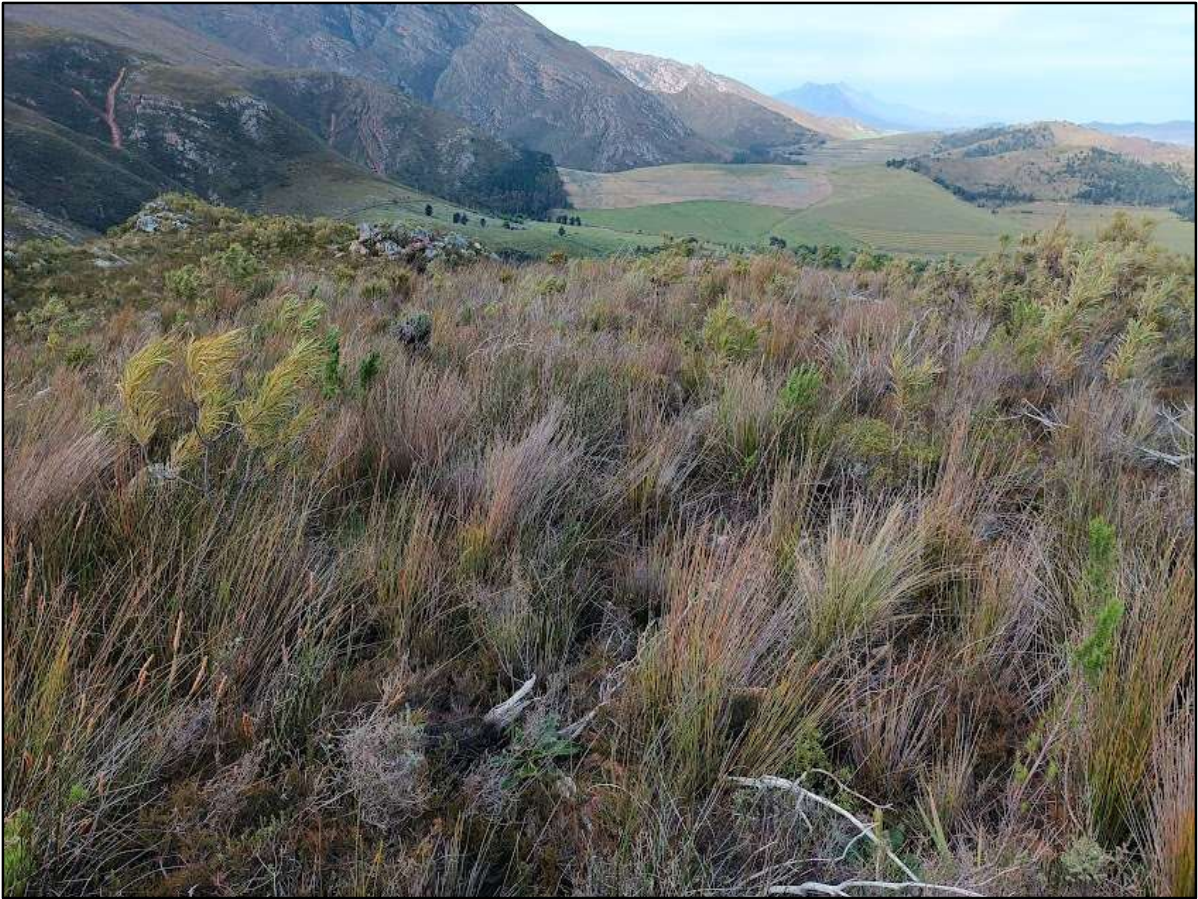
Figure 26: Photo of Site 31 which comprises a grass-dominated spur with exceptional views.

Site 31 comprises a grass-dominated spur overlooking the valley that is the proposed site of 2 new Eco Cabins. The site contains no aquatic habitat and the nearest watercourse, the same non-perennial drainage line referred to in Site 6, lies approximately 220m to the north-east (see Figure 26). Utilisation of this site presents zero risk to any aquatic habitat.

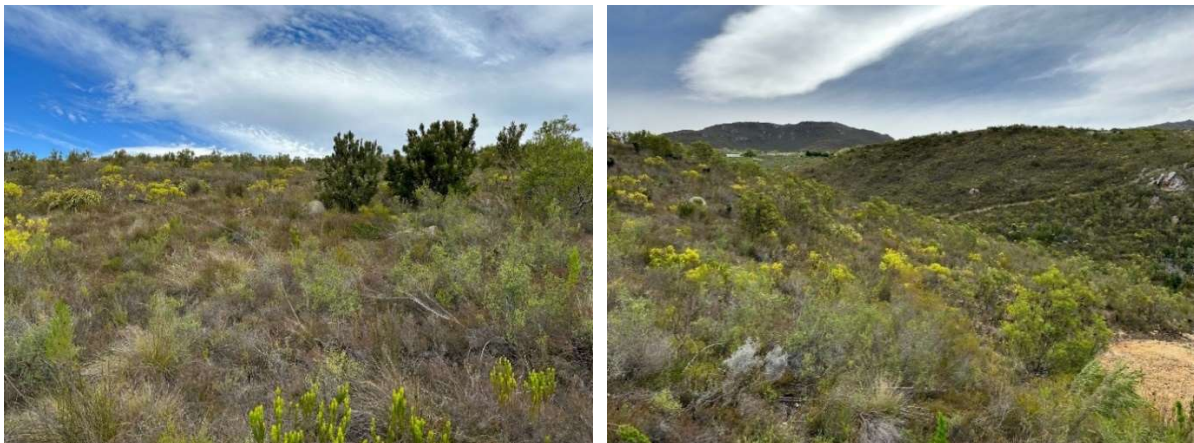
Figure 27: Photos of the proposed site of a new Eco Pod. The vegetation within and surrounding the site comprises terrestrial vegetation. Note the valley in the photo on the left which contains a non-perennial drainage line and associated riparian habitat approximately 50m downslope of the site.

Site 30 is the site of a new Eco Pod. The site lies on a north-east facing slope of a small valley that contains a non-perennial drainage line which is located approximately 60m north of the proposed site. The site and its immediate surrounds contains no signs of aquatic habitat (see Figure 27). The drainage line to the north contains *B. lanuginosa* indicating the presence of riparian habitat associated with the drainage line. Utilisation of this site however is unlikely to present any risk to any aquatic habitat given that the site is suitably set-back from the drainage line.
