Aquatic Biodiversity Impact Assessment

Erf 878 Riebeek–Kasteel, Western Cape

For: Lornay Environmental Consulting

March 2025

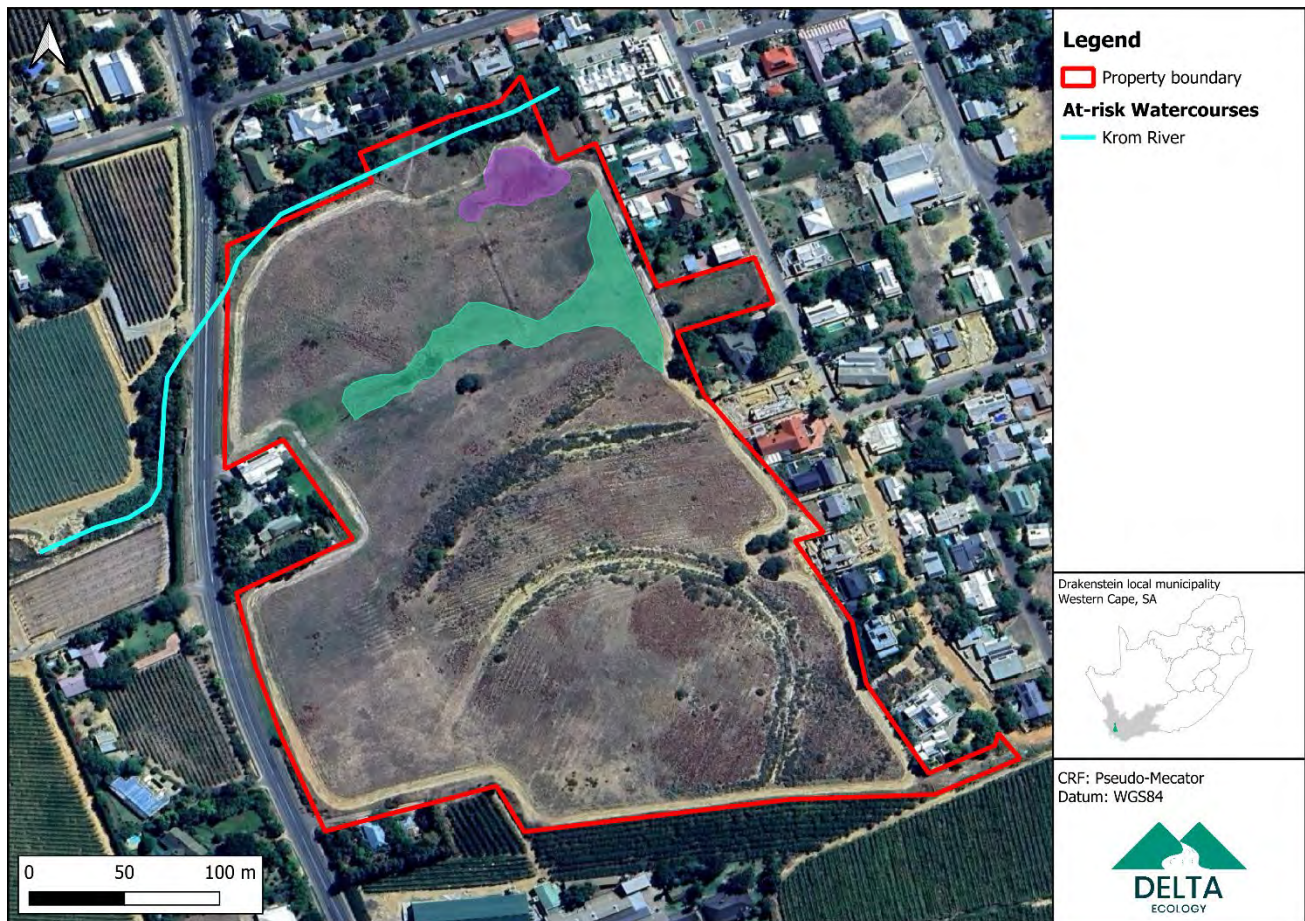
Figure i: At Risk Watercourses on Erf 878.

Following the aquatic biodiversity assessment of the proposed site on the 20th of February 2025, the Krom River was confirmed to intersect the northern boundary of the proposed development site (**Figure i**). In addition, two seep wetland systems were identified onsite, both of which are sustained by groundwater emergence in the form of springs (**Figure i**). Seep wetland 1 historically would have extended to the east, downslope of the site, but the development of roads and residential areas has resulted in canalisation of this flow.

- The loss of the seriously degraded Seep Wetland 2, along with the loss of portions of Seep Wetland 1, should be compensated for by rehabilitating the Remnant Seep Wetland 1. It should be noted that the Offset Calculator needs to be completed and should the rehabilitation of the remnant Seep Wetland 1 not compensate for the loss, additional onsite or offsite wetland areas may need to be considered.

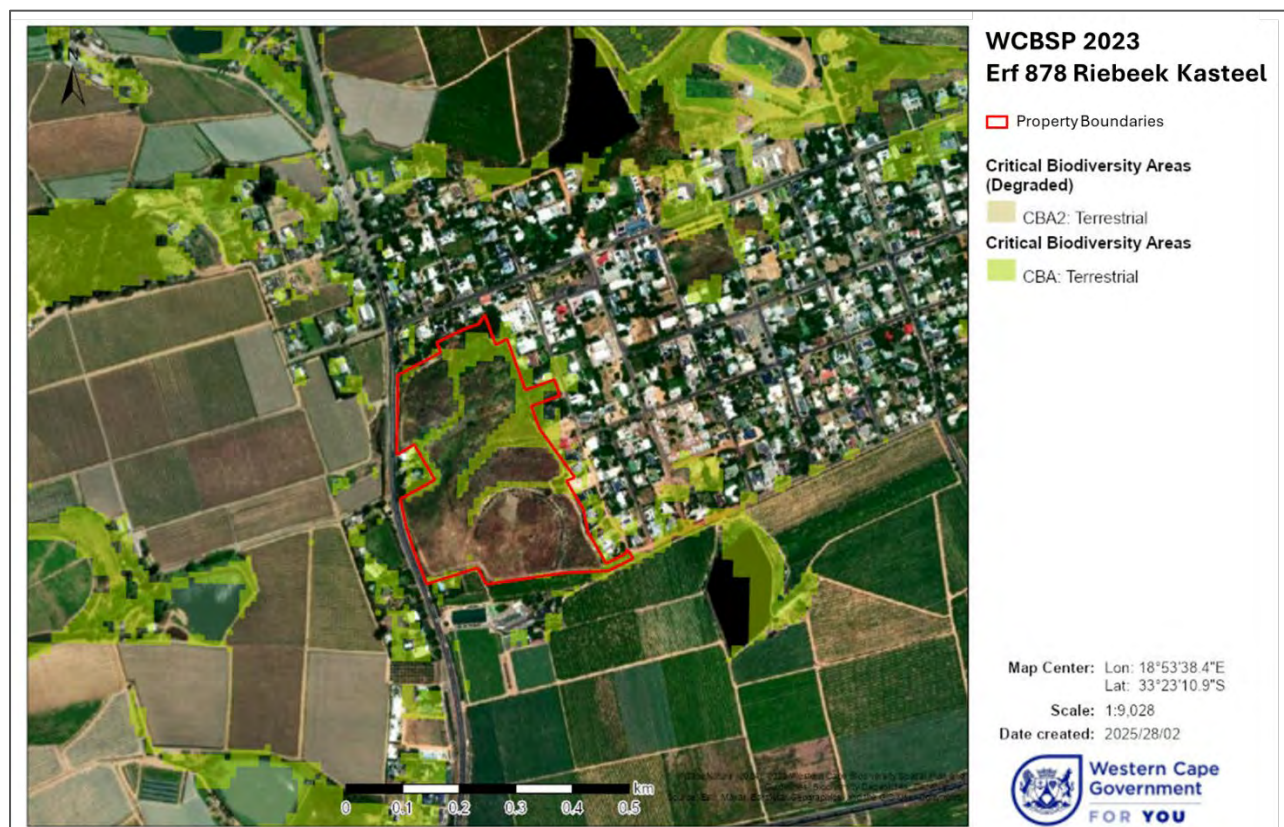
Figure 4-4: 2023 Western Cape Biodiversity Spatial Plan (CapeNature 2024)

The 2023 WCBSP (CapeNature, 2024) indicates the absence of aquatic CBAs indicated within the proposed development site or within 500 m from the site (**Figure 4-4**). The proposed development site is located over a minor fractured aquifer with yields of 0.5 – 2.0 l/s (DWS, 2012).

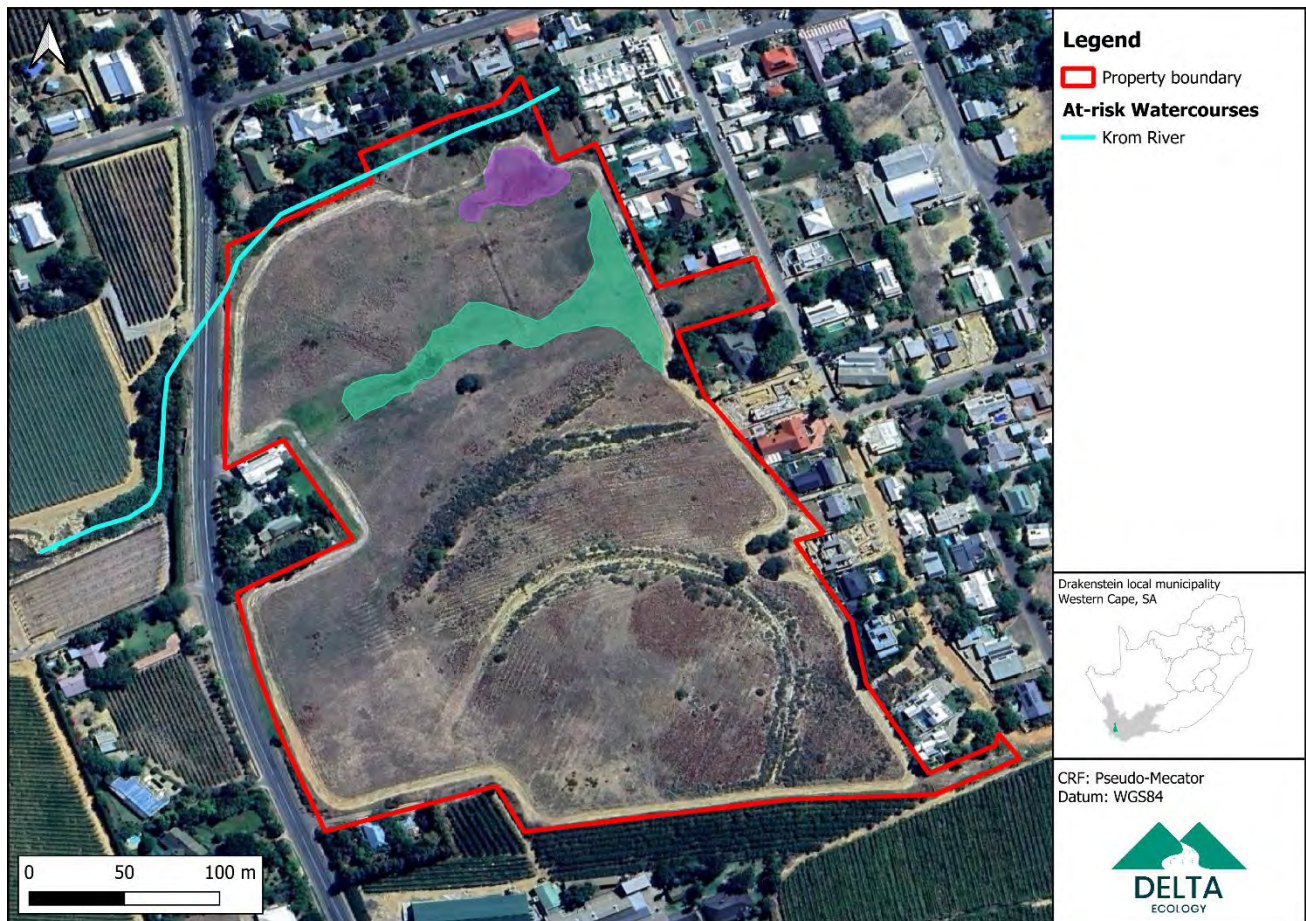
Figure 5-1: Watercourse Delineation Map

Key onsite hydrological features identified and delineated include two seep wetlands, both sustained by groundwater emergence from associated springs in the northern portion of the site (**Figure 5-1**). Additionally, the non-perennial Krom River traverses the northern boundary (**Figure 5-1**). Several patches of artificial seepage dominated by *Pennisetum clandestinum* (kikuyu grass) were observed, primarily along the western boundary (**Figure 5-1 & Figure 5-2**). Field observations, corroborated by aerial imagery, suggest that these artificial seepage areas have likely developed due to agricultural irrigation and stormwater enhancement. These artificially created seepage areas will not be assessed as they lack a natural reference state, do not exhibit ecological importance or sensitivity, and do not fulfil any significant ecosystem services.

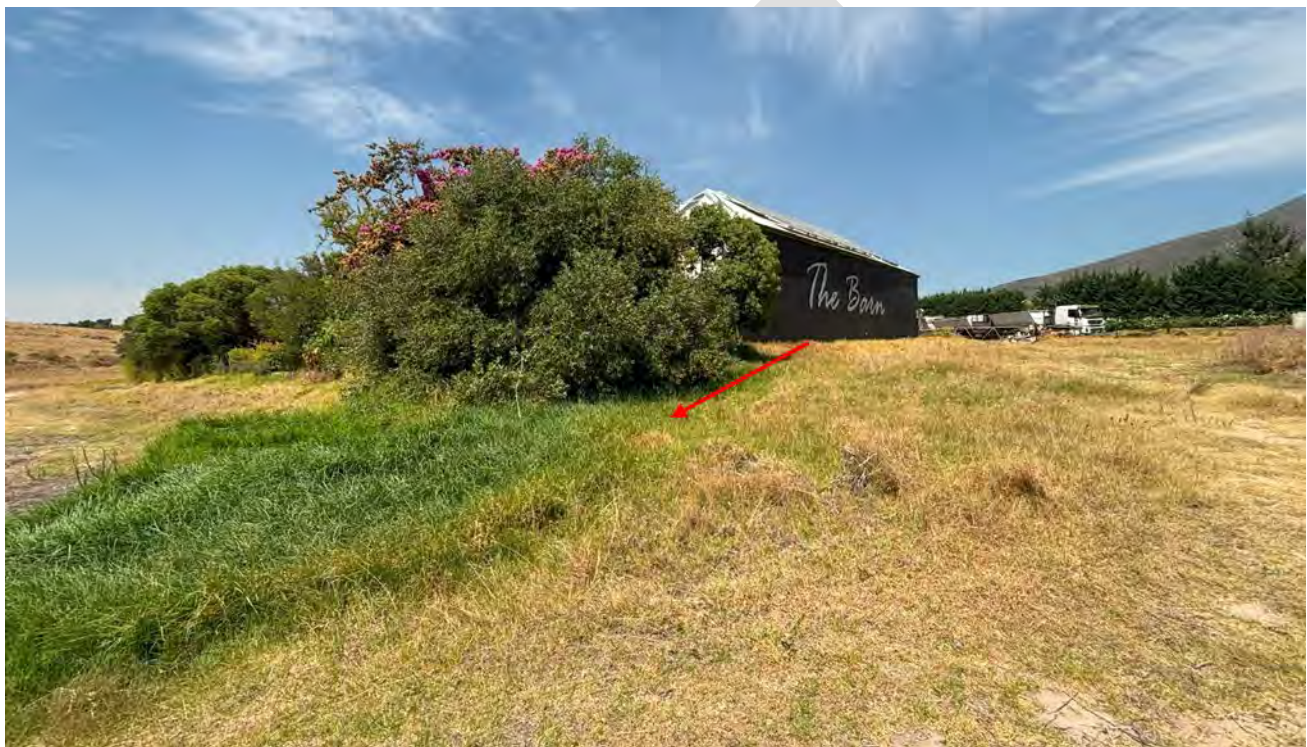
Figure 5-2: Area of artificial seepage dominated by *P. clandestinum* adjacent to the neighbouring restaurant. This area has likely developed as a result of artificial stormwater enhancement and irrigation runoff from the restaurant garden.

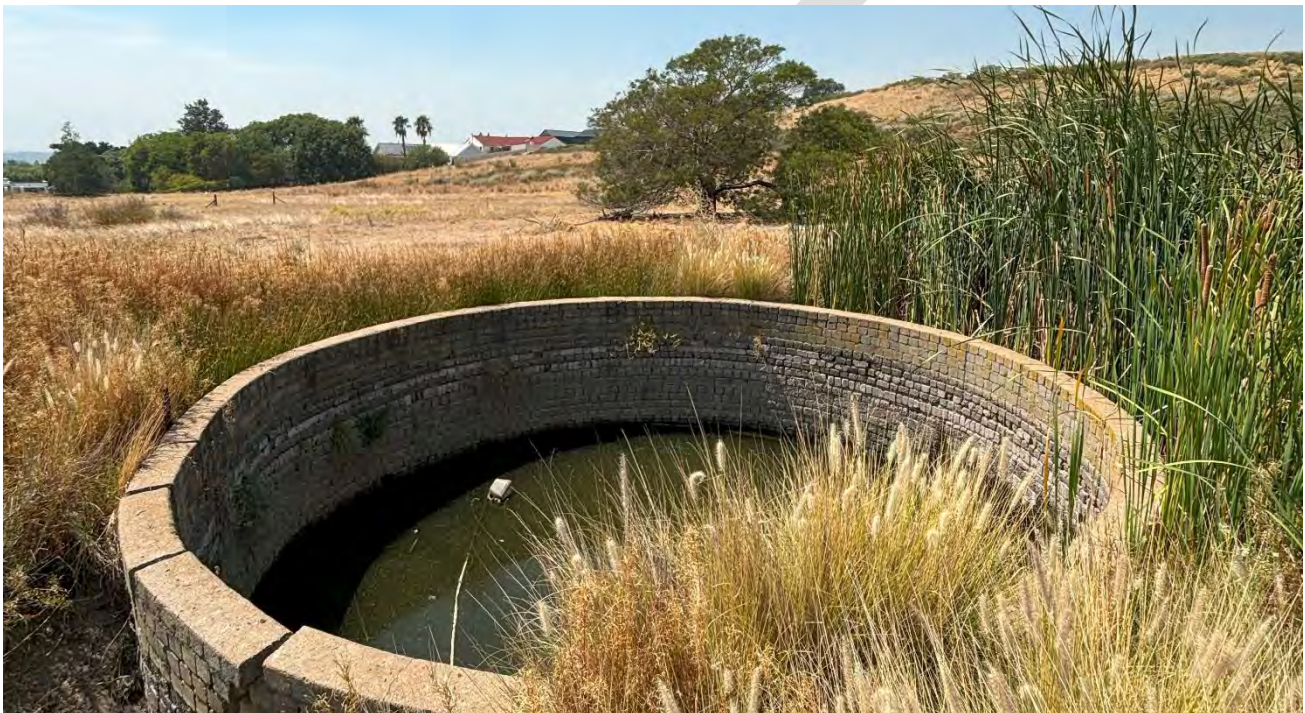
Figure 5-4: A well has been developed within Seep Wetland 1

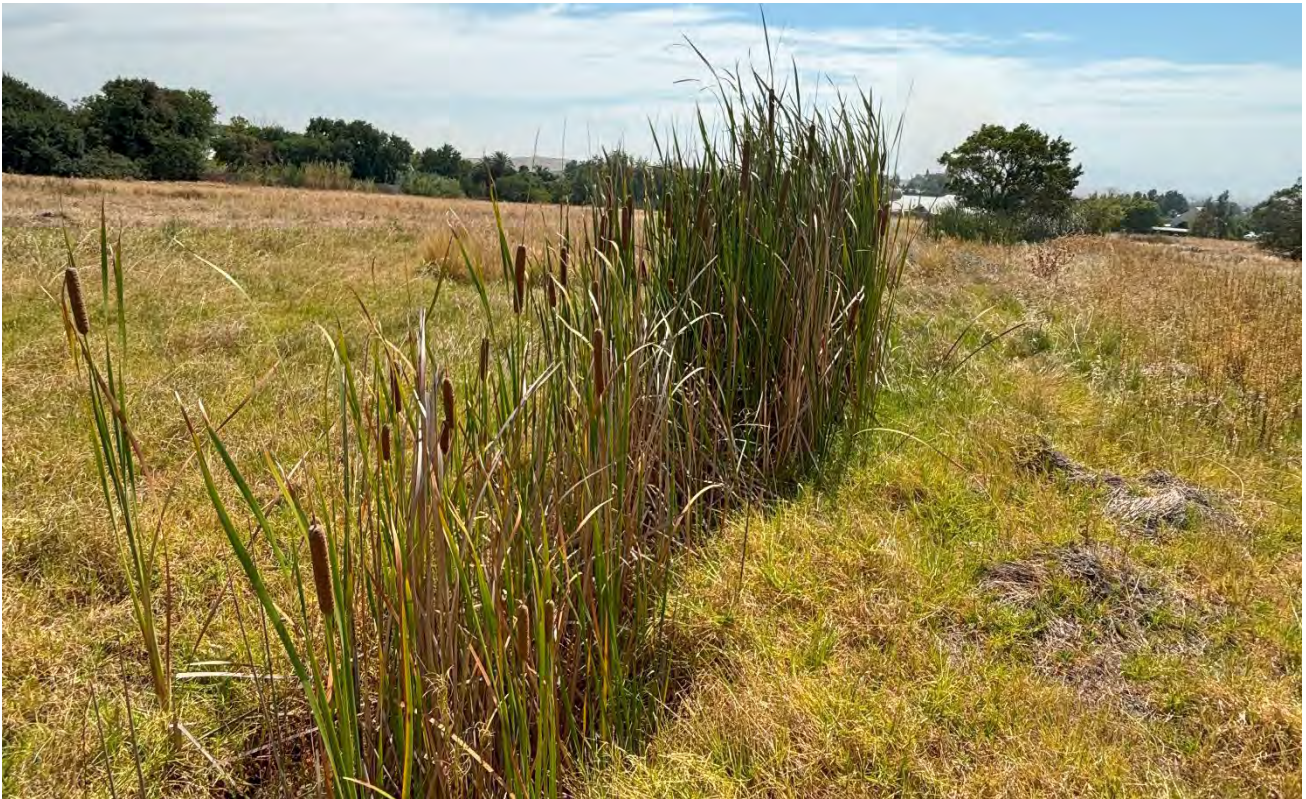
Figure 5-5: A channel has been excavated from the central well in Seep Wetland 1 leading westwards. This has revealed additional points of perched groundwater as indicated by the presence of *T. Capensis*.

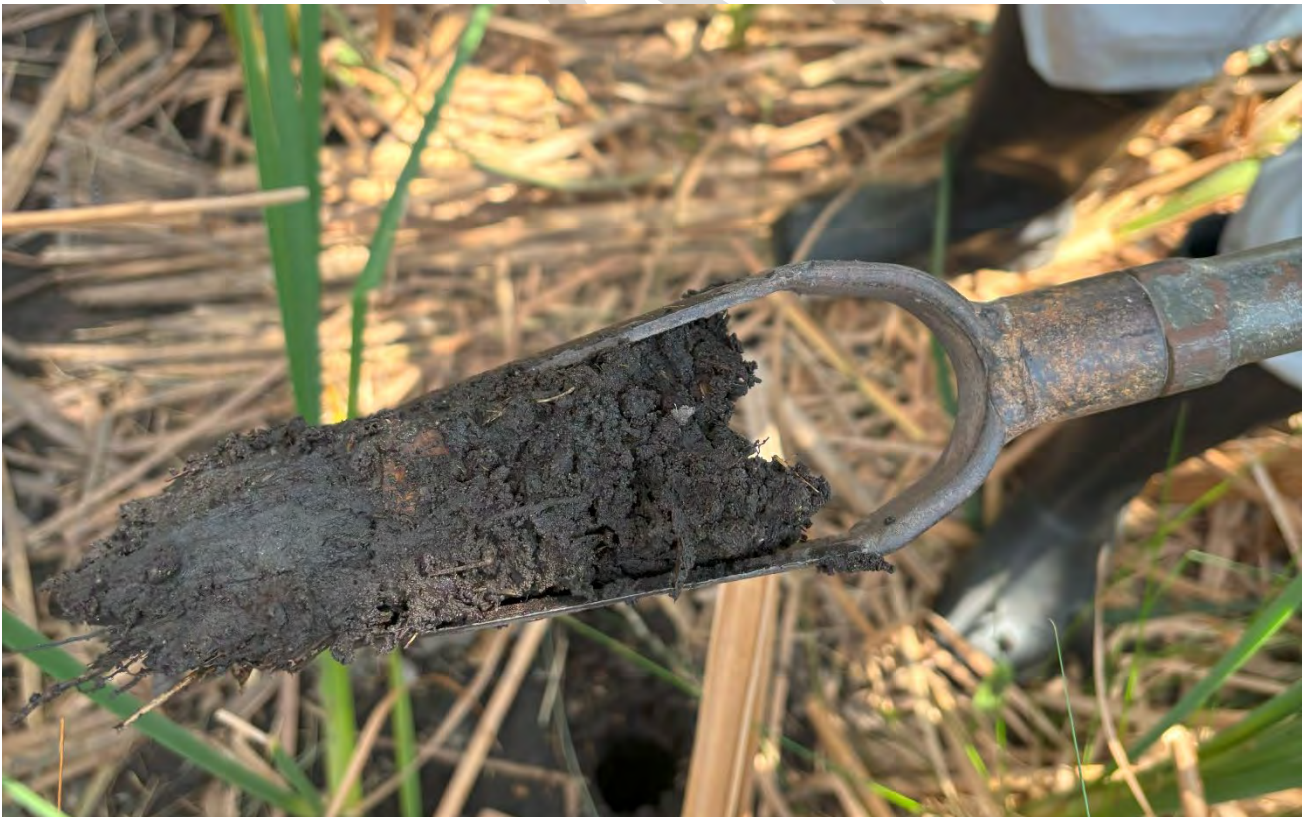
Figure 5-6: Dark, low-chroma, organic soil sampled from within the central portion of Seep Wetland 1.

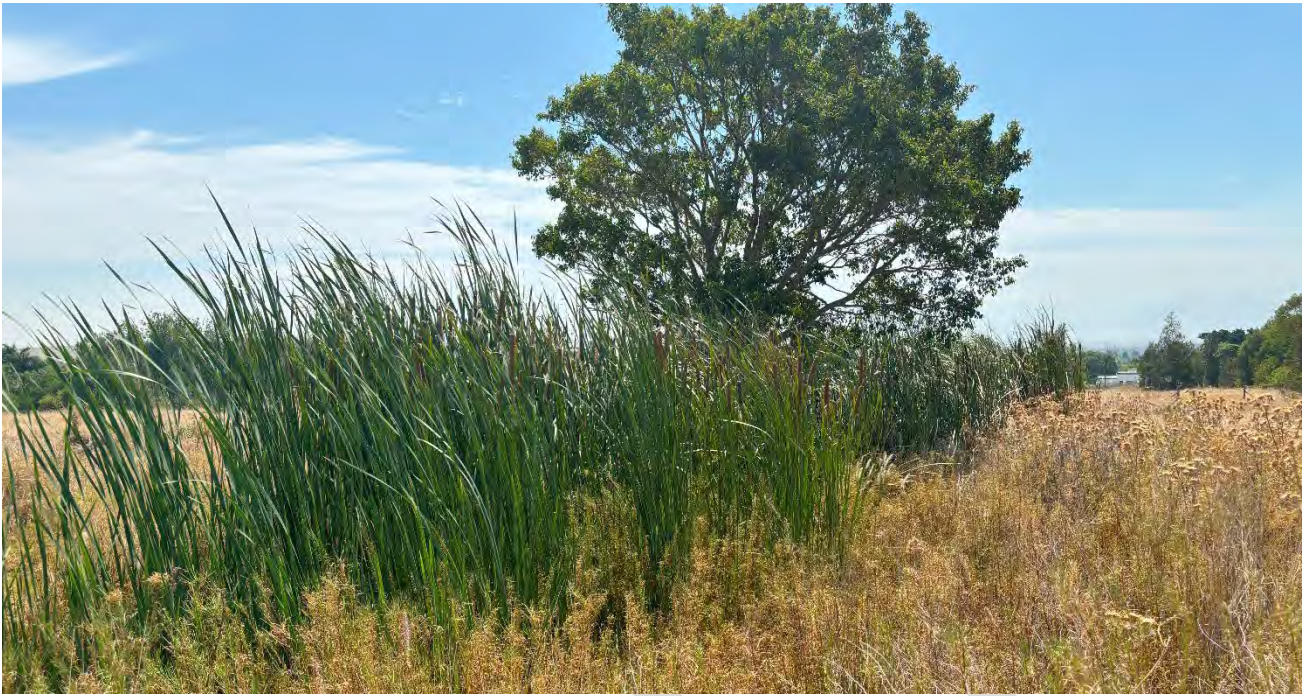
Despite the site visit occurring during the dry summer season, water was visibly present on the surface in the central portion of the wetland, confirming its reliance on groundwater inputs. The soils in this area were waterlogged and exhibited dark, low-chroma, organic characteristics indicative of anaerobic wetland conditions (**Figure 5-6**). Vegetation in this permanent zone was dominated by *Typha capensis* (Bulrush), with additional species such as *Juncus effusus* (Soft Rush), *Zantedeschia aethiopica* (Arum Lily), and a single *Syzygium guineense* (Water Pear Tree) present (**Figure 5-7 & Figure 5-8**).

Figure 5-7: Permanent wetland zone within Seep Wetland 1 dominated by *T. Capensis*. A single *S. guineense* can be seen in the background.

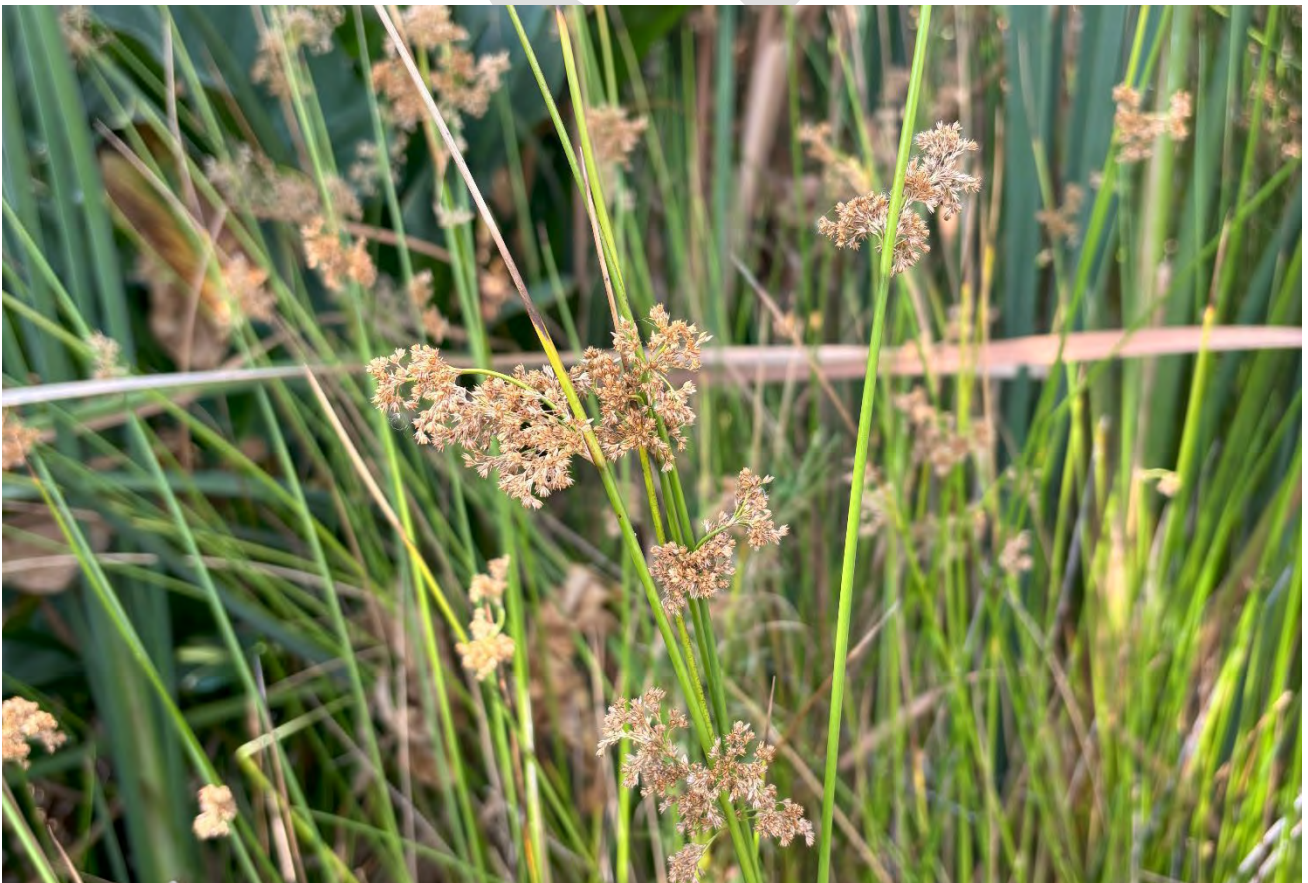
Figure 5-8: *J. effusus* present within Seep Wetland 1.

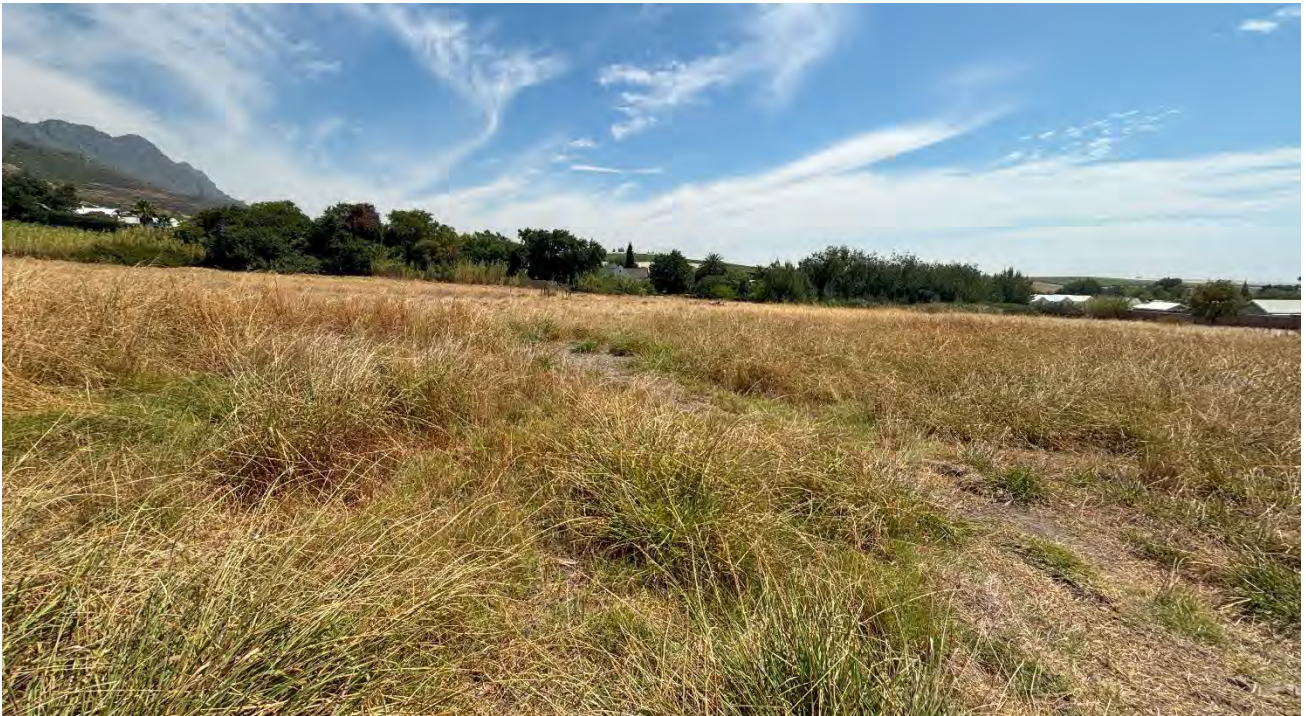
grass). Identification of additional grass species was limited due to the dry season (**Figure 5-9**). A patch of *Seriphium plumosum* (silver stoebe) and areas containing *Pennisetum setaceum* (Fountain Grass) were also noted (**Figure 5-10**). Despite the seasonal dryness observed in the vegetation, soil samples exhibited periodic mottling, confirming seasonal wetland conditions and supporting delineation efforts (**Figure 5-11**).

Figure 5-9: *P. clandestinum* (kikuyu grass) and additional grass species dominating Seep Wetland 1. Identification of additional grass species was limited due to the dry season

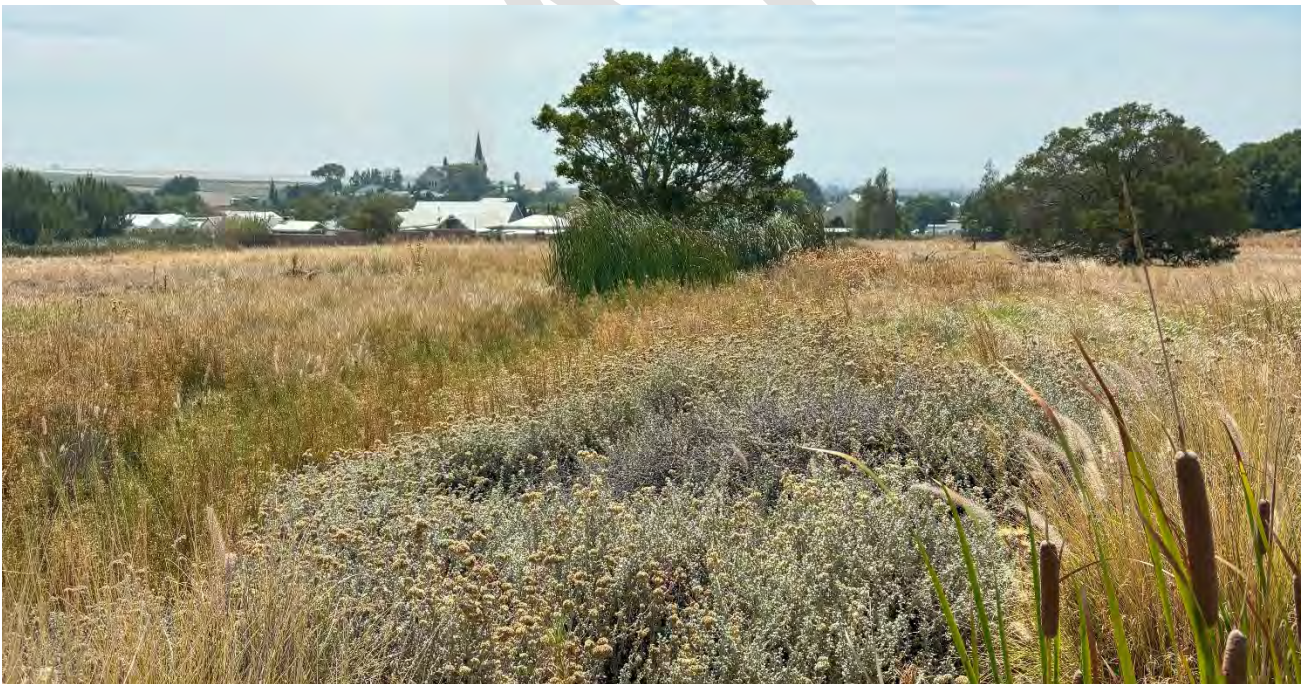
Figure 5-10: A patch of *S. plumosum* within Seep Wetland 1. *P. setaceum* is also present and *T. Capensis* can be seen in the bottom right corner.

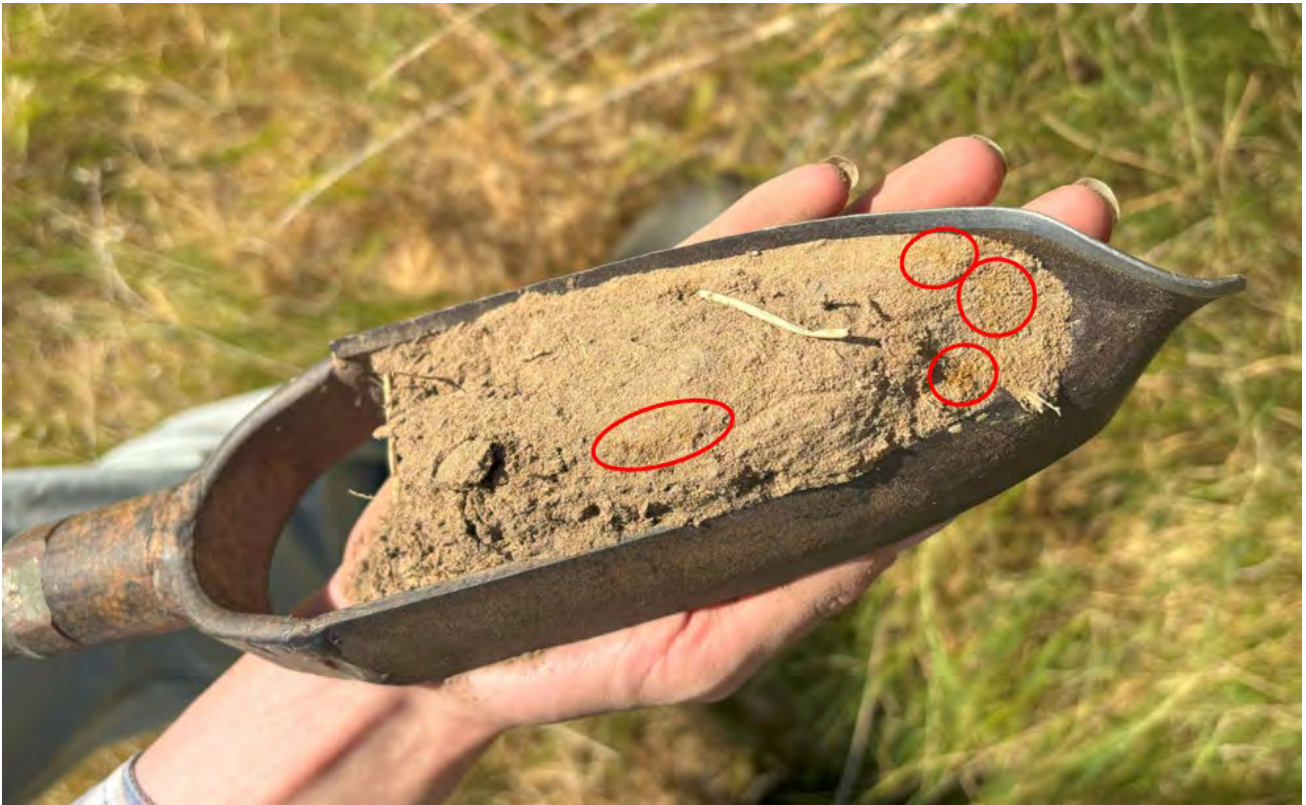
Figure 5-11: Periodic mottling indicative of wetland conditions detected within Seep Wetland 1. Mottles are encircled in red.

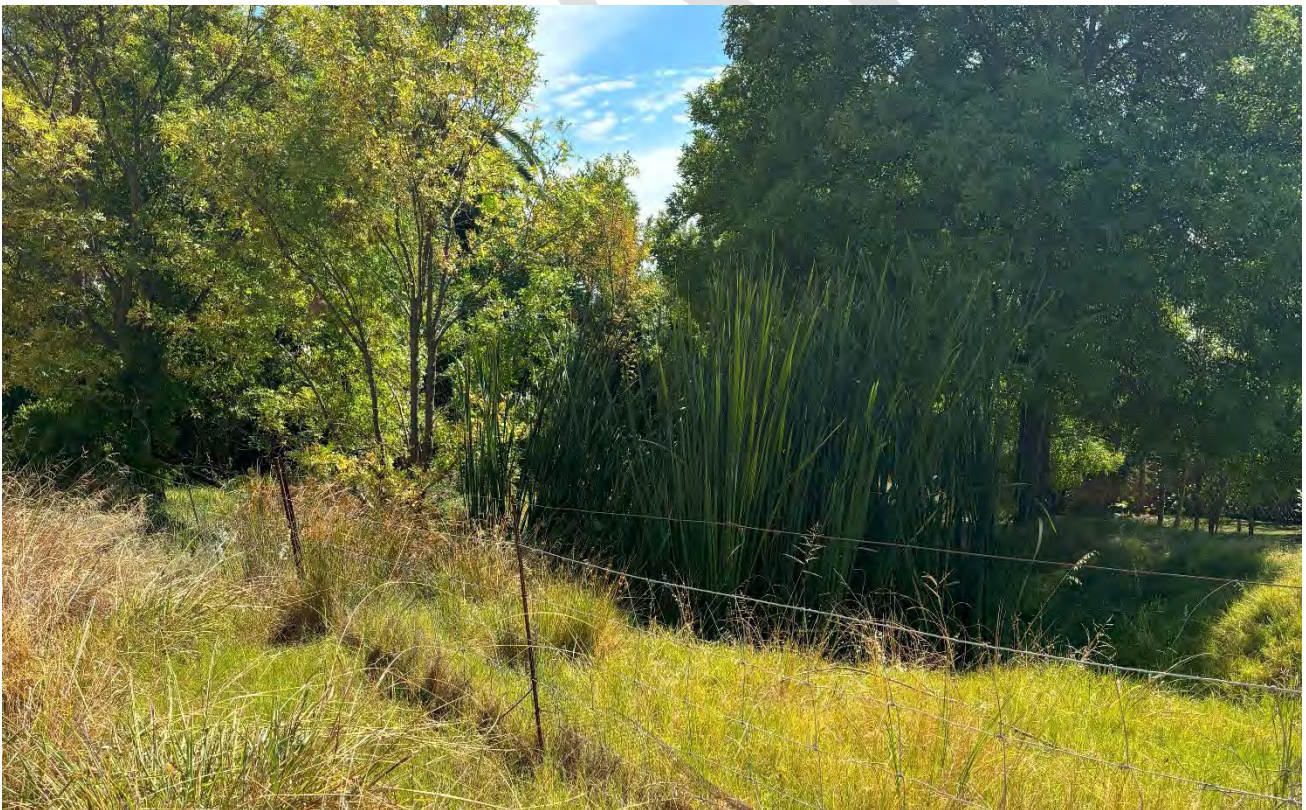
Seep Wetland 1 appeared to extend beyond the site boundary historically. Historic aerial imagery indicates that the wetland likely extended across the current perimeter road prior to its construction. The continued presence of water in this area is evident from erosion features observed across the road and along road verges, indicating ongoing hydrological connectivity, now directed to the Krom River downstream (by the road, residential area, and canalisation) (**Figure 5-12 Figure 5-13**).

Figure 5-12: A SW canal dominated by *T. Capensis* located to the east of the proposed development site boundary.

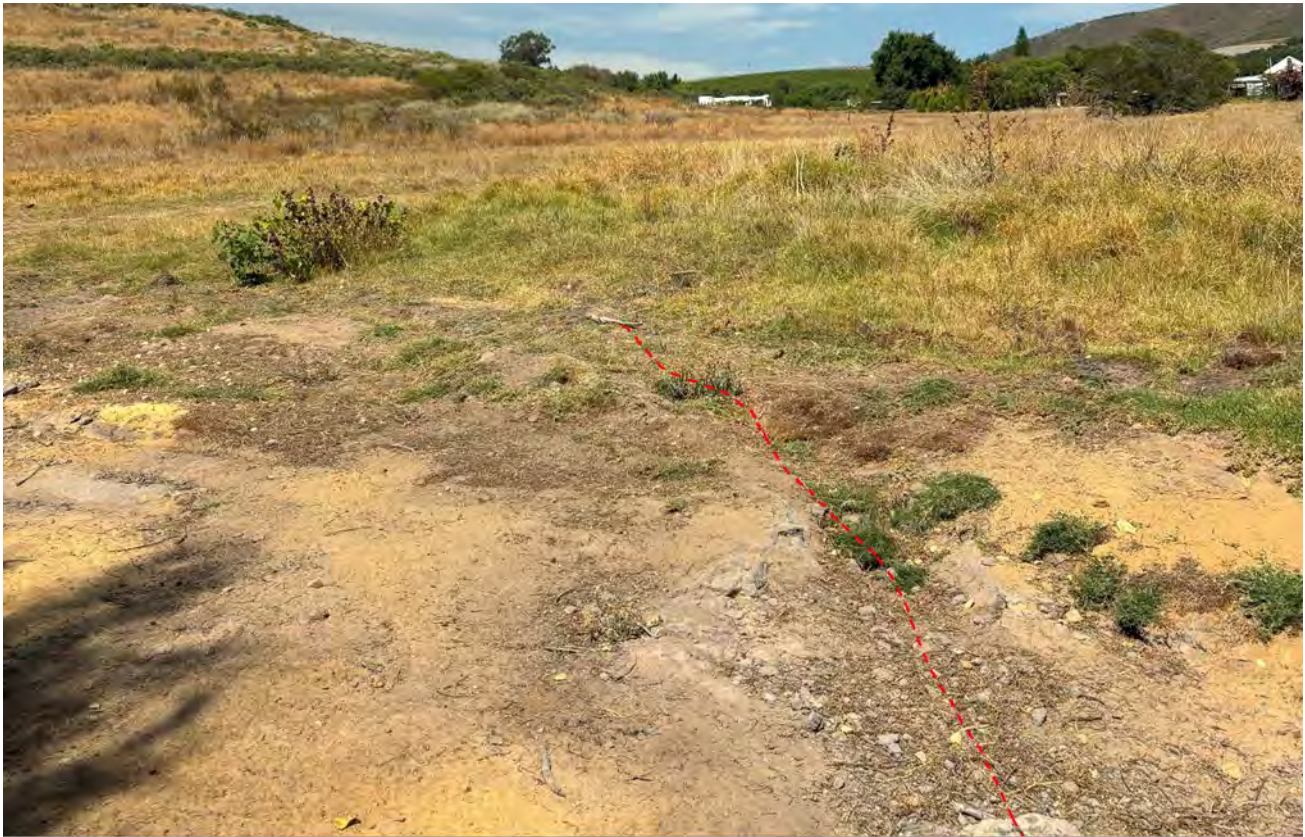
Figure 5-13: Preferential flow path crossing the perimeter road along the eastern boundary. This flow path extends from the portion of Seep Wetland 1 located west of the road.

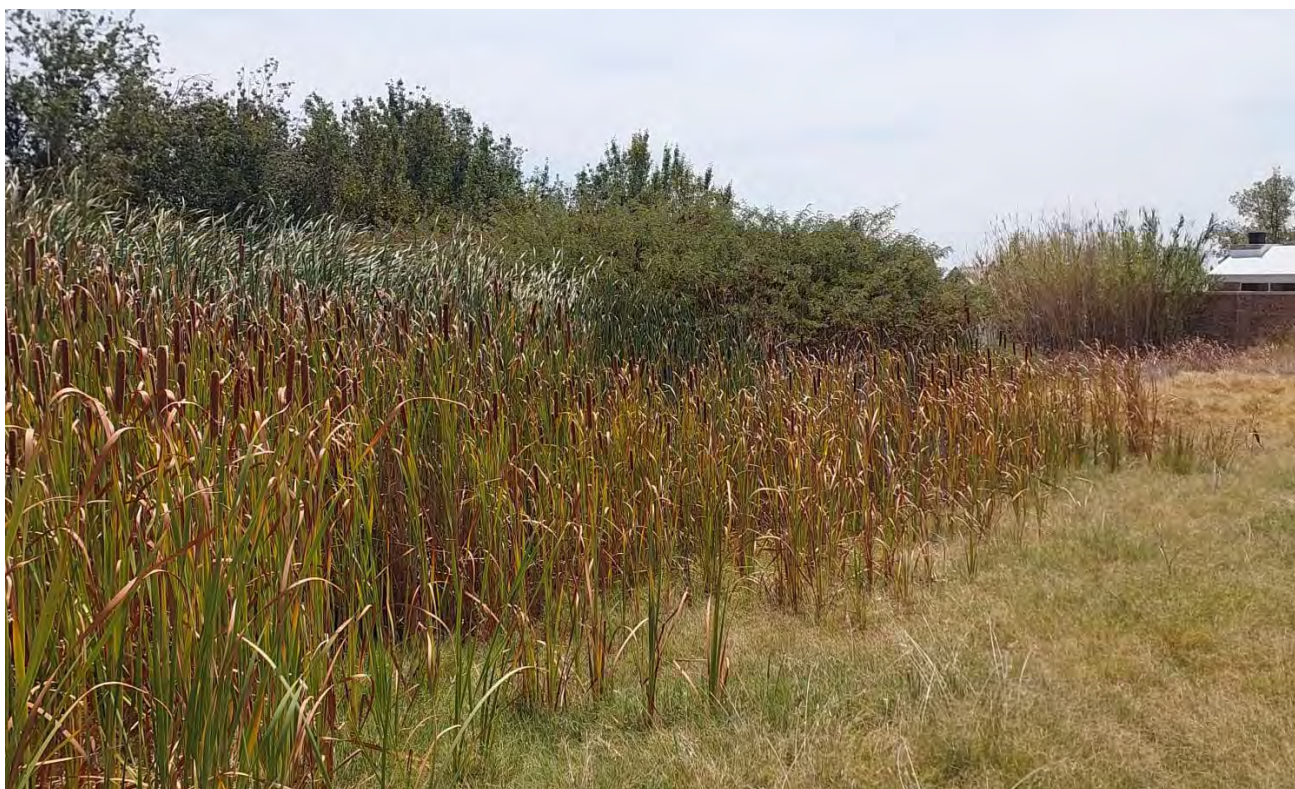
Seep Wetland 2 is located in the northeastern corner of the site and is also groundwater-fed. Similar to Seep Wetland 1, water was visibly present at the surface and the soils in its central wet area exhibited dark, low-chroma, organic characteristics indicative of anaerobic wetland conditions. The wetland comprises a combination of *T. capensis*, *J. effusus*, *P. clandestinum*, *Cynodon dactylon* (Bermuda grass), *Cyperus polystachyos* (bunchy sedge), and *Sesbania* spp (**Figure 5-14** & **Figure 5-15**).

Figure 5-14: Seep Wetland 2 is situated in the northeastern corner of the site. The foreground is dominated by *C. dactylon* grasses, followed by *T. capensis* and a *Sesbania* spp. (small trees). In the background, *P. alba* trees are visible on the left, while *P. australis* is present on the right.

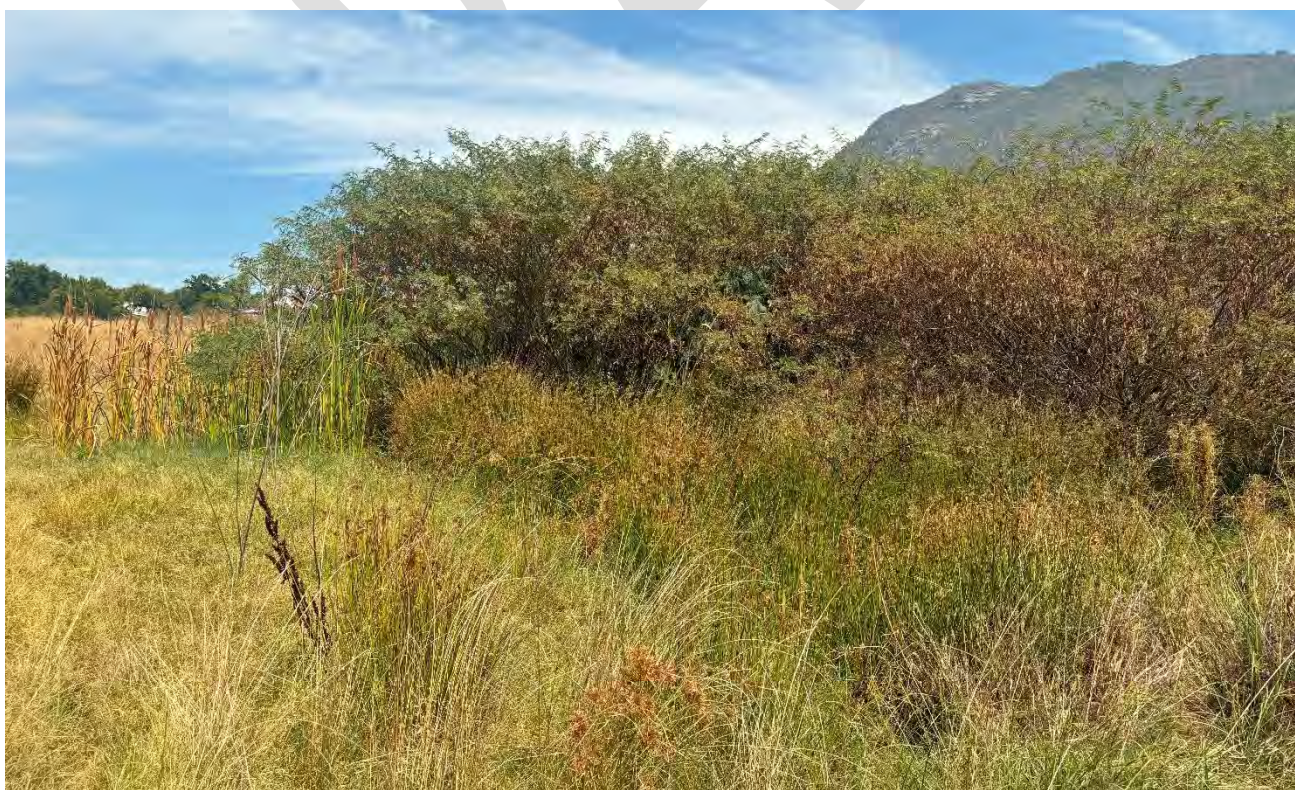
Figure 5-15: Seep Wetland 2 comprises dense areas of *C. polystachyos* (bunchy sedge) which can be seen just in front of the *Sesbania* spp (small tree) in this photo.

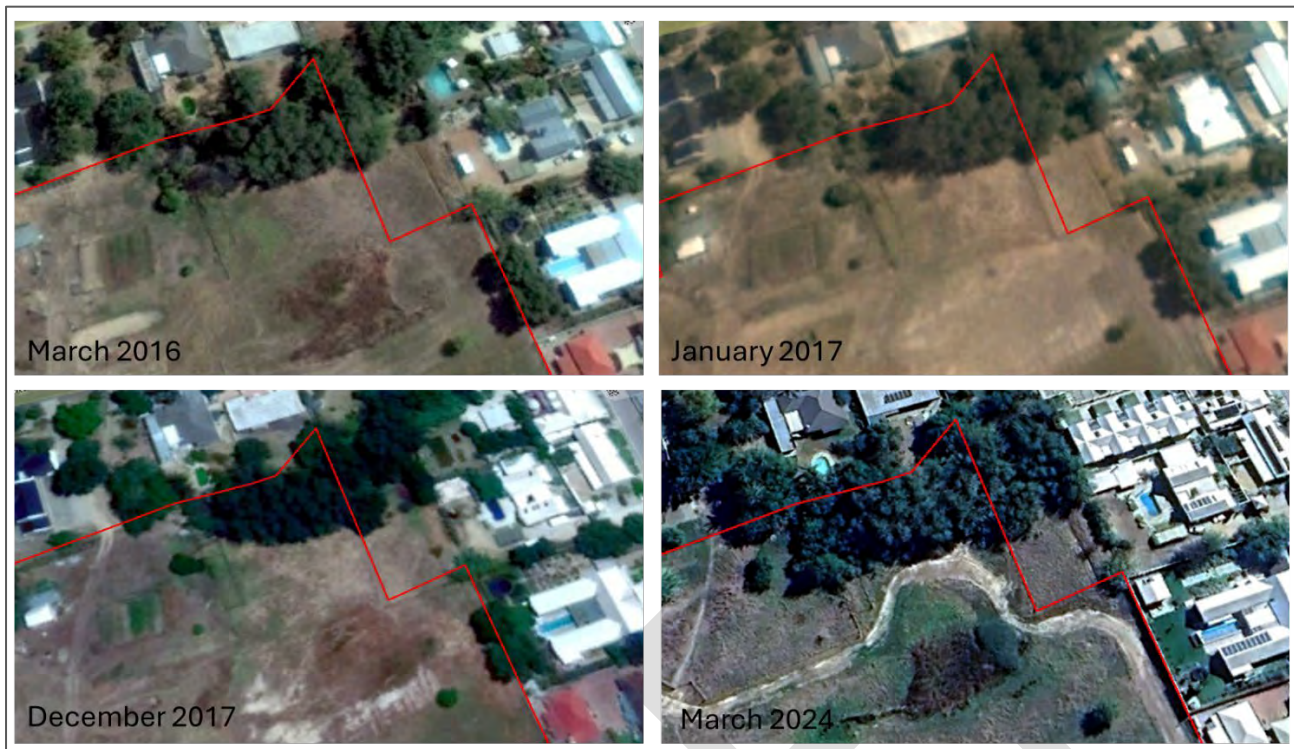
Figure 5-16: Aerial imagery of Seep Wetland 1 from 2016–2024 showing changes over time in response to disturbance

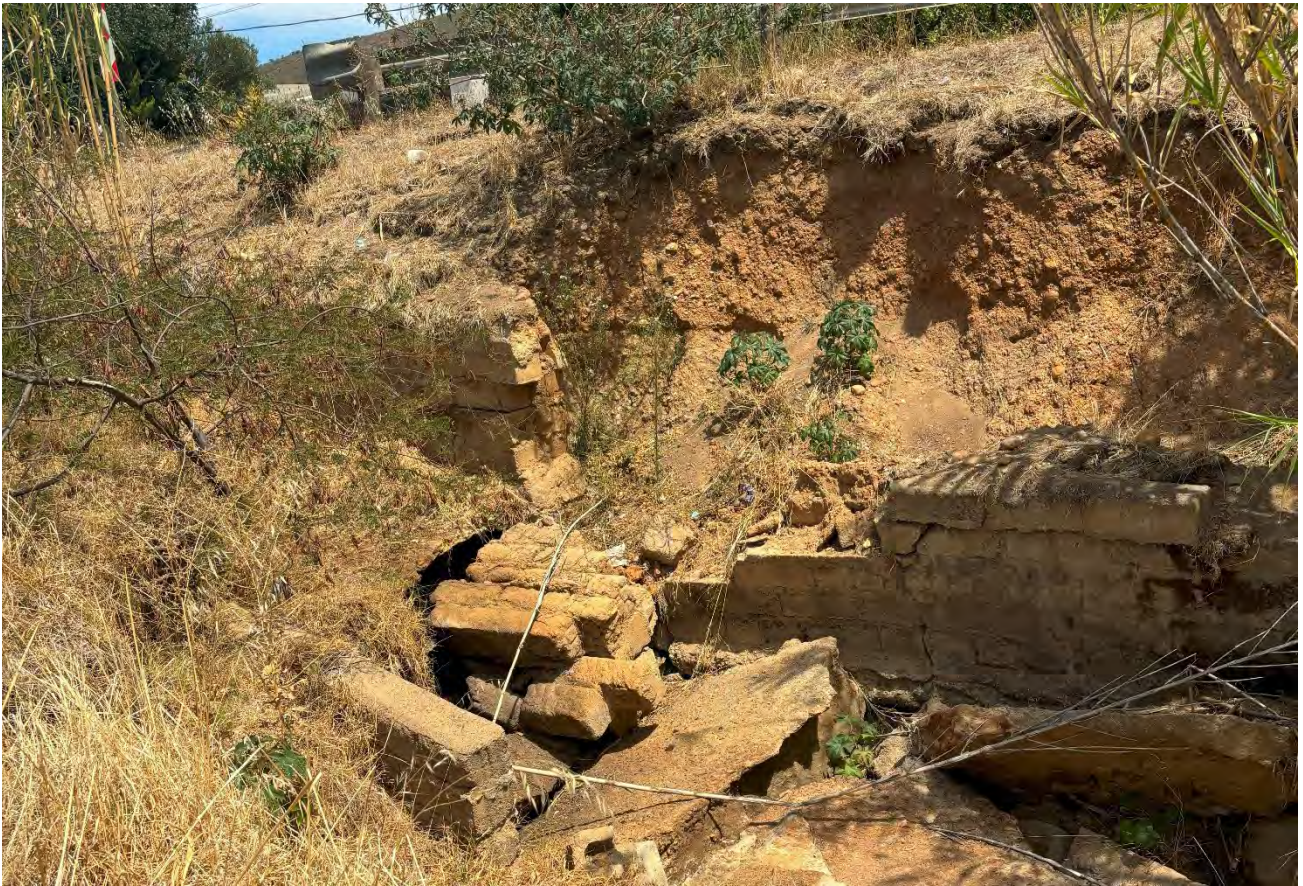
Figure 5-17: Point at which the Krom River enters the proposed development site by means of a degraded stormwater channel. Bank stabilisation measures have collapsed and are currently blocking the stormwater pipeline.

- The Krom River section that occurs within the site should be rehabilitated, as per a River Maintenance and Management Plan.
- It is recommended that a groundwater impact assessment is conducted during the WULA.

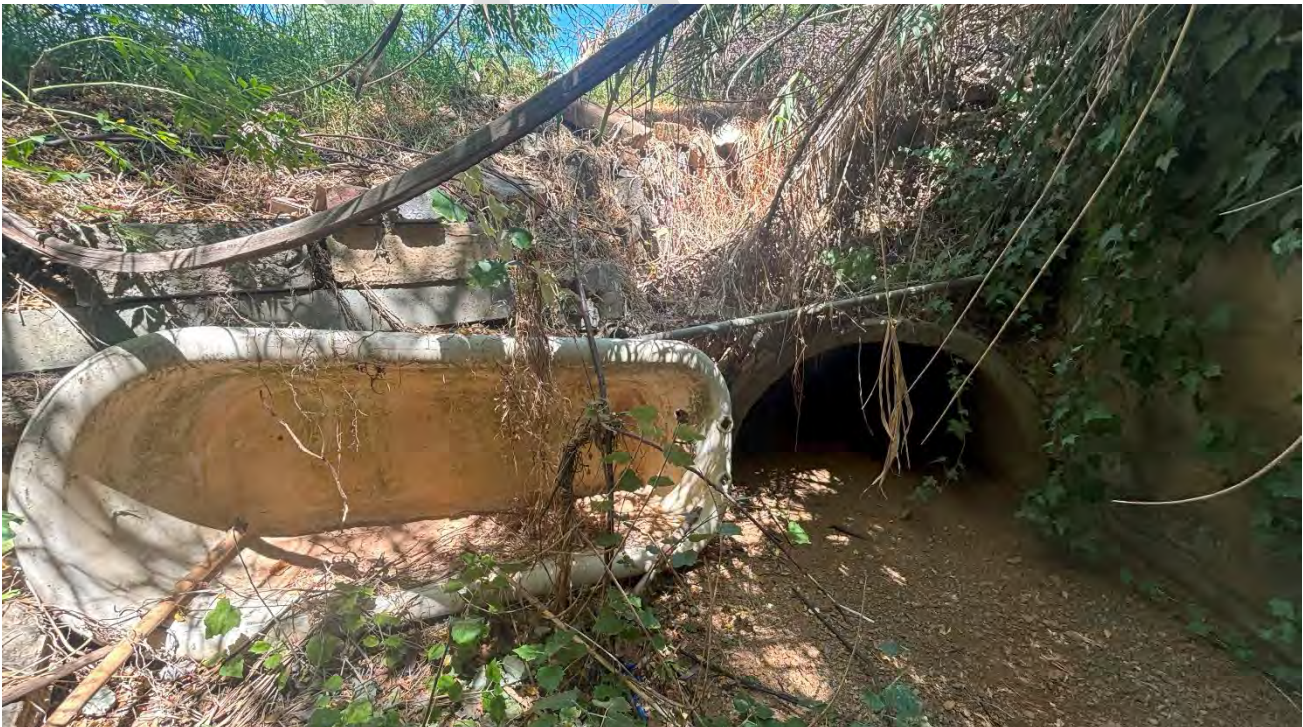
Figure 5-18: Point at which the Krom River emerges from the underground pipeline in the northern portion of the site. Rubble has been used for infill and bank stabilisation.

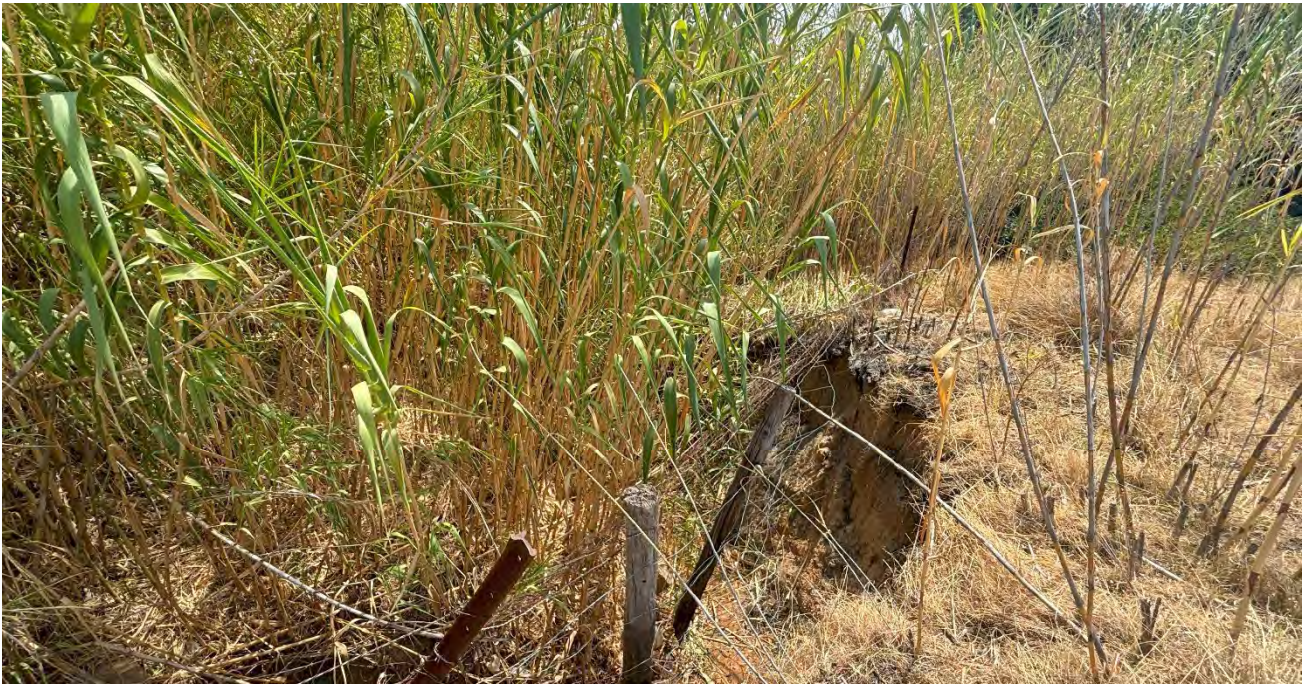
Figure 5-19: The Krom River is overgrown with *P. australis* and the riparian channel is severely modified and eroded.
