Aquatic Biodiversity Impact Assessment

Erf 878 Riebeek–Kasteel, Western Cape

For: Lornay Environmental Consulting

March 2025

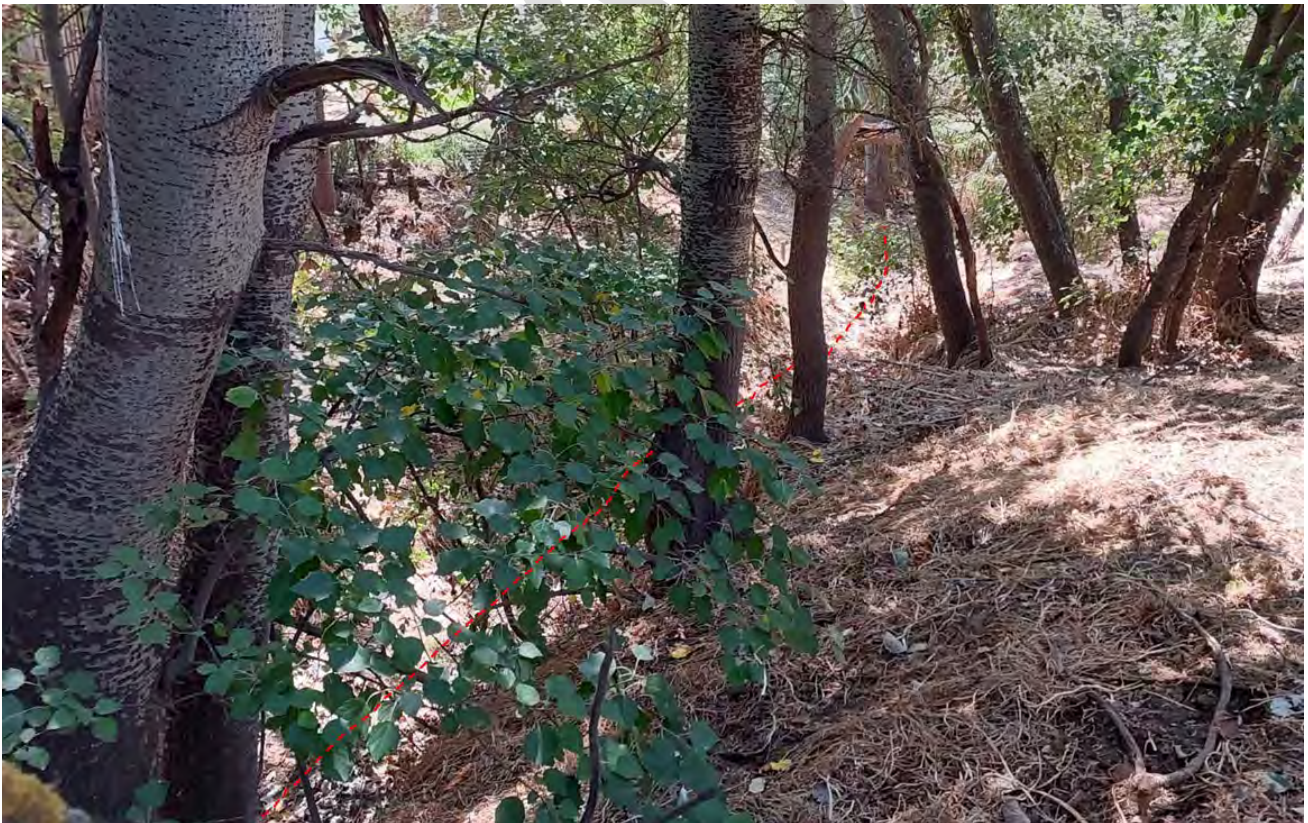
Figure 5-20: Portion of the Krom River downstream in the northern portion of the proposed development site. The riparian vegetation at this point comprises primarily *P. alba* trees.

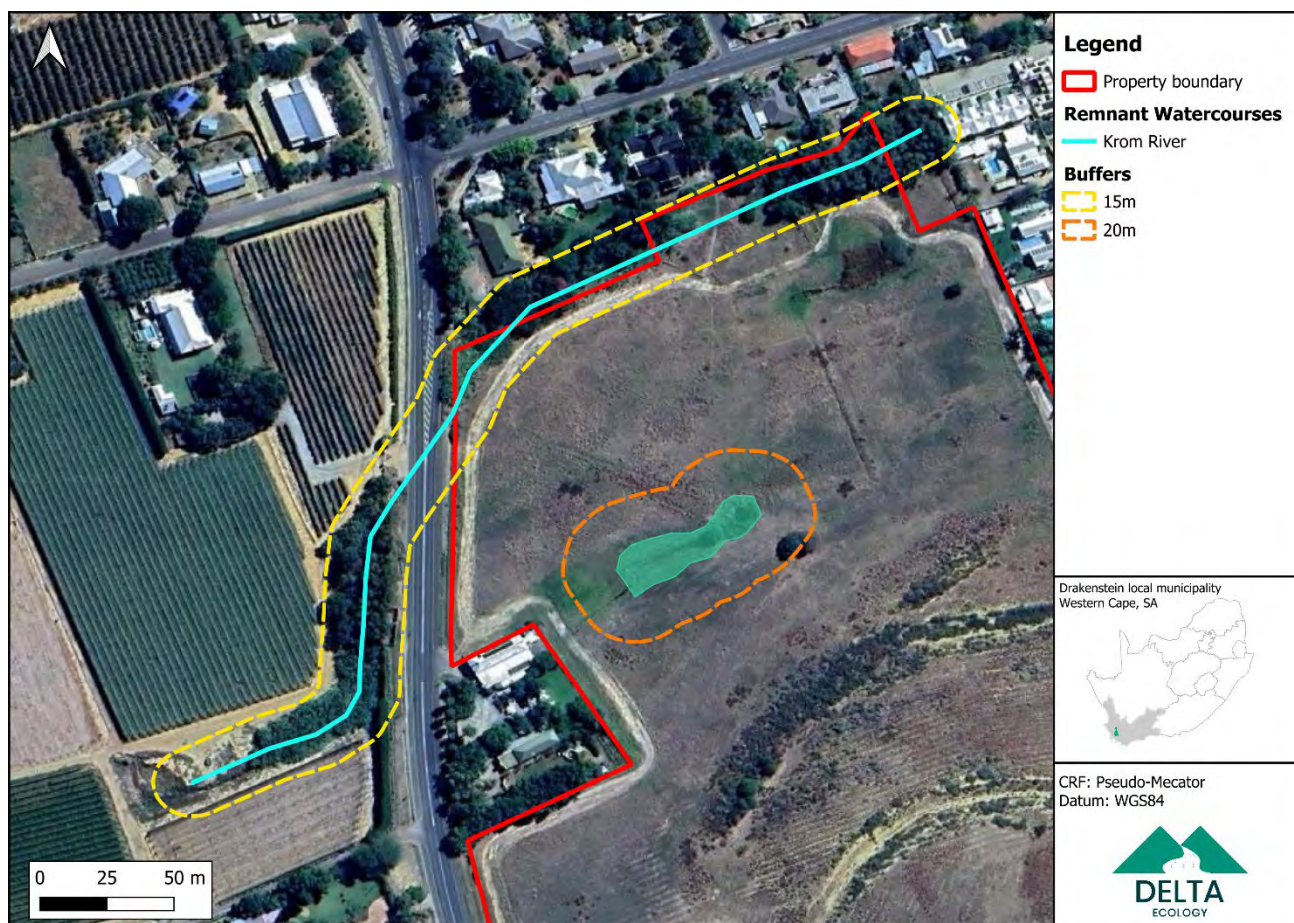
Figure 5-22: Remnant watercourses with respective buffer areas.

It is noted that the complete avoidance of the buffer areas will not be possible, as the proposed development will encroach into the suggested buffer zones. It is recommended that all non-essential construction and operational related activities must be strictly prohibited within the buffers (e.g. construction camps, laydown areas, mixing of cement, stockpiling of soils, ablution facilities etc).
