Detailed Freshwater Ecological Assessment:

**Unlawful clearance of indigenous
vegetation and the proposed development
of tourism facilities on Portion 48 of the
Farm 708, Franskraal, Overstrand
Municipality, Western Cape**

Date: 15.01.2025

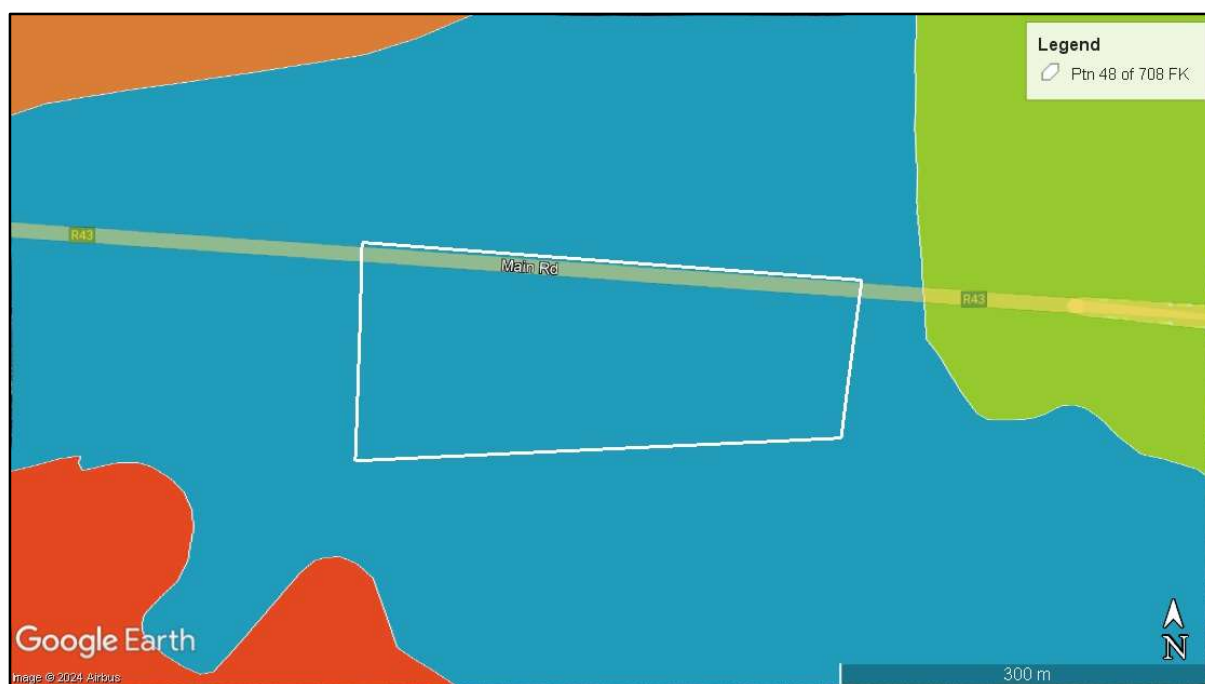
Figure 6: Wetland Vegetation Type Map (NFEPA, 2011). The blue polygon indicates the extent of South Coast Limestone Fynbos.

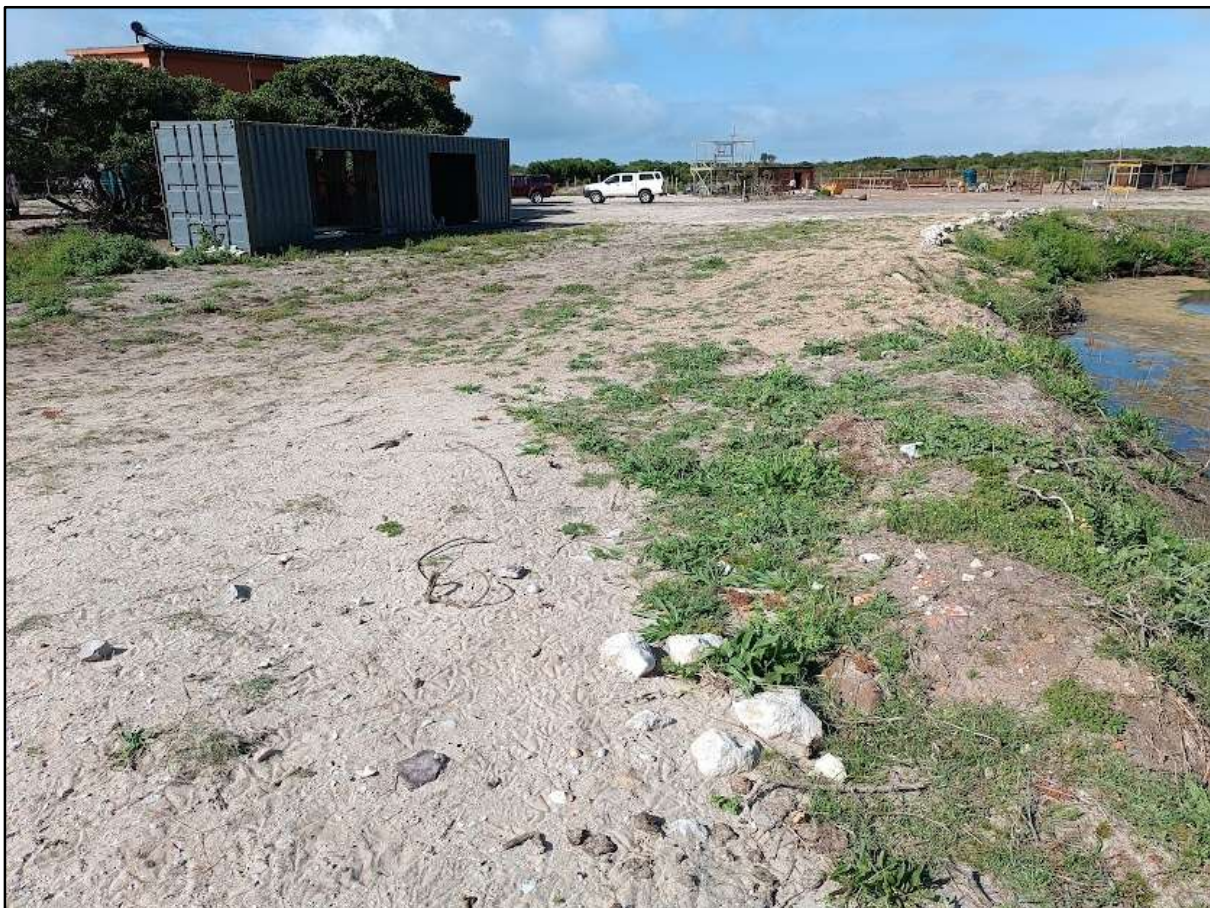
Figure 9: Photograph of the double storey residential dwelling, container and livestock pens. Note the intact stand of *Sideroxylon inerme* (milkwood) behind the container and the area in the foreground and background cleared of vegetation.

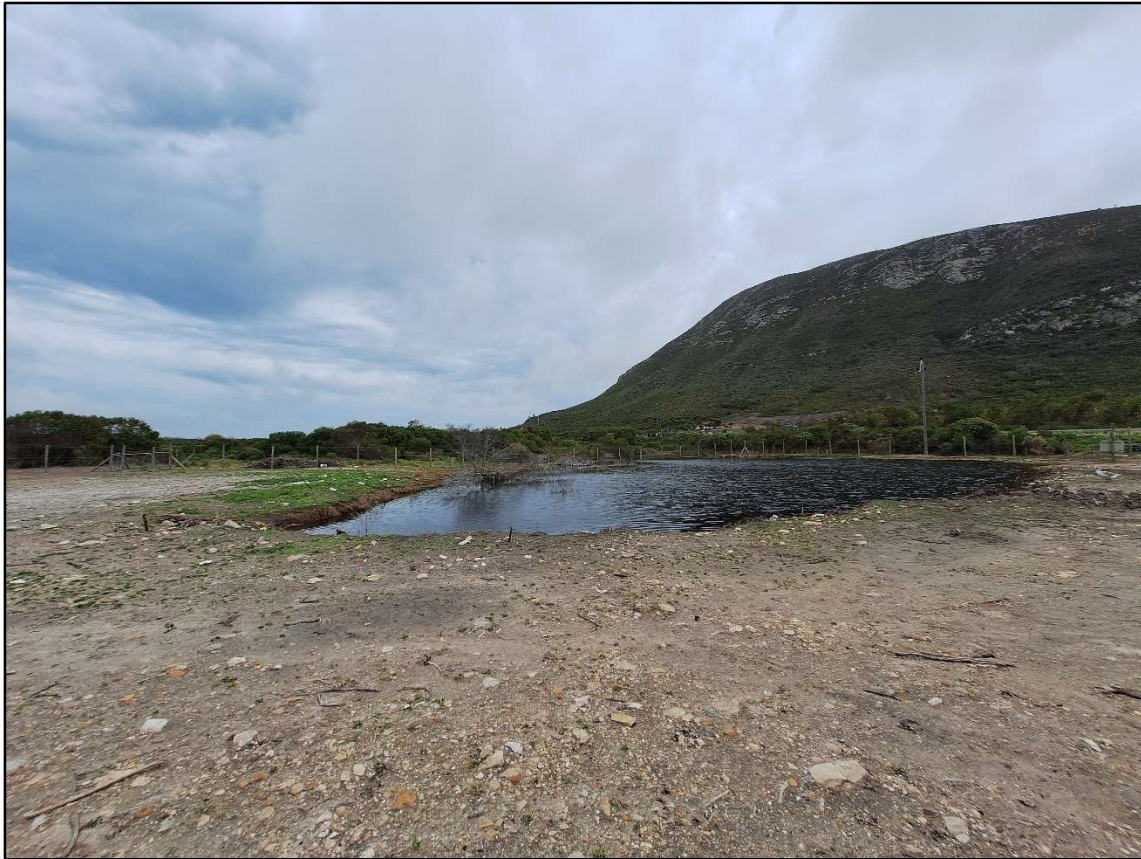
During the site visit which was conducted on 2 November 2024 the central part of the site was observed as comprising mostly bare ground. This central part of the site that has been cleared of vegetation covers an area of approximately 1.5 ha. When entering the property from the R43 one travels along an access road that is aligned between two ponds before arriving a centrally located area cleared of vegetation of approximately 1.5 ha. In this cleared area lies a double storey residential dwelling, a shaded car port and a container (see Figure 9). There is also a centrally located fenced in enclosure which contains a vegetable garden and an informal structure with various miscellaneous artefacts. A stand of *Sideroxylon inerme* (milkwood) has been left intact between the dwelling and the container but otherwise the vegetation has been totally cleared in the central part of the site (see Figure 10).

Figure 10: Photo looking westwards across one of the ponds that flank the access road.

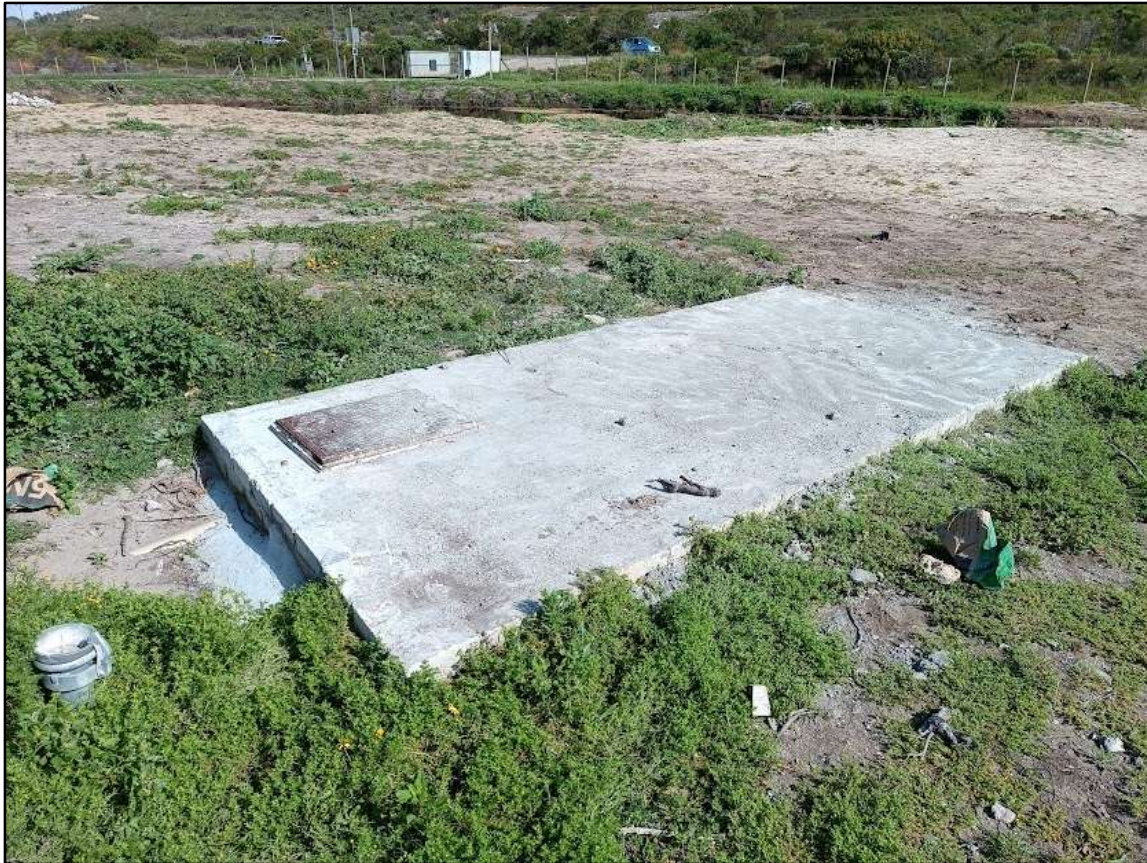
Figure 12: The conservancy tank located immediately north east of the residential dwelling and container.

In terms of services the only notable on-site infrastructure was the newly constructed conservancy tank (see Figure 12). It is assumed that potable water supply is obtained from the Municipal supply which is located within the road reserve of the R43 at the site's boundary.

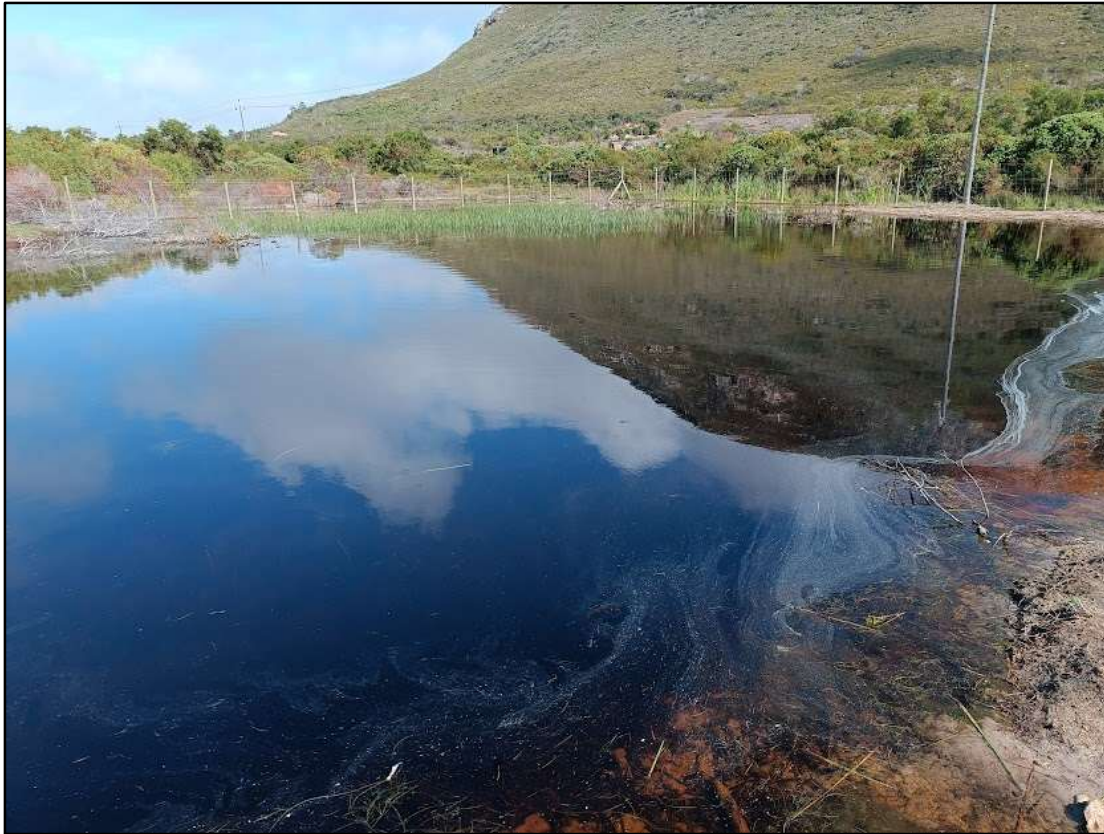
Figure 14: Central-western Pond. The eastern bank of the pond which is where the photograph is taken from comprises the access road.

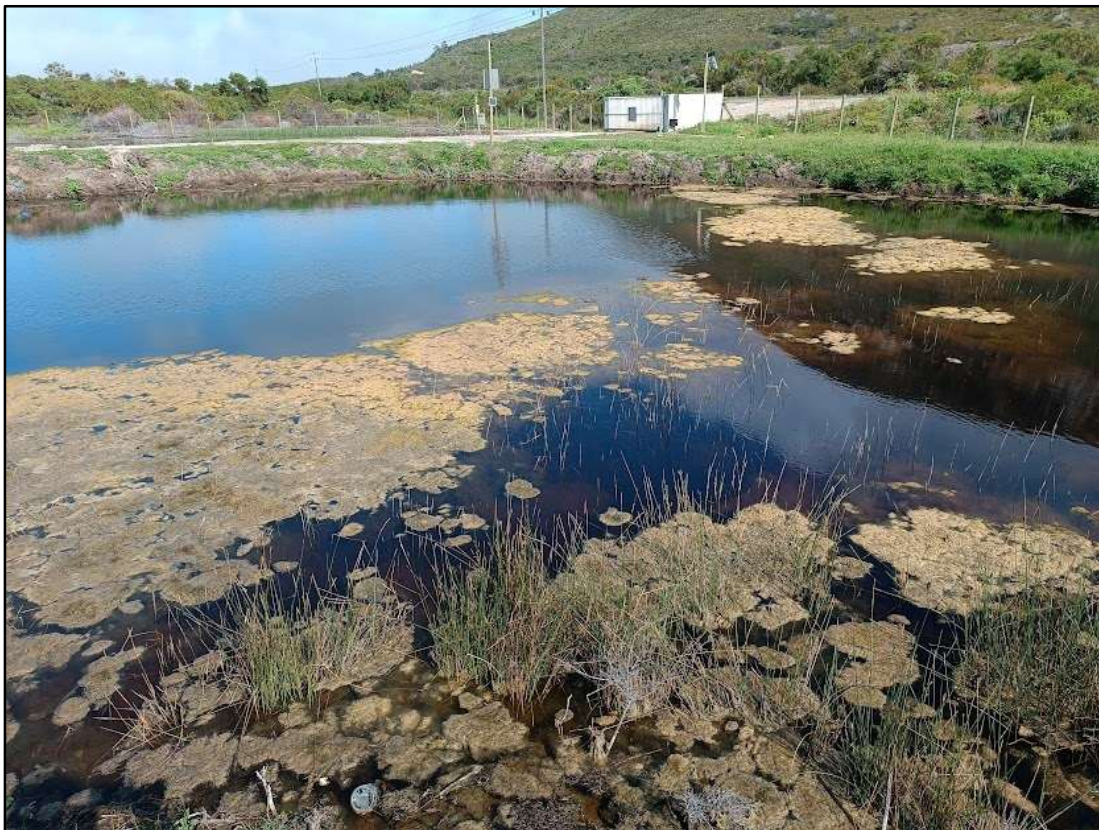
Figure 15: The Central-eastern Pond. Note the algae which is indicative of poor circulation and elevated nutrient inputs. Note the entrance to the property and access road in the background.

- Central-eastern Pond: This pond lies immediately east of the access road and is similar to the Central-western Pond insofar as it is largely devoid of vegetation on its banks (see Figure 15). The pond receives flow from the Central-western Pond via an informal / damaged culvert beneath the access road. A unique characteristic of this pond is the presence of clusters of algae which indicate elevated levels of nutrients, possibly due to the presence of farm animals and in particular geese which defecate in the dam and increase phosphate and nitrate levels.

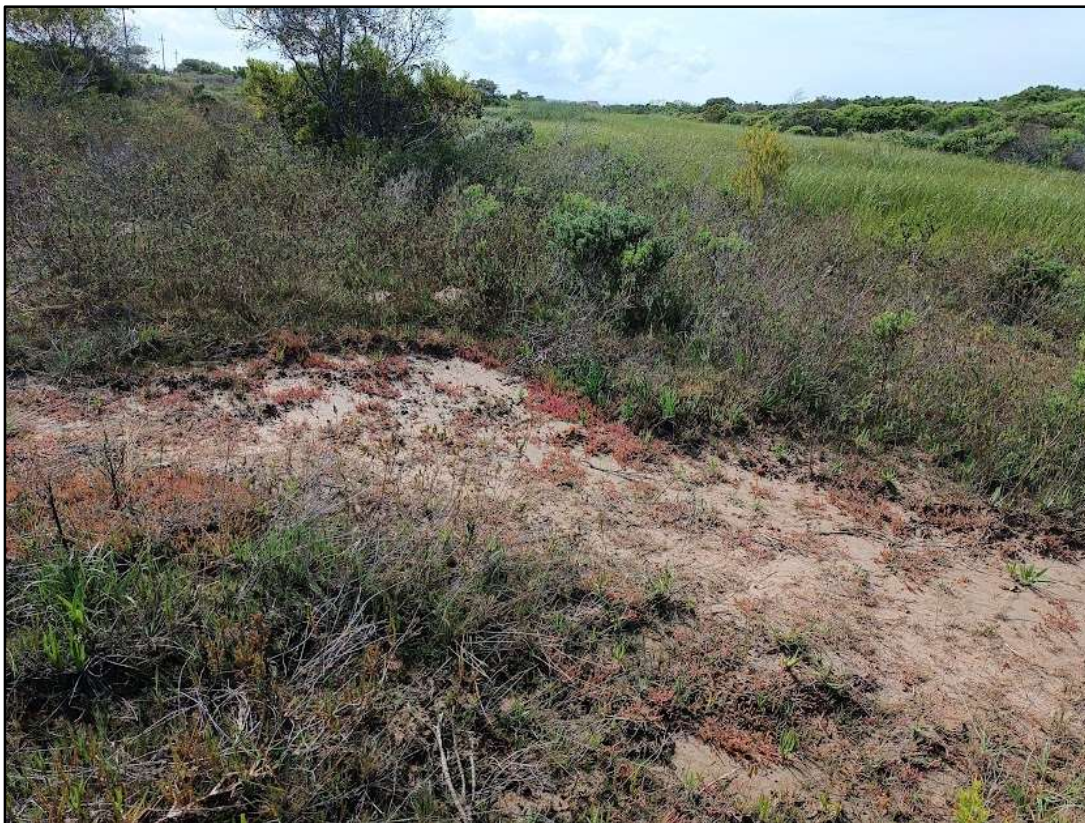
Figure 16: The Eastern Pond. Note the sedges in the background which indicate the extent of the standing water and the *Sarcocornia natalensis* in the foreground indicating saline conditions.

- Eastern pond: and Eastern Pond receives diffuse flow (i.e. not contained within a channel or pipe system) from the Central-eastern Pond and is the least impacted pond in terms of vegetation as the standing body of water is dominated by the sedge *B. maritimus*. The added presence of *Sarcocornia natalensis* confirms the saline nature of the wetland as both species are adapted to surviving in saline conditions (see Figure 16).

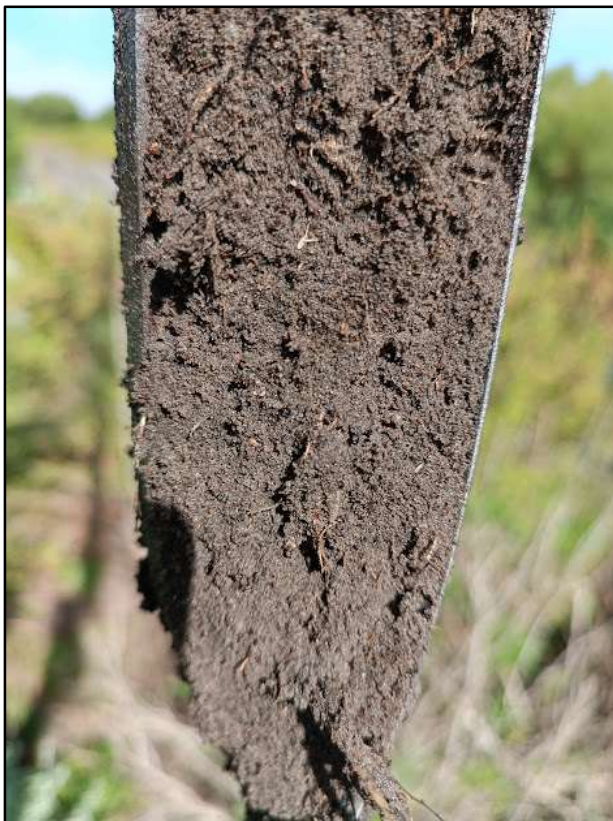
Figure 17: Auger sample taken from the area between the Western Pond and the Central-western Pond. Note the low chroma and lack of any redoximorphic features.

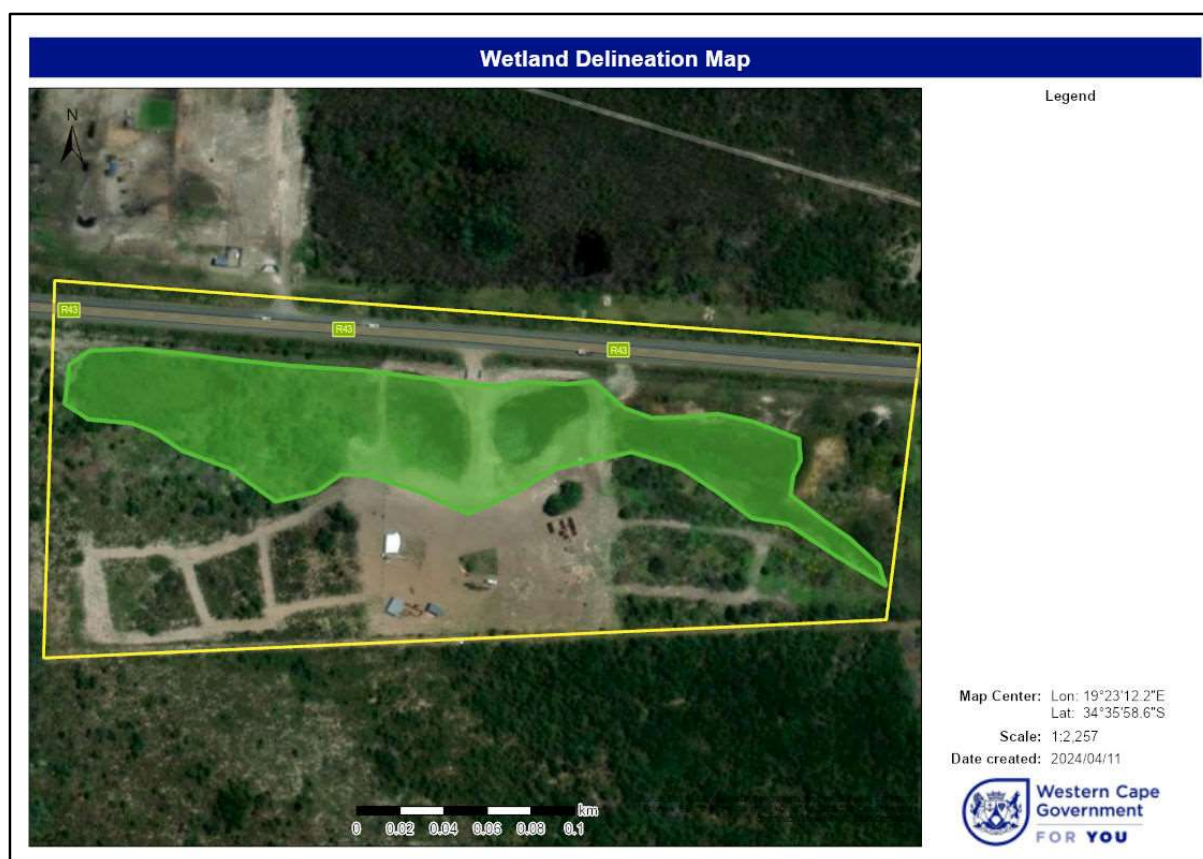
Figure 18: Watercourse delineation map. The green polygon indicates the extent of a Hillslope Seep Wetland.

the pre-disturbance wetland extent. The wetland delineation for the pre-disturbance extent of wetland habitat within the boundary of the site is shown in Figure A below.

Auger samples taken in the area between the ponds and on the banks of the ponds did not reveal redoximorphic features but did exhibit wetness, a rich organic layer at the surface and a low chroma characteristic of wetland soils in the region (see Figure 17), noting that the soils rarely exhibit mottling due to a lack of iron (Job, 2009). Ordinarily using these soil characteristics in addition to the presence of hydrophytic vegetation the outer limit of the wetland temporary/seasonal zone can be determined. However, in this instance given the lack of vegetation in the central part of the site due to clearance undertaken by the owner and also grazing by livestock, historical aerial imagery was also consulted to determine the pre-disturbance wetland extent. The wetland delineation for the pre-disturbance extent of wetland habitat within the boundary of the site is shown in Figure 18.
