Delineation of the wetland edge on a section of Portion 1 of the Farm Wortelgat 723, Hermanus (Spookhuis Area)

Including DWS Risk Assessment

Mosaic Farm (Portion 1 of Farm 723 Hermanus) – Spookhuis Area Wetland delineation report and DWS Risk Assessment

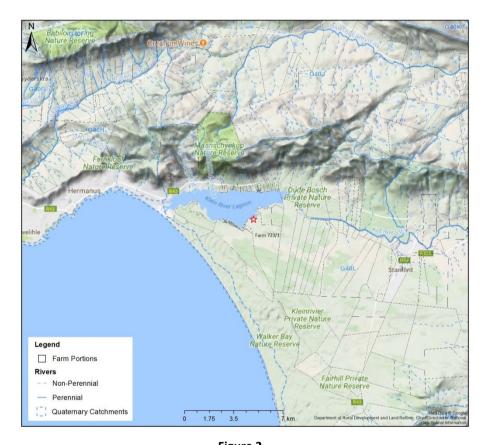
Figure 2

Catchment context of Farm 723/1. Figure adapted from Cape Farm Mapper output (https://gis.elsenburg.com/apps/cfm), with approximate position of delineated part of Farm 723/1 site marked with a star.

The site lies in the DWS's Olifants / Berg Catchment Management Area, in quaternary catchment G40L. The only significant river in this quaternary is the Kleinrivier and its tributaries. Flows from this river enter the lagoon from the east, near the town of Stanford (see Figure 2). Drainage from this quaternary enters the Hermanus Lagoon ("Klein River Lagoon in Figure 2). Numerous mainly seasonal minor watercourses pass off the steep mountain slopes of the Kleinriviersberge and pass into the northern shores of the lagoon. South of the lagoon, in the area in which the current site is located, there are no permanent river channels, excluding the Kleinrivier itself, and the watercourses mapped in the national 1:50 000 rivers layer (see Figure 2) all comprise seasonal systems, many of which peter off into the surrounding sands long before they reach the lagoon.

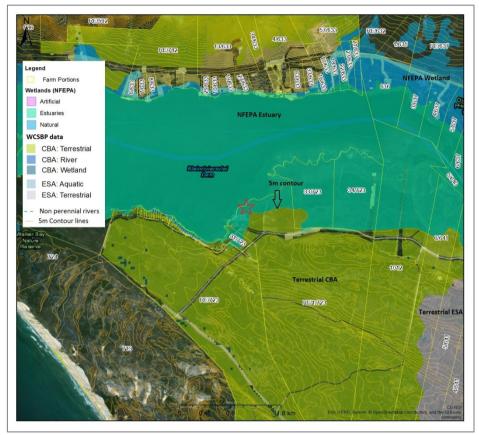
Conservation status of site and surrounding area, with figure (adapted from Cape Farm Mapper output (https://gis.elsenburg.com/apps/cfm), showing WCSBP data (Stanvliet et al 2017) and NFEPA wetland data, with approximate position of delineated part of Farm 723/1 site marked with a star

Figure 3 shows the site and surrounding area in the context of the Western Cape Spatial Biodiversity Plan (WCSBP) (Stanvliet et al 2017). The figure indicates that most of the site, excluding the area below the 5m contour around the lagoon has been mapped as a terrestrial Critical Biodiversity Area (CBA), with some disturbed patches that have been mapped as Ecological Support Areas (ESAs), mainly along the road. No aquatic CBAs or ESAs have been mapped in this area, with the lagoon and its margins registered only in the National Freshwater Ecosystem Priority Area (NFEPA) data layer of Driver et al (2011). The reason for the exclusion of the lagoon and its margins from the WCSBA is not that the system is not of biodiversity importance. Rather it reflects the classification of the

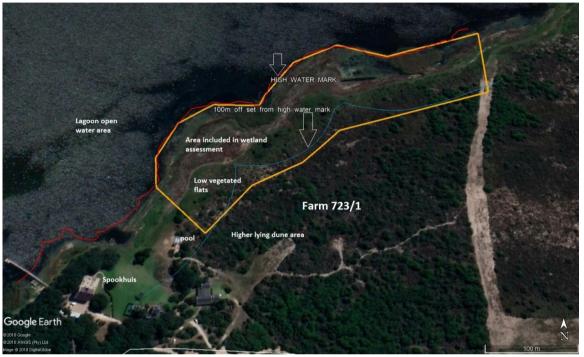
Figure 4

GOOGLE Earth image showing the portion of Farm 723/1 in which wetlands were delineated in this assessment (orange polygon) as well as the high water mark and 100m setback from the highwater mark as surveyed by Geomatics Africa.

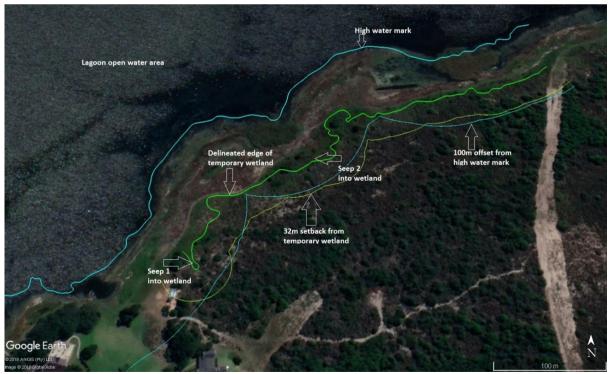
Figure 5
Results of 2018 wetland delineation, as plotted onto GOOGLE Earth imagery.

The delineation includes mostly floodplain flat wetlands associated with the lagoon itself. However, in at least two areas (seep 1 and Seep 2) these wetlands were extended further upslope than elsehwhere along the shoreline, with Seep 1 in fact narrowing and extending as a band of *Imperata cylindrica* up a dune slope. This indicated a source of water emanating from the dune itself, with water close enough to the surface at the lowpoint down the slope that periodic near-surface saturation it supports temporary wetland conditions.

The other seep (seep 2 in **Figure 5**) comprises a broader, lower-lying area just upslope of a patch of milkwoods, which again occurs at a higher level to the main wetland flats along the shoreline, and is assumed to be fed by water percolating from the dunes to the south.

Any built development within 32m of the demarcated wetland edge or within 100m of the highwater mark would require authorisation in terms of NEMA. Figure 5 indicates that, along most of the shoreline considered in this assessment, the 32m setback from the delineated wetland defines the lower development boundary, and development closer to the lagoon than this line would require NEMA authorisation. Along a short section of the south western and north eastern ends of the assessed shoreline, the 100m setback from the high water mark in fact extends out slightly beyond the 32m setback, and in these areas would define the development edge for which no authorisation in terms of NEMA would be required. All of these lines fall well beyond the 3.44m contour line that was also surveyed.

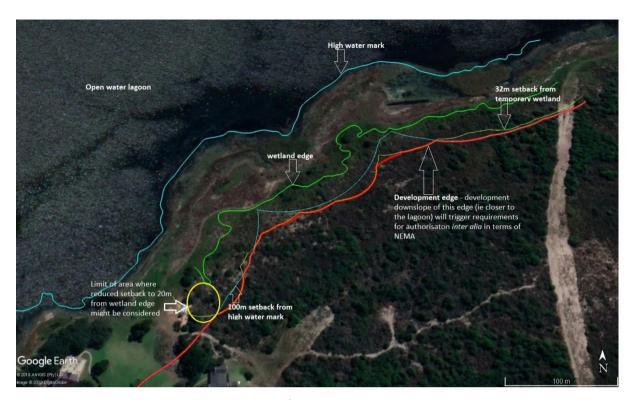
Development setback line, as derived by GEOMATICS Africa and based on the most upland of any of the surveyed development-limiting lines included in Figure 5

Figure 6 shows the combined development edge, derived by Geomatics Africa, and taking into account the outermost development-limiting edge mapped.

Assuming that the Client sets any development back from the development edge shown in **Figure 6**, there should be no triggers for authorisation in terms of NEMA from the perspective of the impacts of the development on any aquatic ecosystem, including estuaries.

Depending on the detailed design and layout of the proposed development, even if it is situated outside of the development setback shown in **Figure 6**, it is arguable that it might nevertheless incur Section 21c and i "water uses", defined in terms of the NWA as (21c) "impeding or diverting the flow of water in a watercourse" and (21i) "altering the bed, banks, course or characteristics of a watercourse". Such uses might arise through activities such as subsurface drains that diverted subsurface seepage flows away from the wetlands (Section 21c use), as well as through activities that altered the quality or quantity of surface and/or subsurface flows into the water course, or the characteristics of the watercourse. Such activities could include seepage from septic tanks, overflows from conservancy tanks, runoff from irrigated lawns, channelled runoff from hardened surfaces that caused erosion or channel incision in the wetlands, or simply the spread of alien plant material into wetlands that currently have only low levels of impacts associated with alien invasion or other disturbance.

As noted in Section 4.3, it is considered extremely unlikely that the proposed development would be associated with any risk to aquatic resources, assuming that all development lies outside of the nodevelopment line shown in **Figure 6**. Nevertheless, in order to allay any concerns on the part of the DWS regarding this issue, a number of best practice measures have been listed below, which if implemented would both completely address any outlying concerns that the development might impose Risk on aquatic resources, and be in line with the non flow-related measures outlined in Anchor (2015), designed to bring about the required improvement in estuary condition. The following measures are recommended for incorporation into development design:
