# **Wetland Offset, Rehabilitation, and Management Plan**

**Erf 1486, Vermont, Western Cape Province**

September 2025

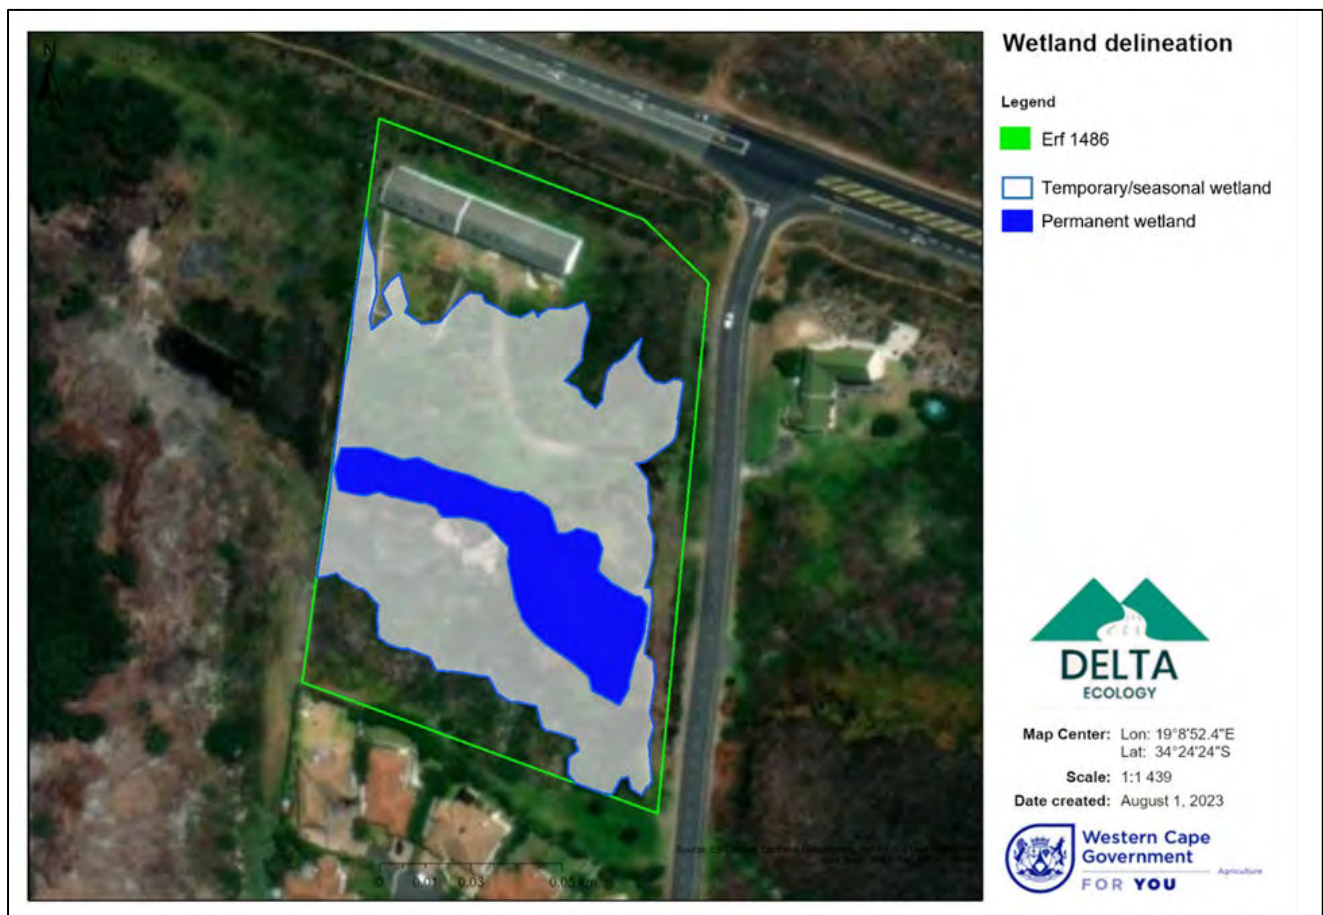
**Figure 4-1: Delineated wetland within Erf 1486.**

The health of the UVB wetland within Erf 1486 was assessed as part of the Van Zyl *et al.* (2023) Aquatic Biodiversity Impact Assessment using the current best practice methods (Macfarlane *et al.* 2020 WET-Health Version 2.0). The UVB wetland was found to have a Present Ecological State (PES) within Category D, indicating that the wetland was in a largely modified condition at the time of assessment. In addition, the wetland has Moderate Ecological Importance and Sensitivity (EIS) and Wetland Ecosystem Service (WES) scores, which indicates that the wetland is moderately sensitive or important in terms of conservation planning or provision of ecosystem services (Van Zyl *et al.* 2023).

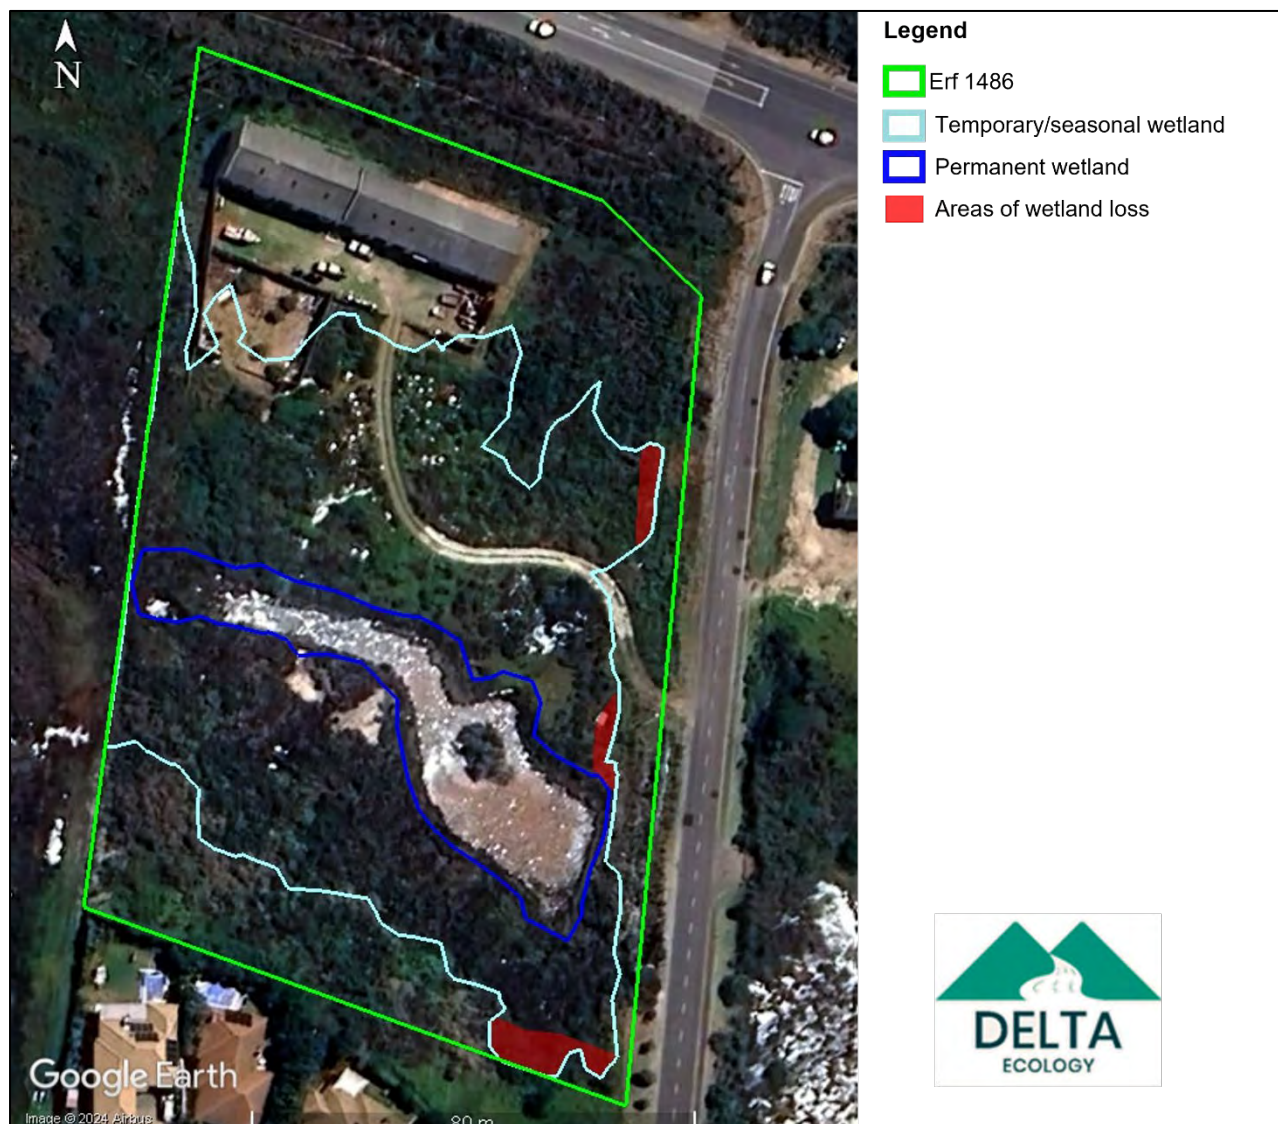
**Figure 5-1: Wetland area to be lost and developed.**

The delineated wetland within the site boundary was found to cover approximately 0,90 ha (60%) of the approximate 1,50 ha development site. A total of 0,70 ha (47%) of the entire site will be required to establish the proposed development. A relatively small portion of the largely modified wetland will be lost, resulting in the loss of approximately 0,024 ha (3 %) of the 0,90 ha UVB wetland (**Figure 5-1**). Maximum wetland offsetting opportunities were thus identified within the proposed development site. The proposed development is split into 6 dwellings in the north and 3 dwelling in the south of the property. The remaining undeveloped area within the centre of the site consists of the permanent wetland zone and the remaining temporary/seasonal wetland zone, leaving a total of 0,74 ha of the wetland to be rehabilitated and used as the offset (**Figure 5-1**). The wetland was characterised by a mixture of alien and indigenous vegetation. The remaining wetland area thus offers good onsite wetland offsetting opportunities.

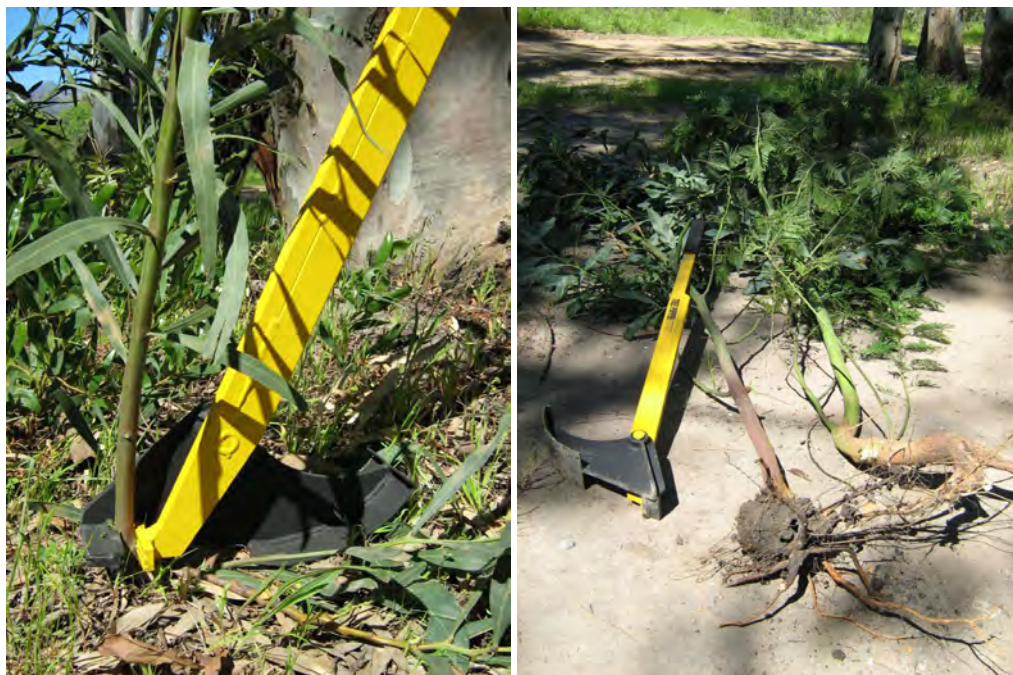
**Figure A1: Tree-Popper**

This technique is used for medium tree specimens and involves the use of an implement referred to as a "Tree-Popper". This tool consists of a base plate and a lever that are joined to form a small pair of jaws (**Figure A1**). The tree is placed in the jaws of the tool and the lever is used to pull the entire tree, including the roots, out. This tool is extremely useful for trees that are too large to be effectively removed by hand pulling yet are not yet large enough to require felling. The method to be used is similar as outlined for hand pulling, however the Tree-Popper is used instead of pulling.

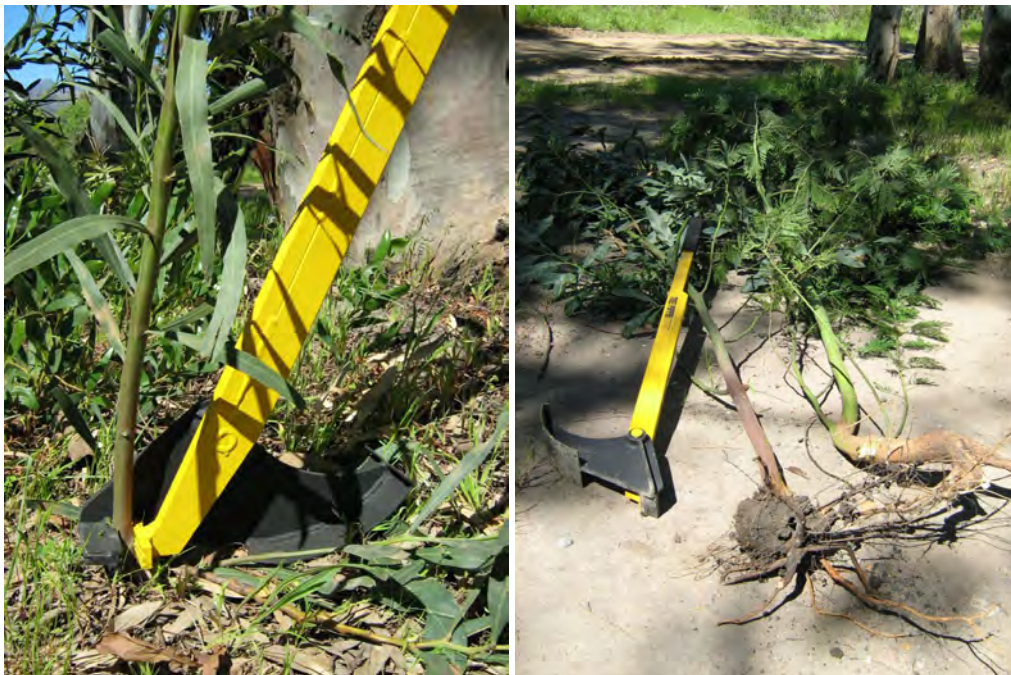
**Figure A1: Tree-Popper**

This technique is used for medium tree specimens and involves the use of an implement referred to as a "Tree-Popper". This tool consists of a base plate and a lever that are joined to form a small pair of jaws (**Figure A1**). The tree is placed in the jaws of the tool and the lever is used to pull the entire tree, including the roots, out. This tool is extremely useful for trees that are too large to be effectively removed by hand pulling yet are not yet large enough to require felling. The method to be used is similar as outlined for hand pulling, however the Tree-Popper is used instead of pulling.
