# Aquatic Biodiversity Impact Assessment

**Erf 438 Stanford, Western Cape**

For: Lornay Environmental Consulting

August 2024

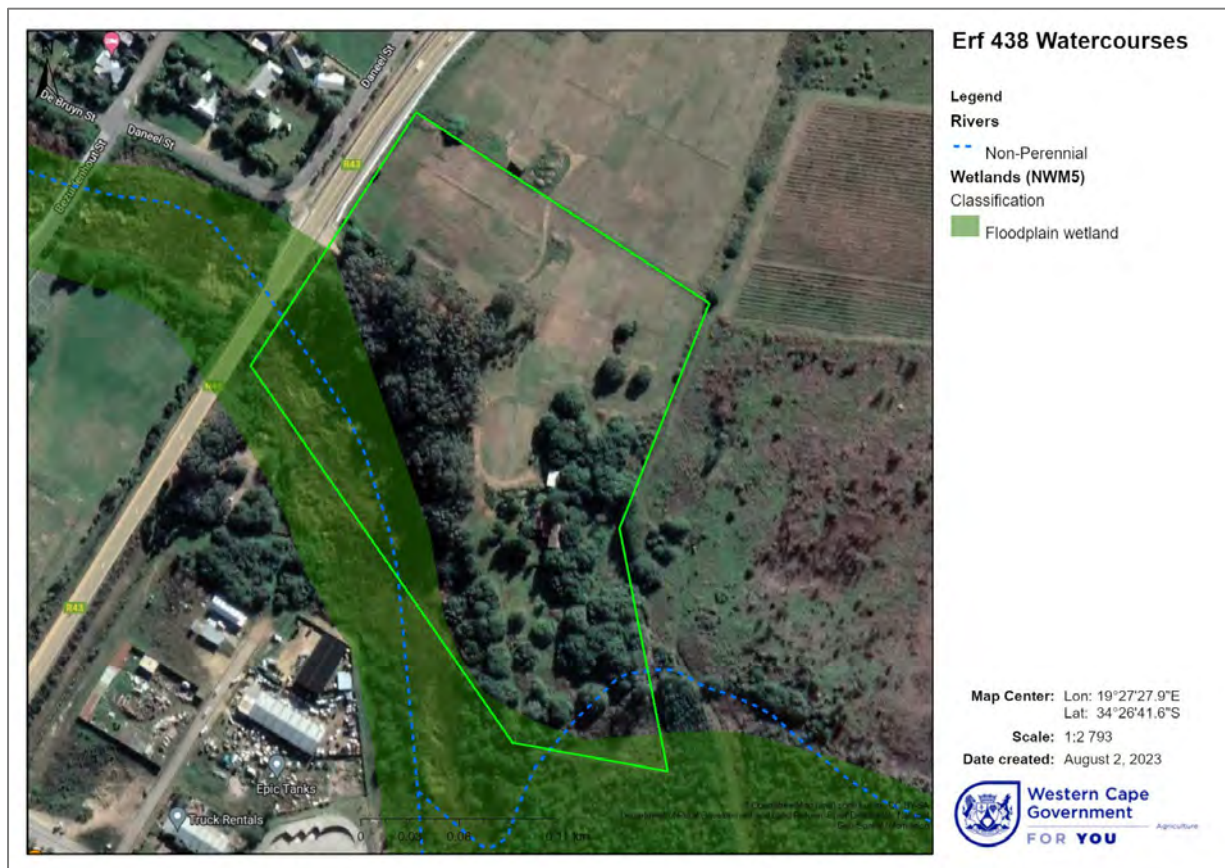
Figure 4-3: Regional Drainage Map (NGI Rivers, NWM5 Wetlands and NFEPA Wetlands).

The proposed site is underlain by the Overberg Regional Aquifer. The Department of Rural Development and Land Reform (DRDLR) National Geo-spatial Information (NGI) river line vector data indicates two non-perennial drainage lines that intersect the proposed site across the southern and western corners and confluence just south of the site (**Figure 4-3**). The National Wetlands Map Version 5 (NWM5) (SANBI, 2018) wetland layer indicates a floodplain wetland coinciding with the non-perennial drainage lines. The National Freshwater Ecological Priority Areas (NFEPA) (CSIR, 2011) maps this wetland as a Channelled Valley-Bottom wetland (CVBW) (**Figure 4-3**). Both aquatic systems extend across the 500 m regulated proximity of the Erf, but no other watercourses were noted in this area (**Figure 4-4**).

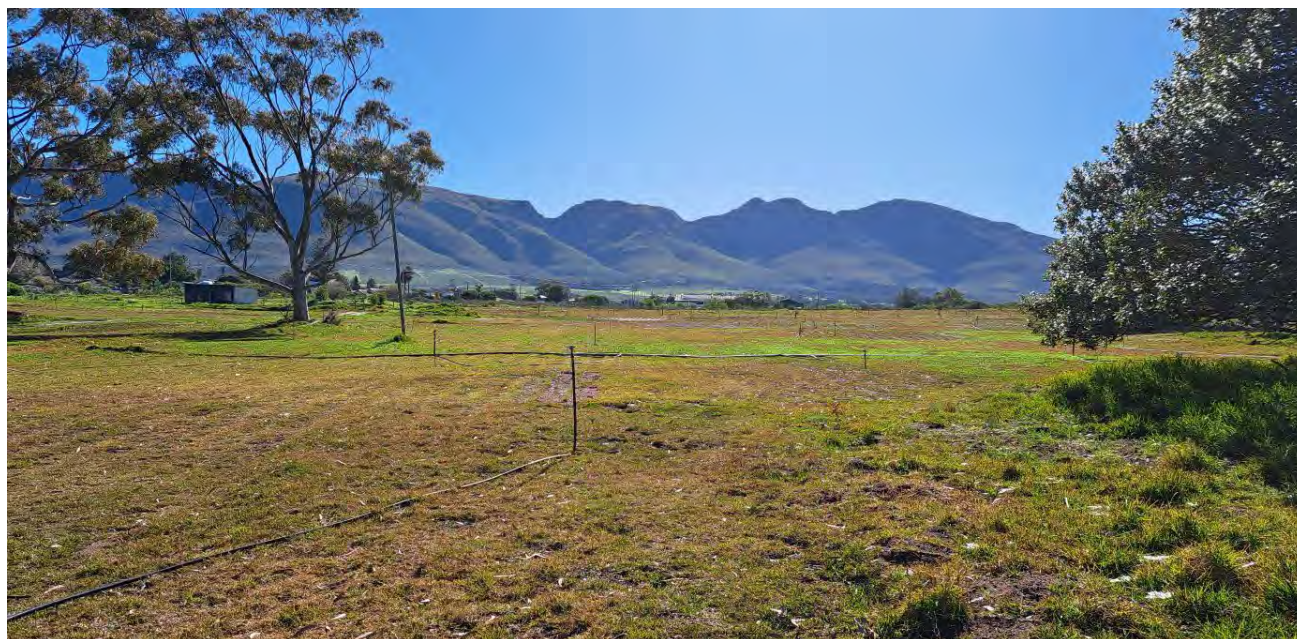
**Figure 5-1: Compacted areas used for growing roll-on lawn.**

In the agricultural area, the artificially compacted soils often exhibited surface water from the recent rain, but deeper augering revealed dry soils just under the surface with no redoximorphic or other hydromorphic soil features. Some areas were noted however where the soil was waterlogged

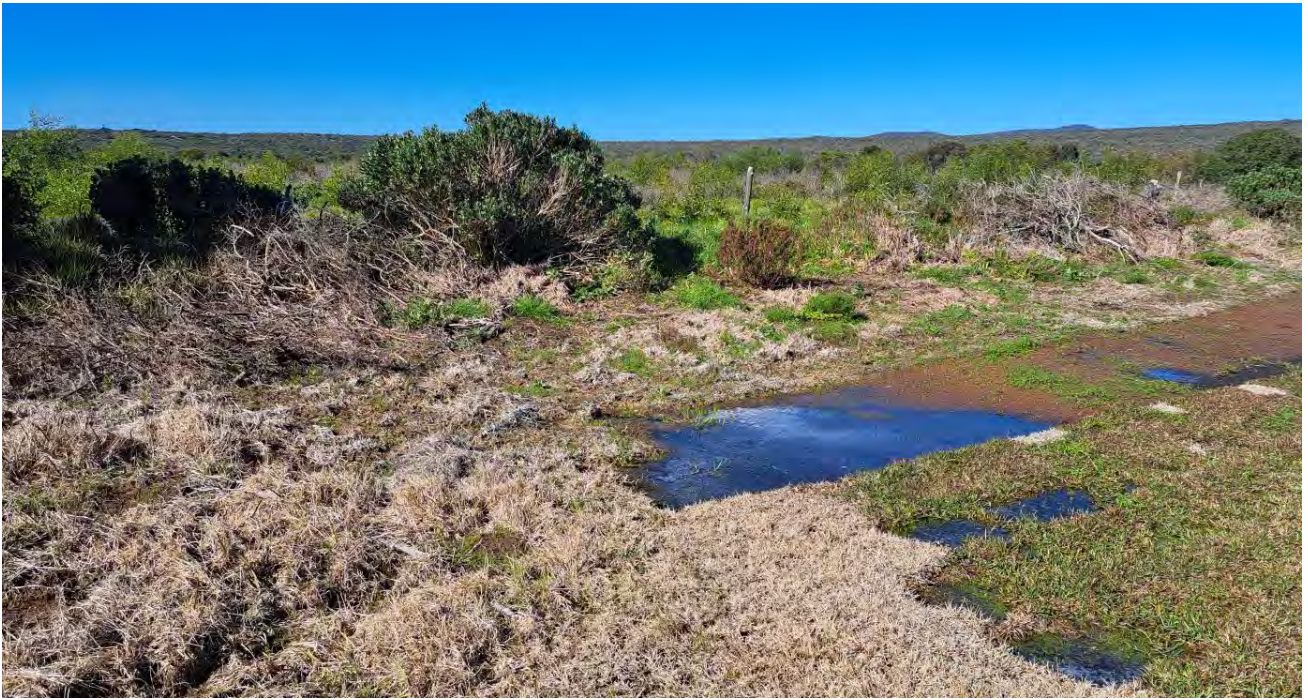
**Figure 5-2: A portion of the hillslope seep where it flows onto the compacted lawn area.**

- The majority of the hillslope seep wetland had been cleared of natural vegetation and currently is used to grow grass for sale as roll-on lawn. Some disturbance tolerant wetland species were present; however, their extent was limited.
- No species of conservation concern were noted.

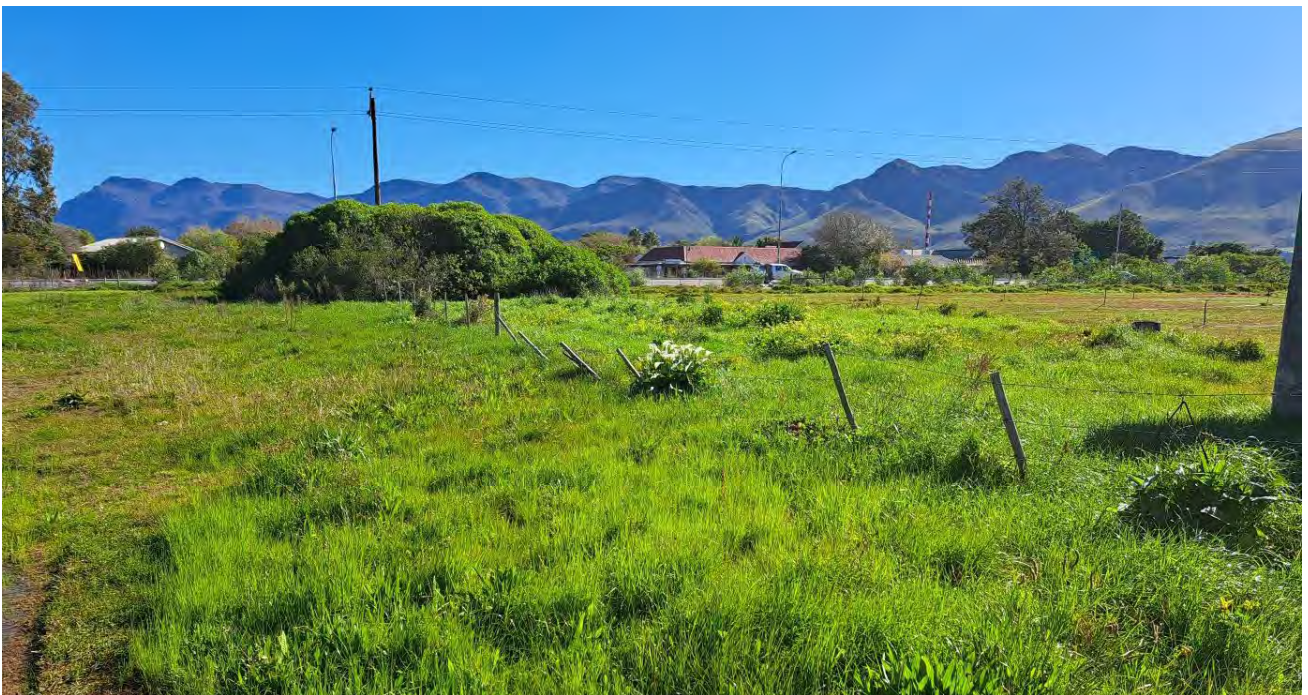
**Figure 5-3: A portion of the hillslope seep near the R43.**

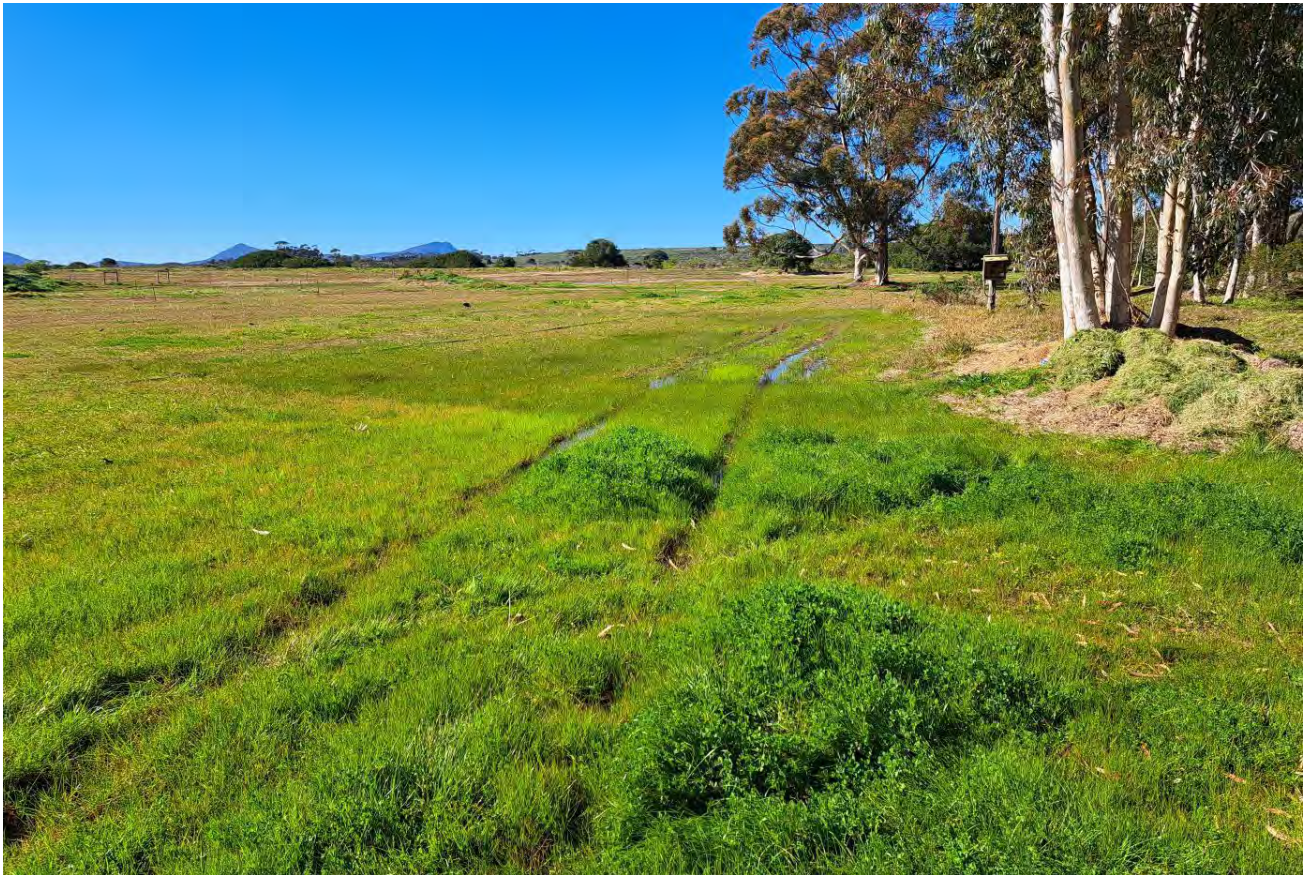
**Figure 5-4: A portion of the hillslope seep near the access road and Mill Stream wetland.**

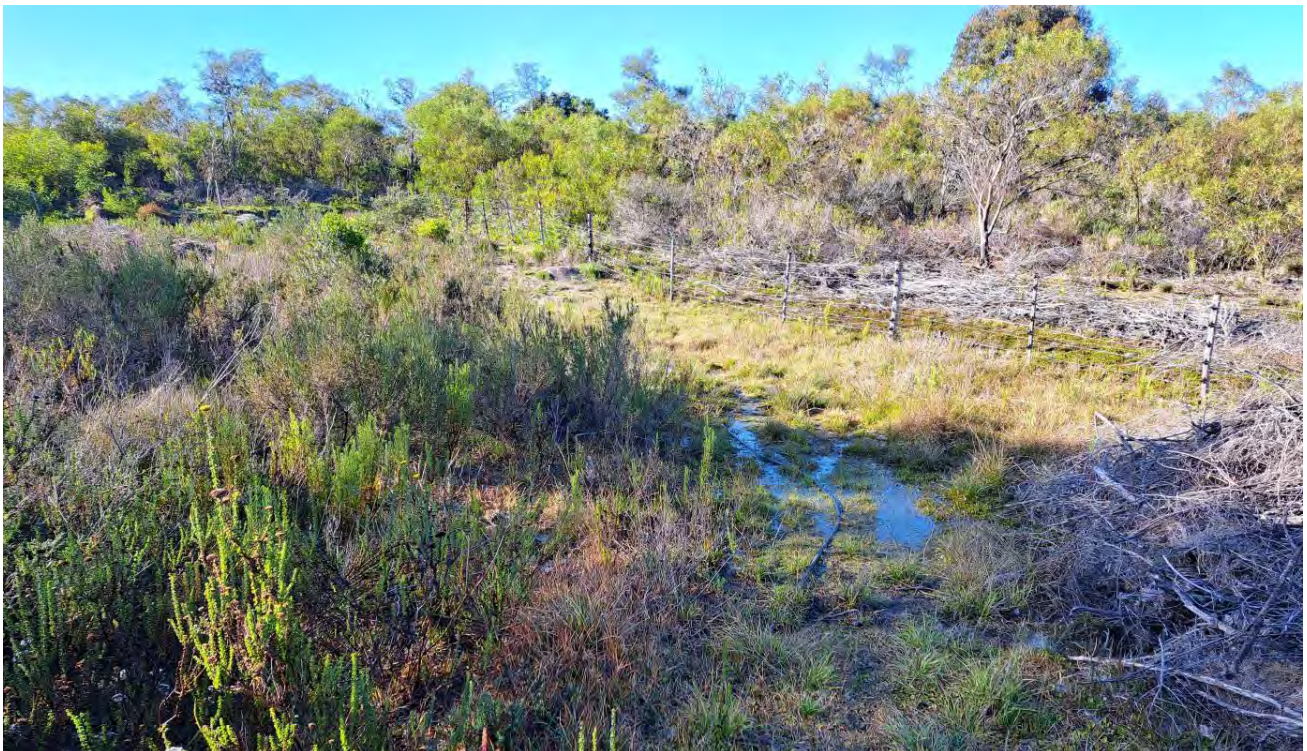
**Figure 5-5: Tributary wetland flowing left to right across the track. Note the brush pile to the right from recent invasive species clearing.**

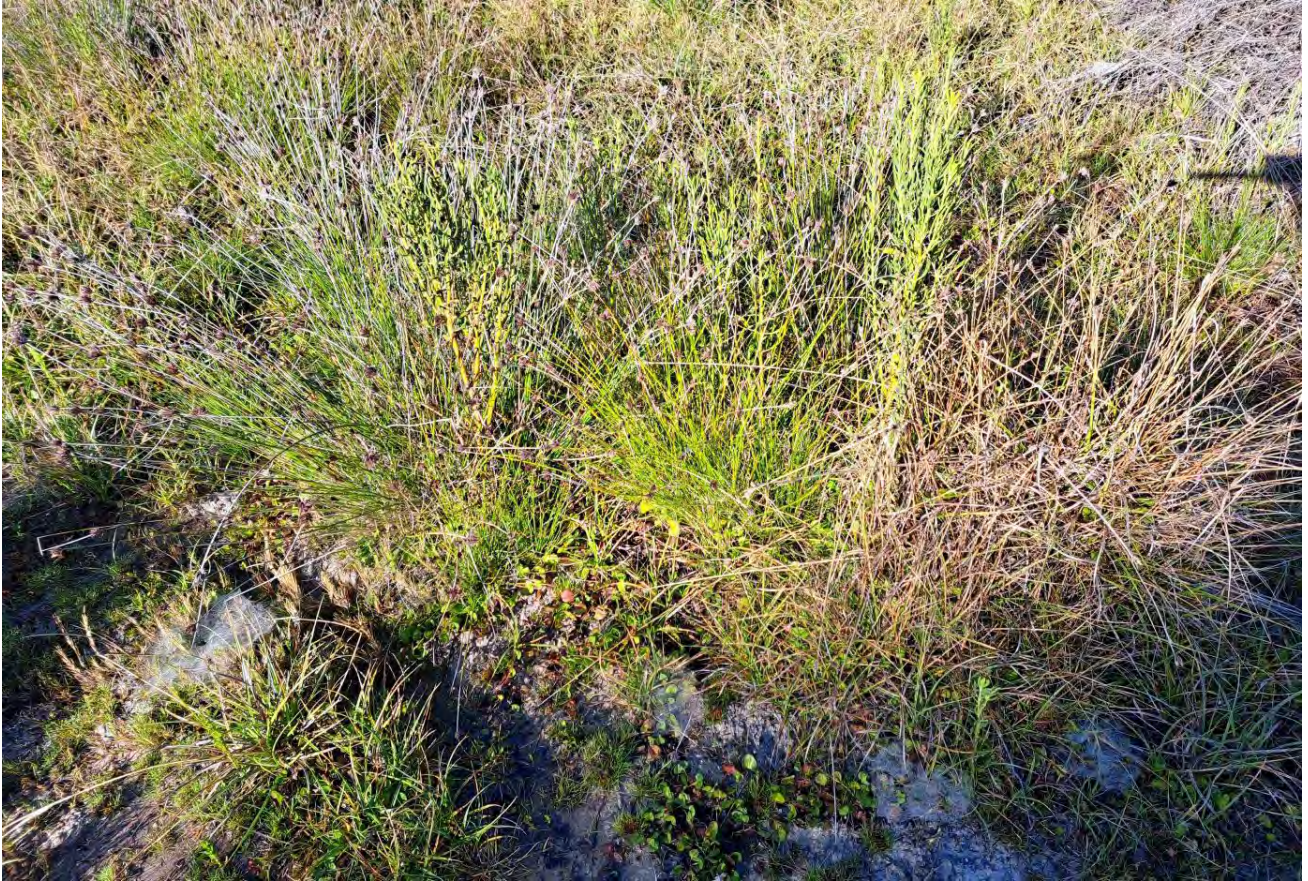
**Figure 5-6: Vegetation typical of the tributary wetland.**

- The small tributary wetland exhibits a moderately diverse wetland community dominated by native species such as *Carex clavata*, *Ficinia elatior*, *Orphium frutescence*, and *Stenotaphrum secundatum*. The wetland has been cleared recently of alien invasive species (*Acacia saligna*) and is recovering well. However, the adjacent property is still densely invaded and poses a threat to the long-term recovery and stability of the wetland vegetation. No species of conservation concern were noted.

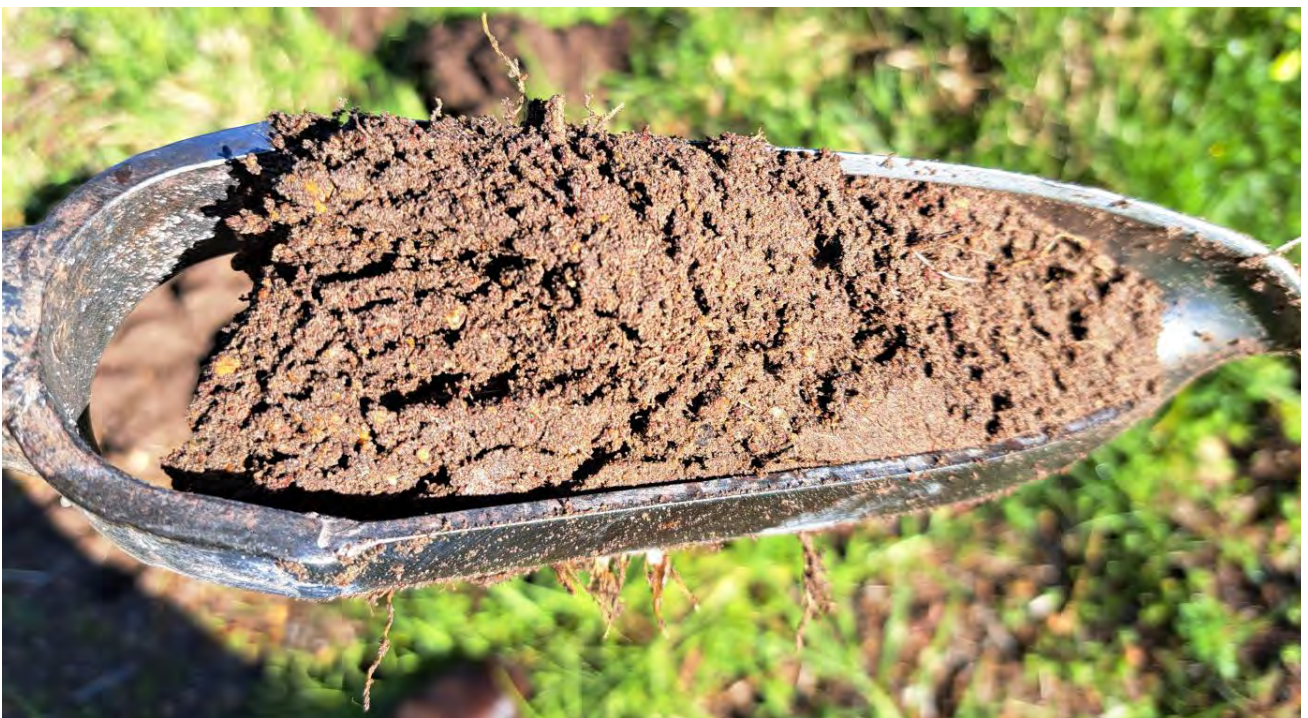
**Figure 5-7: Brown, uniform soils typical of the terrestrial parts of the site.**

Terrestrial soils were a damp uniform brown sandy loam, while wetland soils were waterlogged and exhibited gleying. Limited mottling was noted due partially to the high concentration of quartzitic sand in the soil matrix which does not contain significant iron, and partly because the seasonal zone was entirely waterlogged to the degree that soils could not be held in the auger for photography. Only occasional temporary zone mottles were noted. Wetland soils were examined for the presence of peat. Typical peat characteristics such as high organic matter content, spongy texture, and distinct odour were not observed within the soil samples.

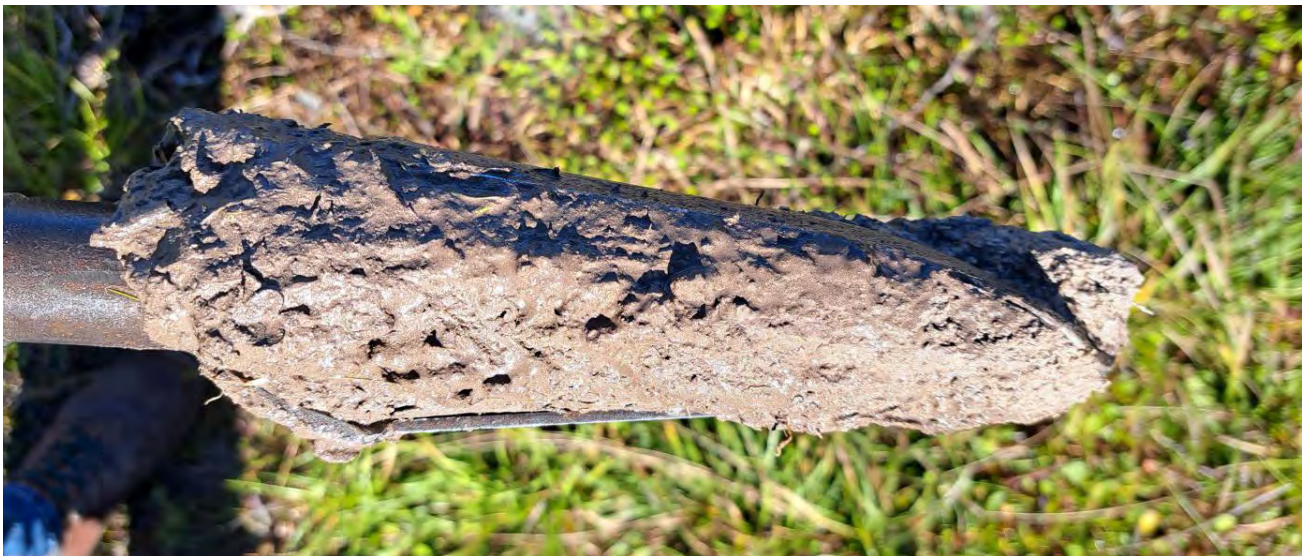
Figure 5-8: Saturated wetland soils exhibiting gleying.

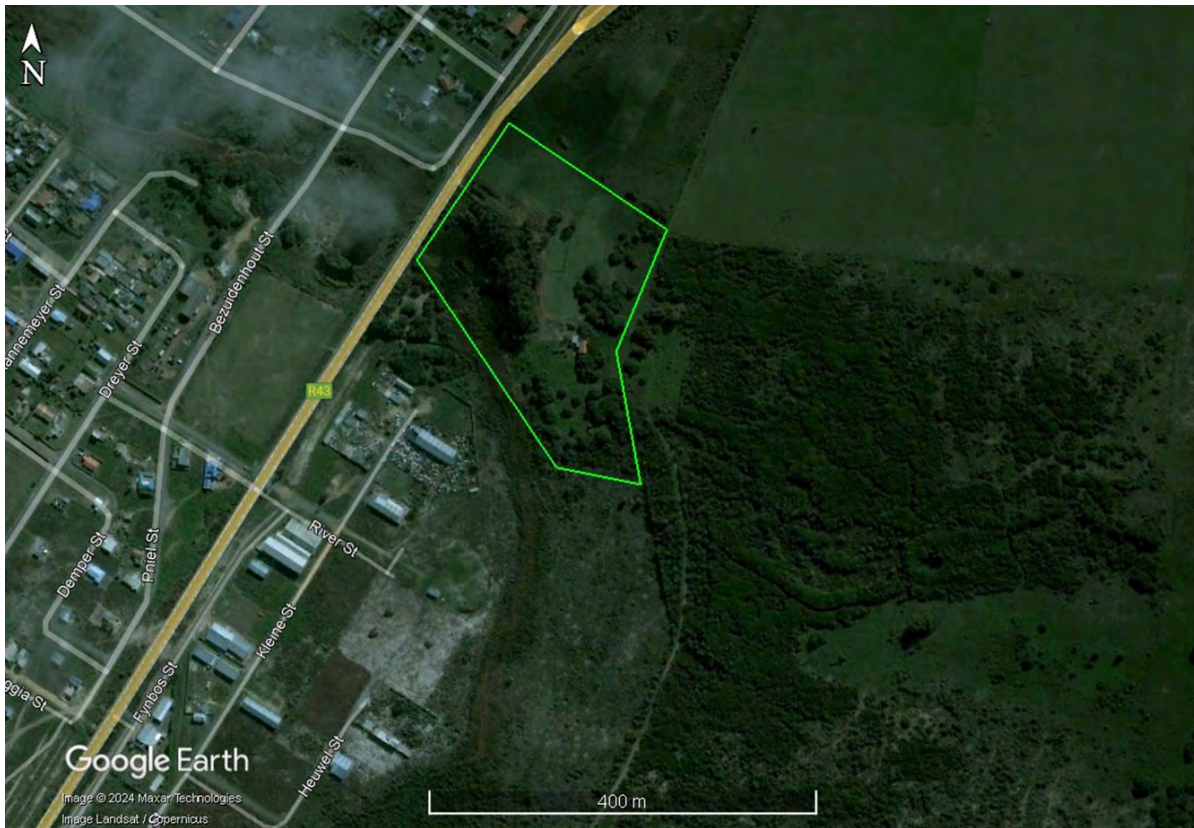
**Figure 5-10: Historical image from 2003, Erf 438 outlined in green.**

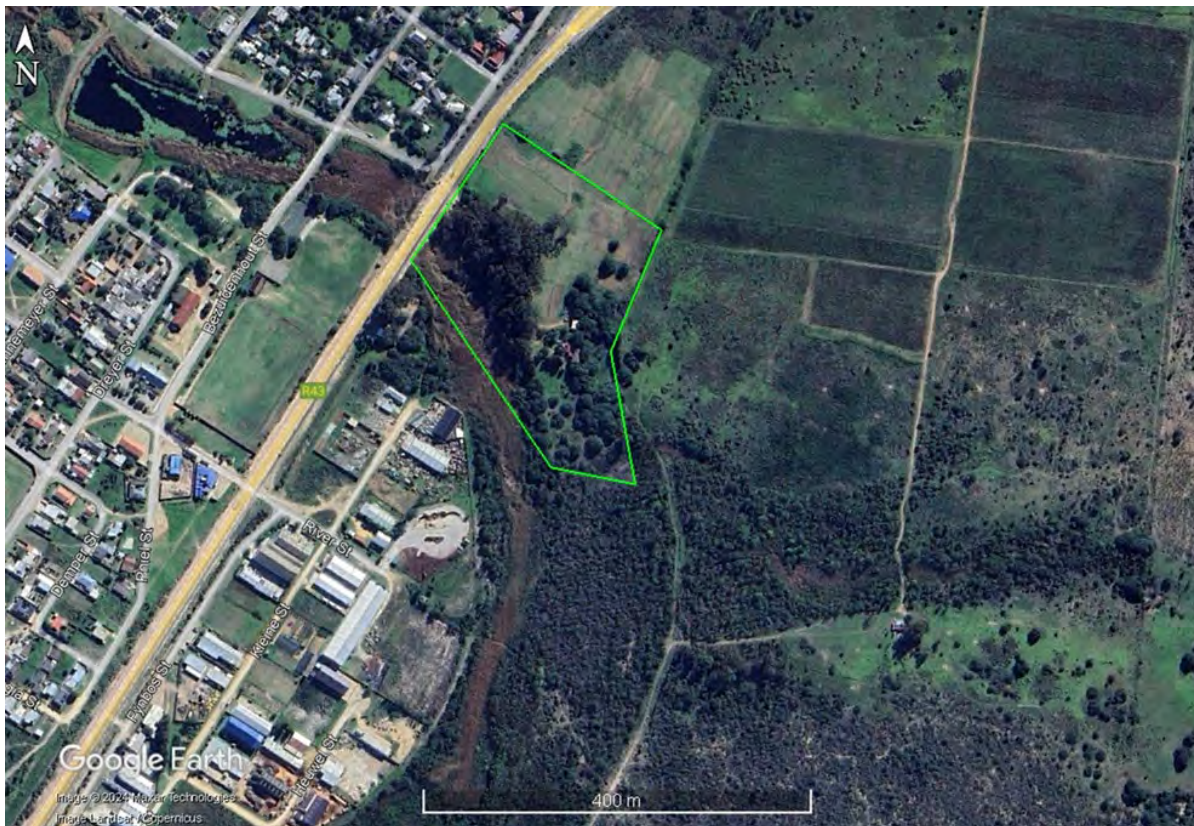
**Figure 5-11: Image from 2023, illustrating the changes within and surrounding Erf 438 (outlined in green).**

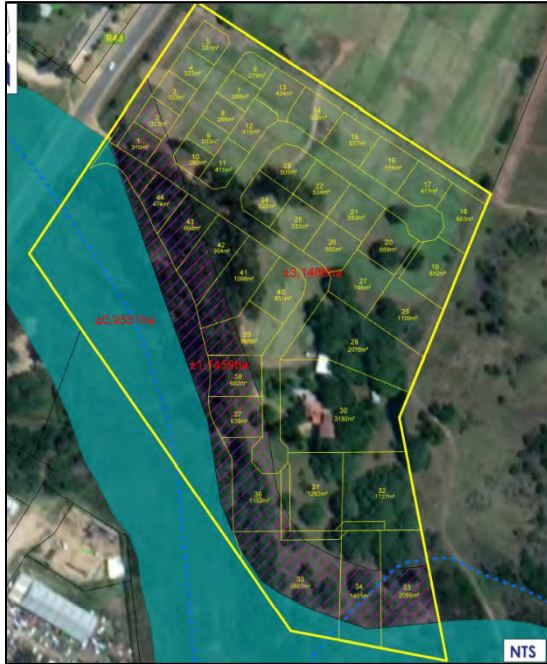
## Option 1

Option 1 was designed with the primary objective of maximizing space and increasing the number of residential units. However, this option did not account for the environmental sensitivity of the site. The plan proposed the removal of the milkwood trees, a protected species with substantial ecological and heritage value. Additionally, the wetland and its buffer zones were disregarded in the layout.

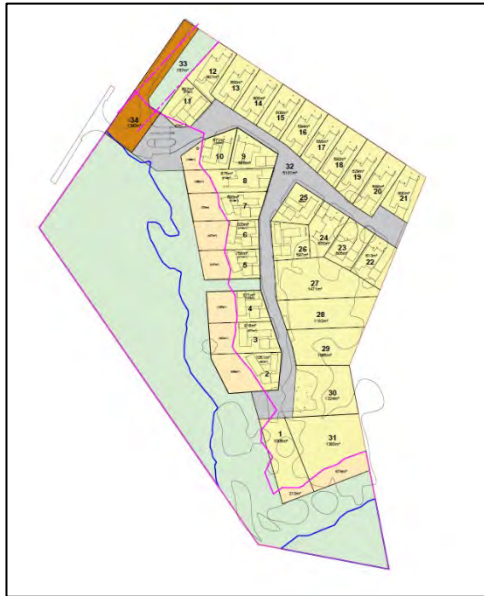
#### **Option 4: The Preferred Alternative**

Option 4 represents the conclusion of careful planning and environmental consideration, emerging as the preferred alternative for the development. This plan takes into full account both the wetland and the milkwood trees, ensuring that these critical ecological features are preserved and enhanced.
