Aquatic Biodiversity Impact Assessment

Erf 878 Riebeek–Kasteel, Western Cape

For: Lornay Environmental Consulting

April 2026

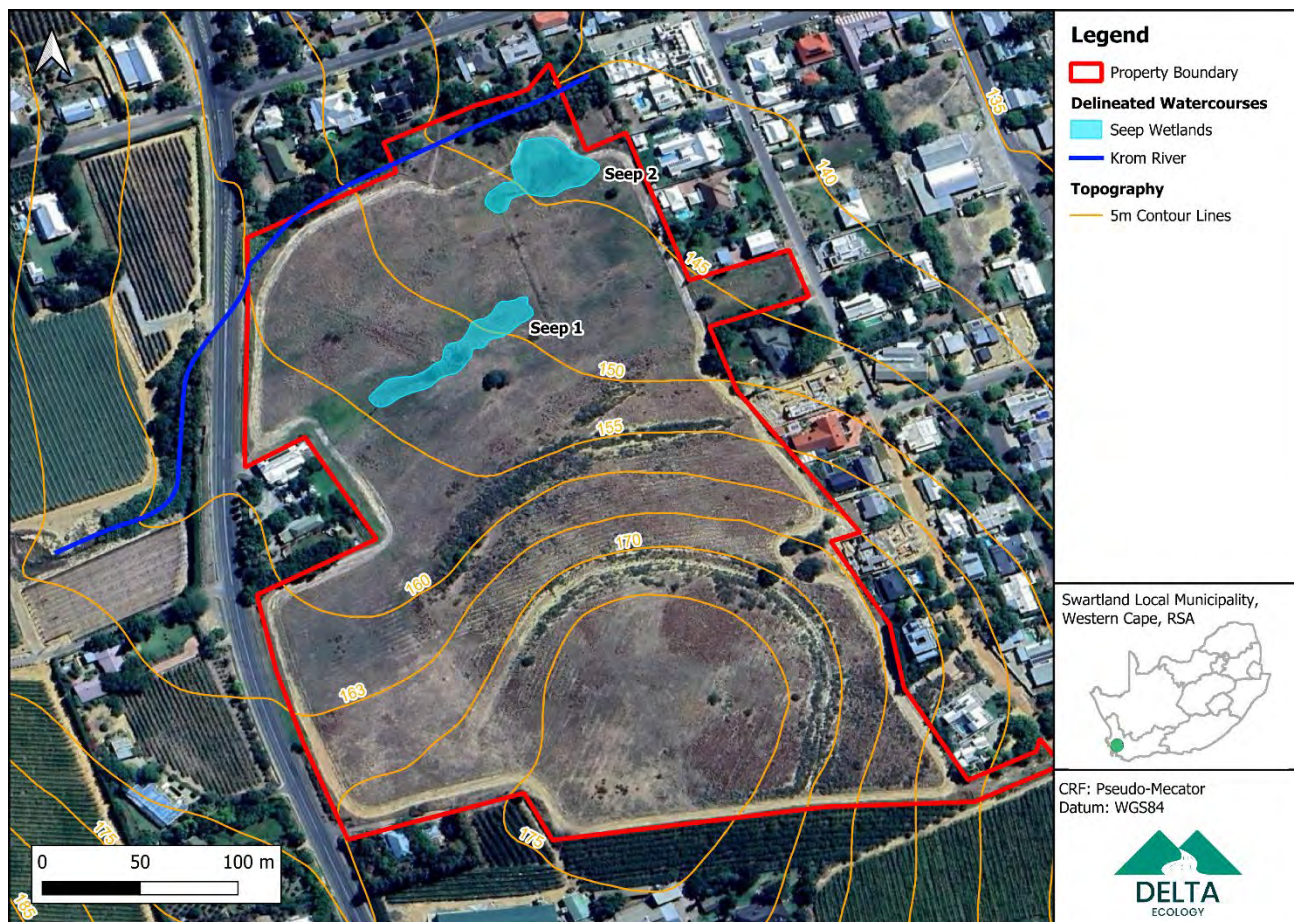
Figure 5-1: Watercourse Delineation Map.

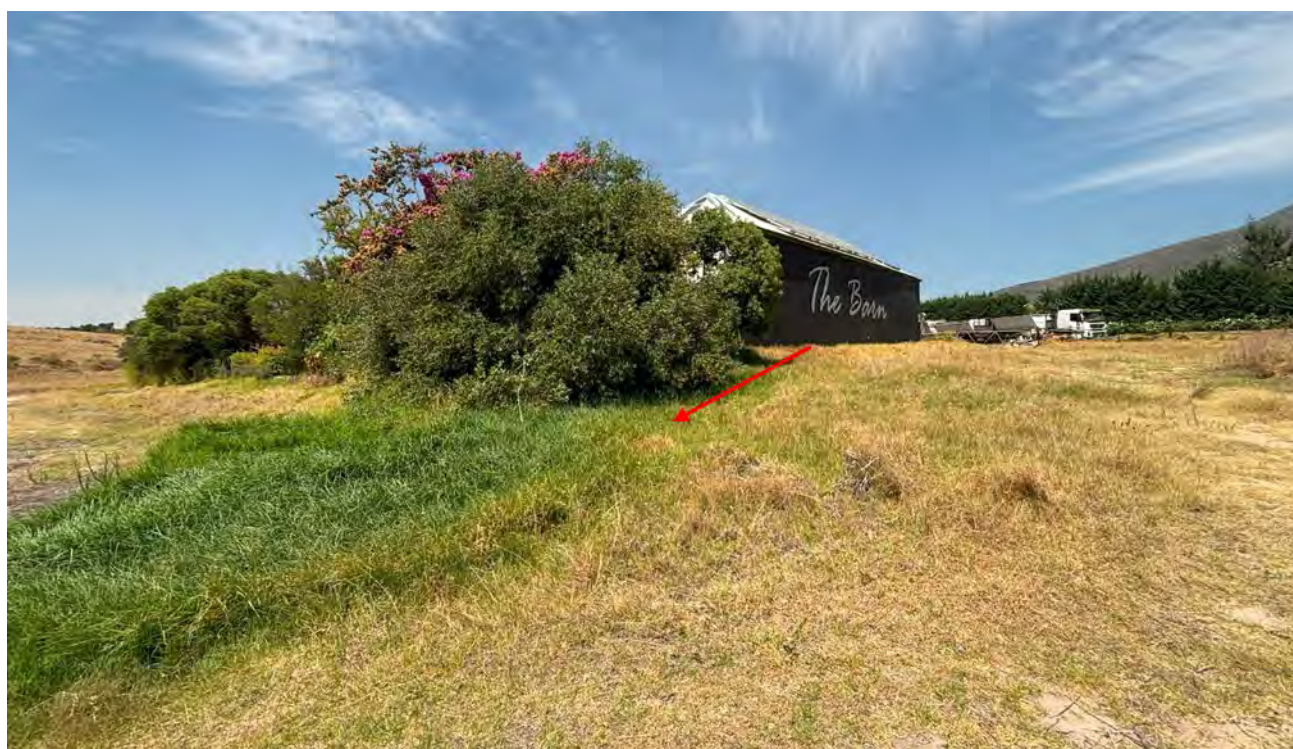
Figure 5-2: Area of artificial seepage dominated by *P. clandestinum* adjacent to the neighbouring restaurant. This area has likely developed because of artificial stormwater enhancement and irrigation runoff from the restaurant garden.

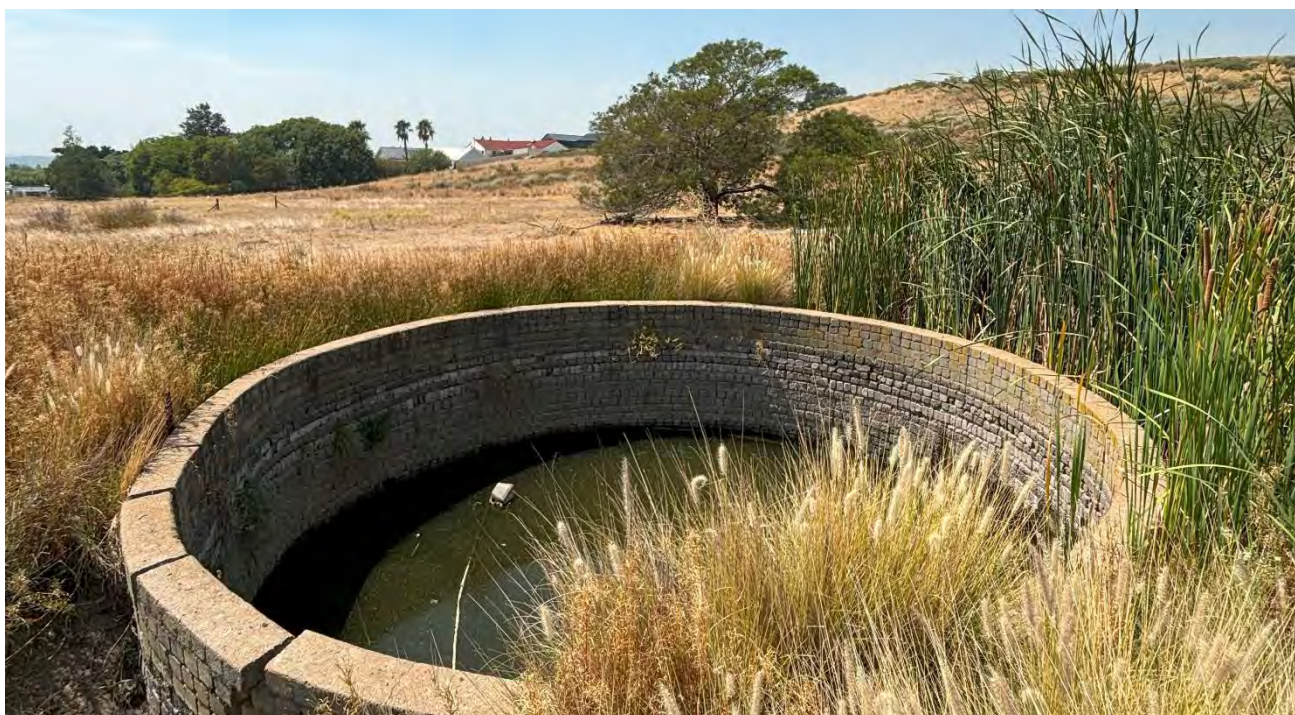
The two natural seep wetlands appear to have formed through strong surface-groundwater interactions, although each is influenced by different geomorphological factors. Seep 1 is associated with a spring-fed system, where a well point has been installed at or near the natural groundwater emergence point. While the well point may affect localised saturation patterns, the seep itself remains driven predominantly by natural spring discharge. Seep 2, in contrast, appears to be influenced by historic infilling and excavation that has intercepted the shallow water table, creating conditions conducive to sustained wetness. Historical imagery indicates that both seep systems are dynamic and have fluctuated in extent over time (**Figure 5-3**). Consequently, delineation relied on a combination of field indicators and analysis of long-term satellite imagery. It is noted, however, that delineating a precise boundary - particularly for the spring-associated seep (Seep 1) - is challenging, as the extent of saturation may shift under varying hydrogeological conditions and as a result of the well.

Figure 5-4: A well has been developed within Seep Wetland 1.

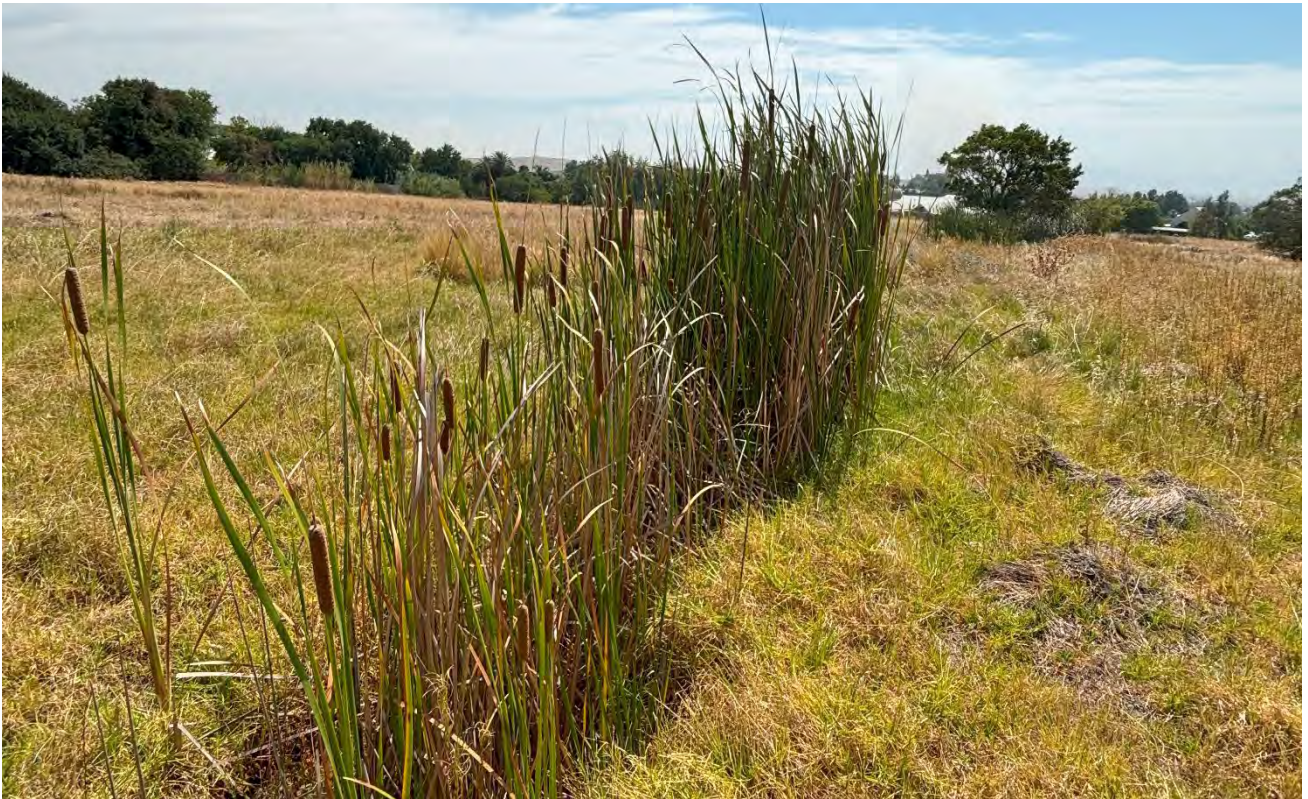
Figure 5-5: A channel has been excavated from the central well in Seep Wetland 1 leading westwards. This has revealed additional points of perched groundwater as indicated by the presence of *T. Capensis*.

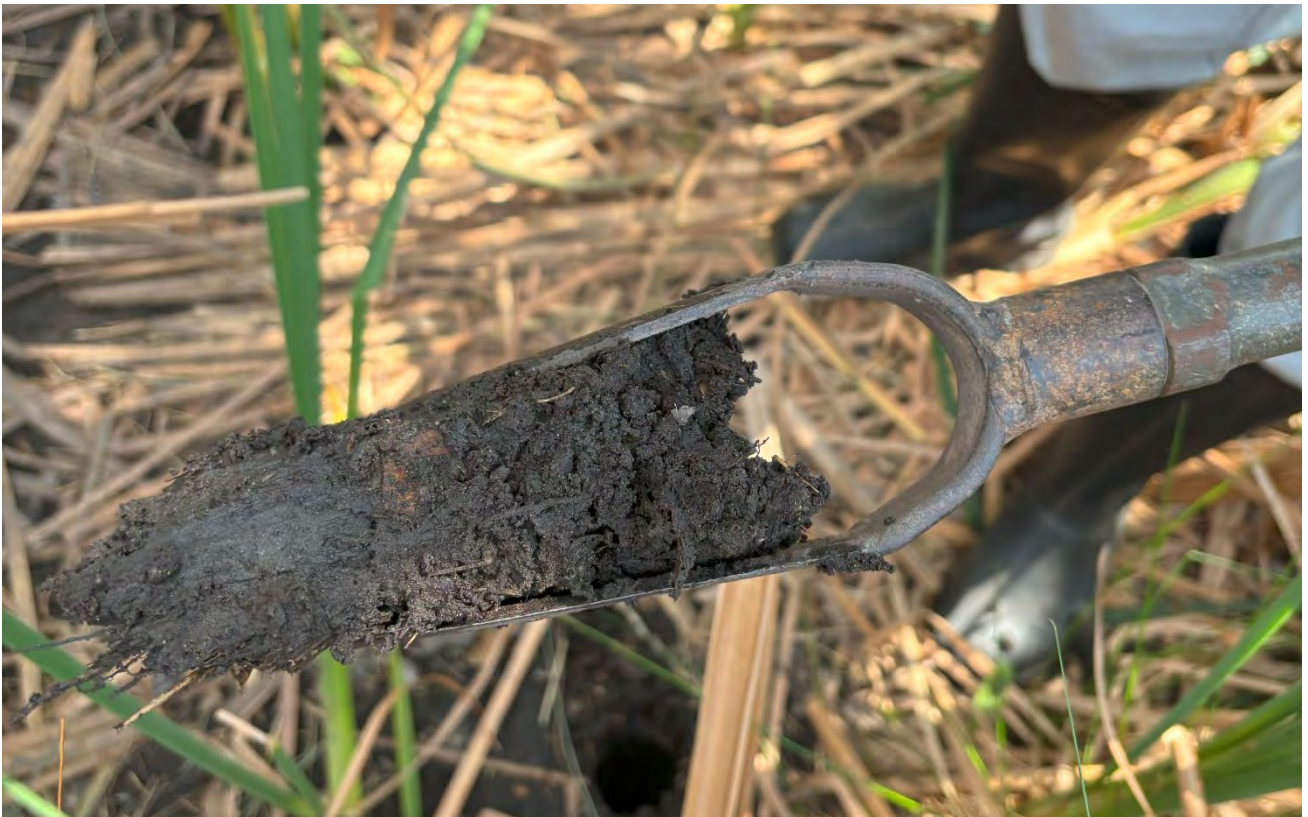
Figure 5-6: Dark, low-chroma, organic soil sampled from within the central portion of Seep Wetland 1.

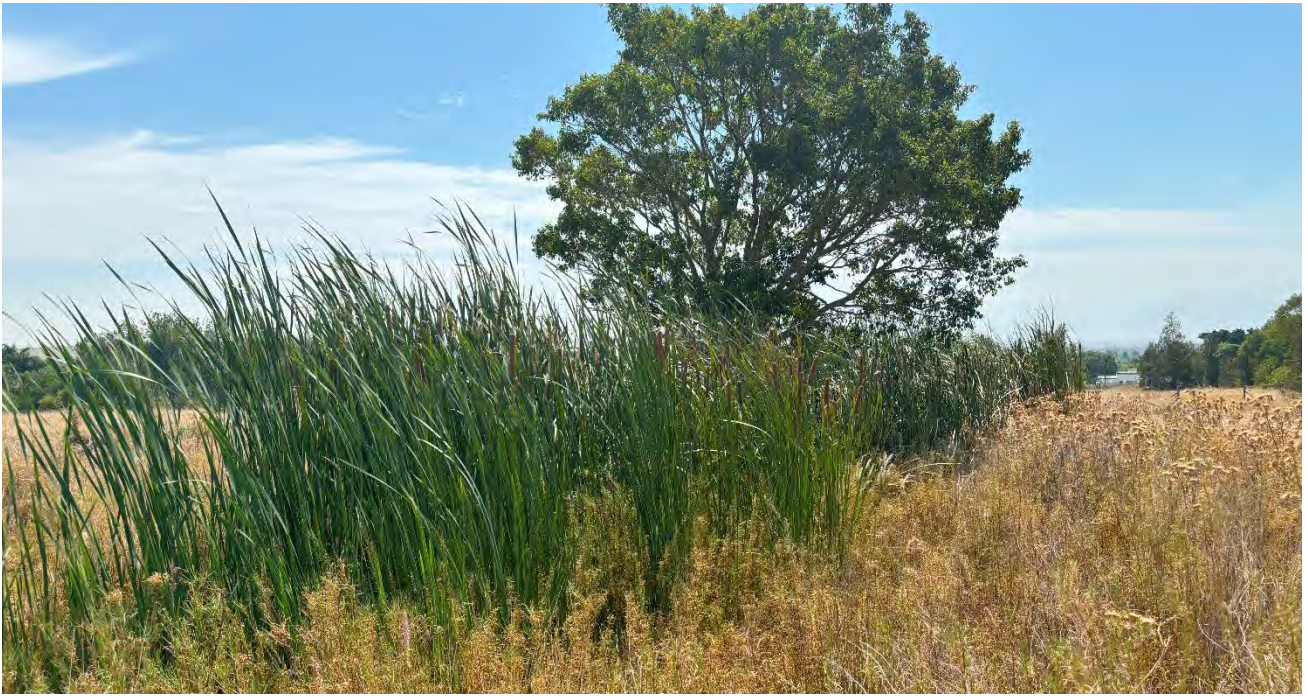
Despite the site visit occurring during the dry summer season, water was visibly present on the surface in the central portion of the wetland, confirming its reliance on groundwater inputs. The soils in this area were waterlogged and exhibited dark, low-chroma, organic characteristics indicative of anaerobic wetland conditions (**Figure 5-6**). Vegetation in this permanent zone was dominated by *Typha capensis* (Bulrush), with additional species such as *Juncus effusus* (Soft Rush), *Zantedeschia aethiopica* (Arum Lily), and a single *Syzygium guineense* (Water Pear Tree) present (**Figure 5-7 & Figure 5-8**).

Figure 5-7: Permanent wetland zone within Seep Wetland 1 dominated by *T. Capensis*. A single *S. guineense* can be seen in the background.

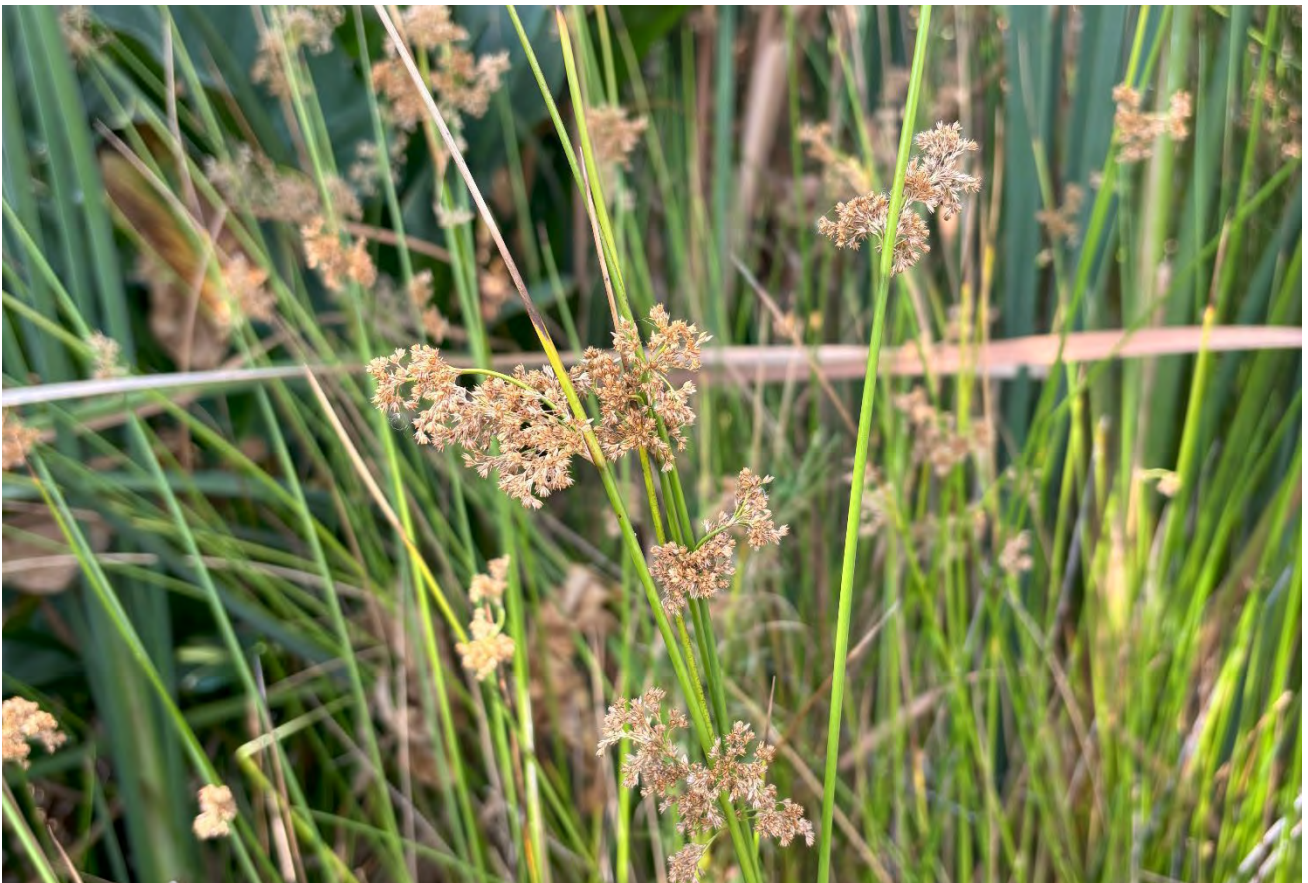
Figure 5-8: *J. effusus* present within Seep Wetland 1.

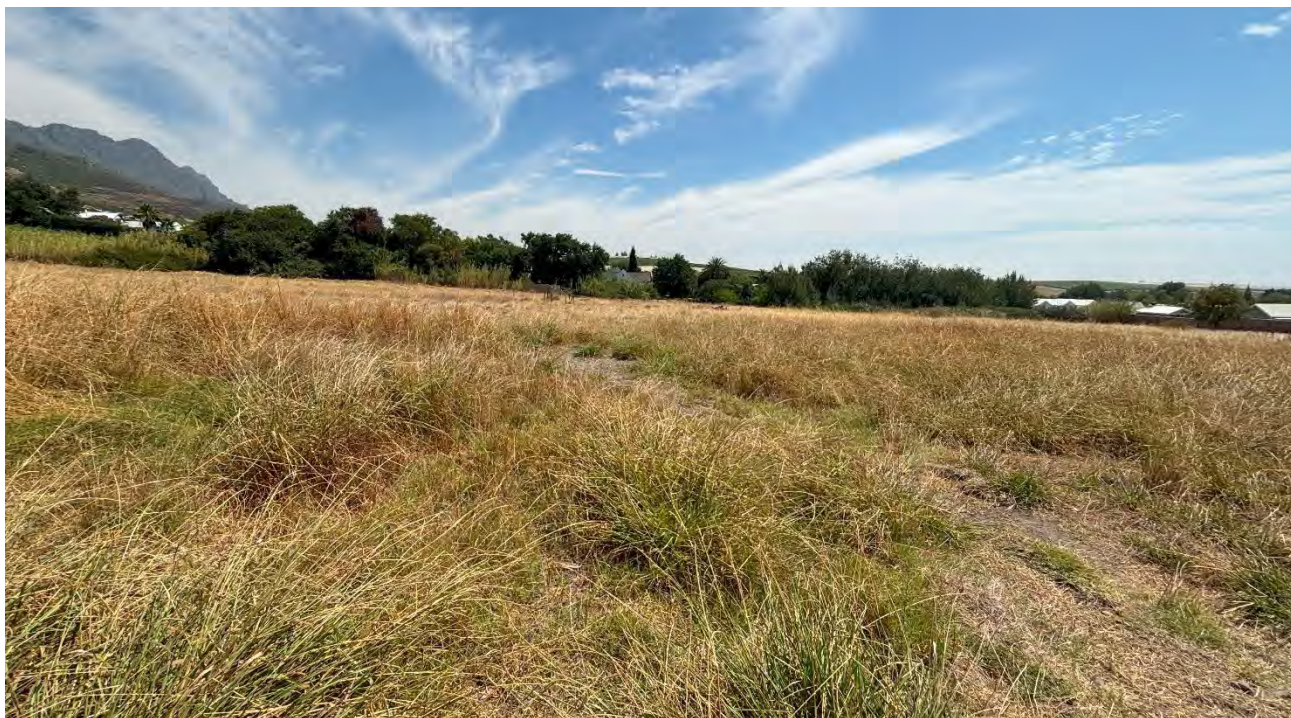
Pennisetum clandestinum (kikuyu grass). Identification of additional grass species was limited due to the dry season (**Figure 5-9**). A patch of *Seriphium plumosum* (silver stoebe) and areas containing *Pennisetum setaceum* (Fountain Grass) were also noted (**Figure 5-10**). Despite the seasonal dryness observed in the vegetation, soil samples exhibited periodic mottling, confirming seasonal wetland conditions and supporting delineation efforts (**Figure 5-11**).

Figure 5-9: *P. clandestinum* (kikuyu grass) and additional grass species dominating Seep Wetland 1, in the overflow area from the well. Identification of additional grass species was limited due to the dry season.

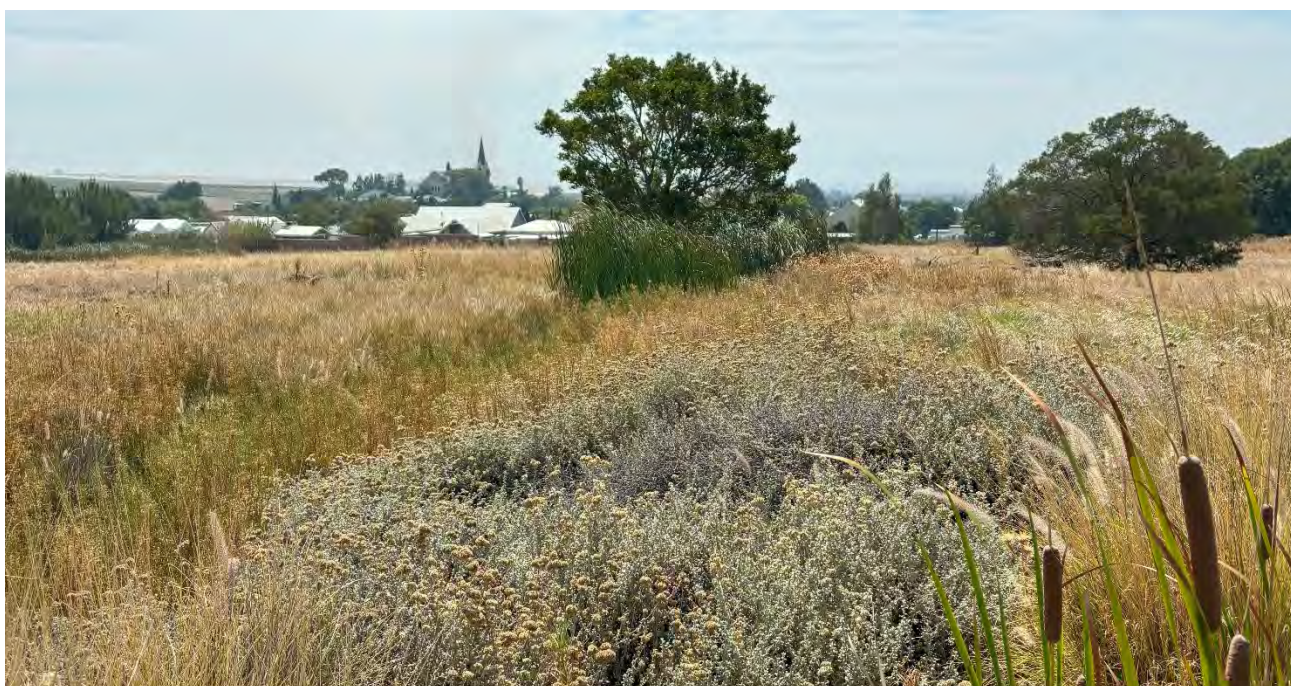
Figure 5-10: A patch of *S. plumosum* within Seep Wetland 1. *P. setaceum* is also present and *T. Capensis* can be seen in the bottom right corner.

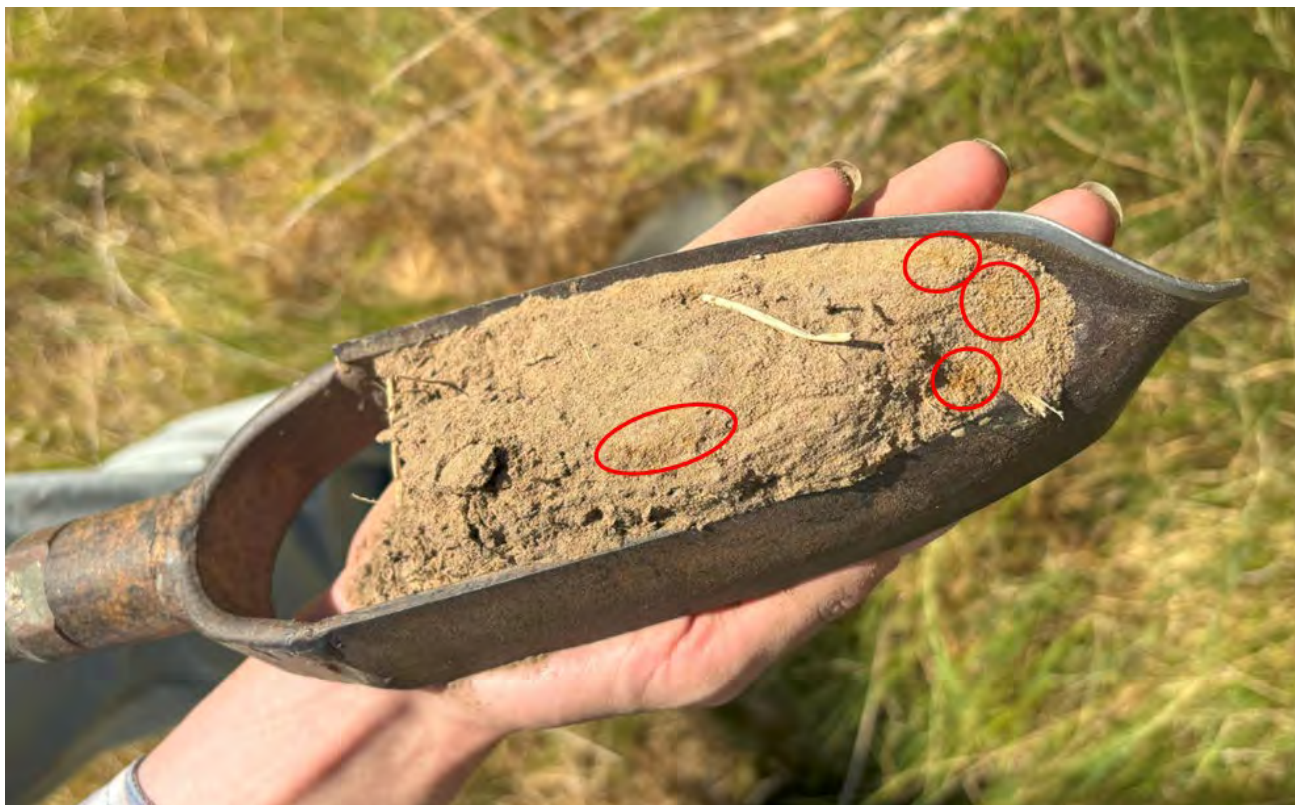
Figure 5-11: Periodic mottling indicative of wetland conditions detected within Seep Wetland 1. Mottles are encircled in red.

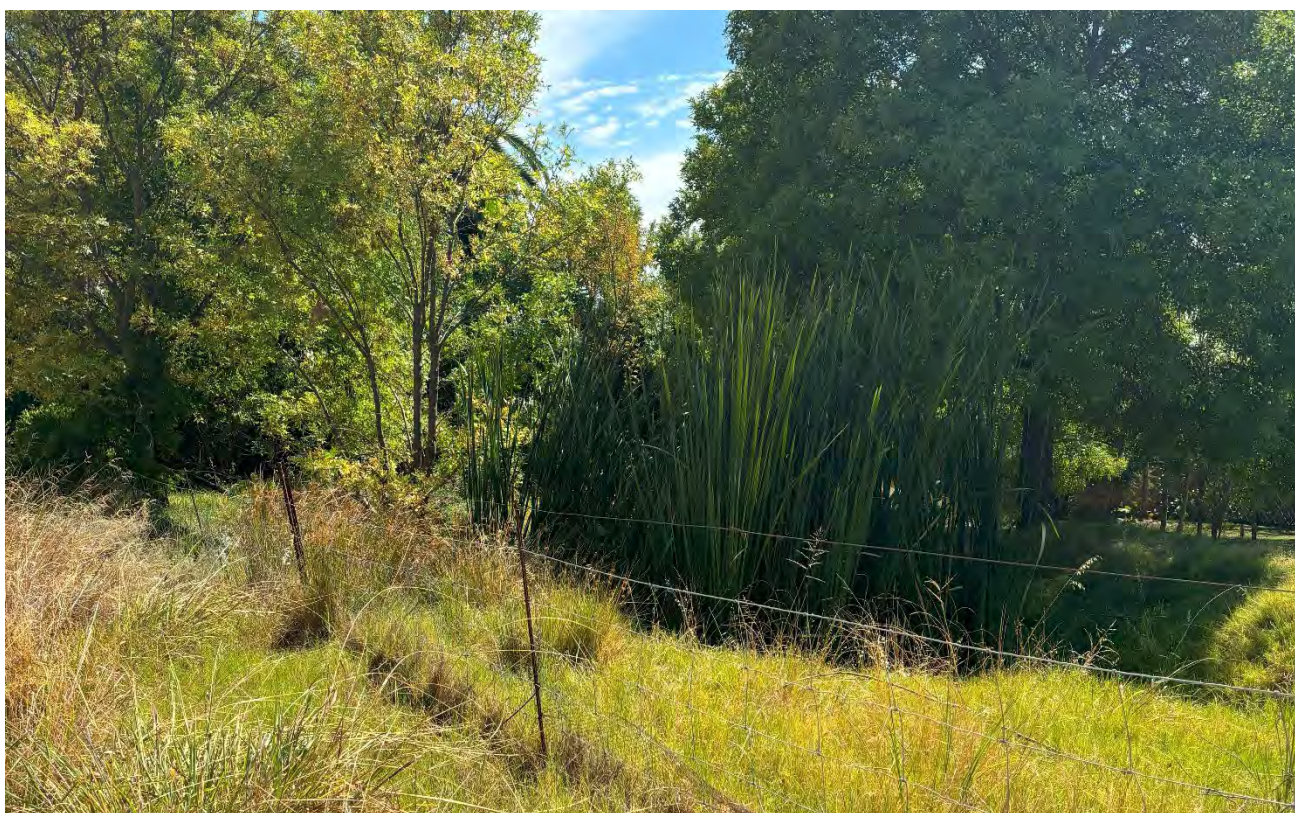
Seep Wetland 1 historically appeared to extend beyond the current site boundary. Analysis of historic aerial imagery indicates that this wetland likely extended across the area now occupied by the perimeter road, prior to its construction. Evidence of continued hydrological connectivity is visible in the form of erosion features across the road surface and along the road verges, suggesting that surface flows persist but are now redirected towards the Krom River downstream via the road, residential area, and canalised drainage. However, these areas did not exhibit wetland indicators during the field assessment. Only areas containing hydric soils and wetland vegetation were therefore included in the wetland delineation (**Figure 5-12 - Figure 5-13**).

Figure 5-12: A SW canal dominated by *T. Capensis* located to the east of the proposed development site boundary.

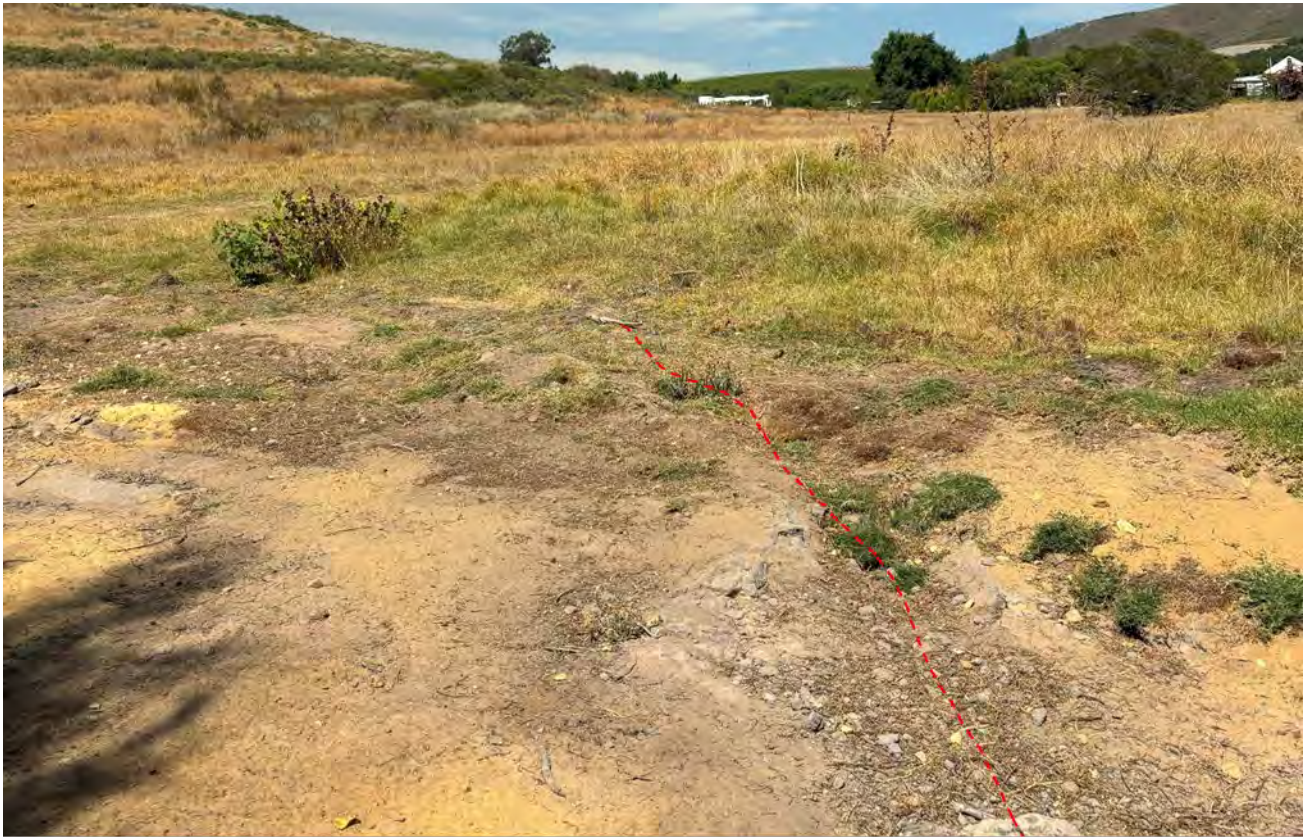
Figure 5-13: Preferential flow path crossing the perimeter road along the eastern boundary. This flow path extends from the portion of Seep Wetland 1 located west of the road.

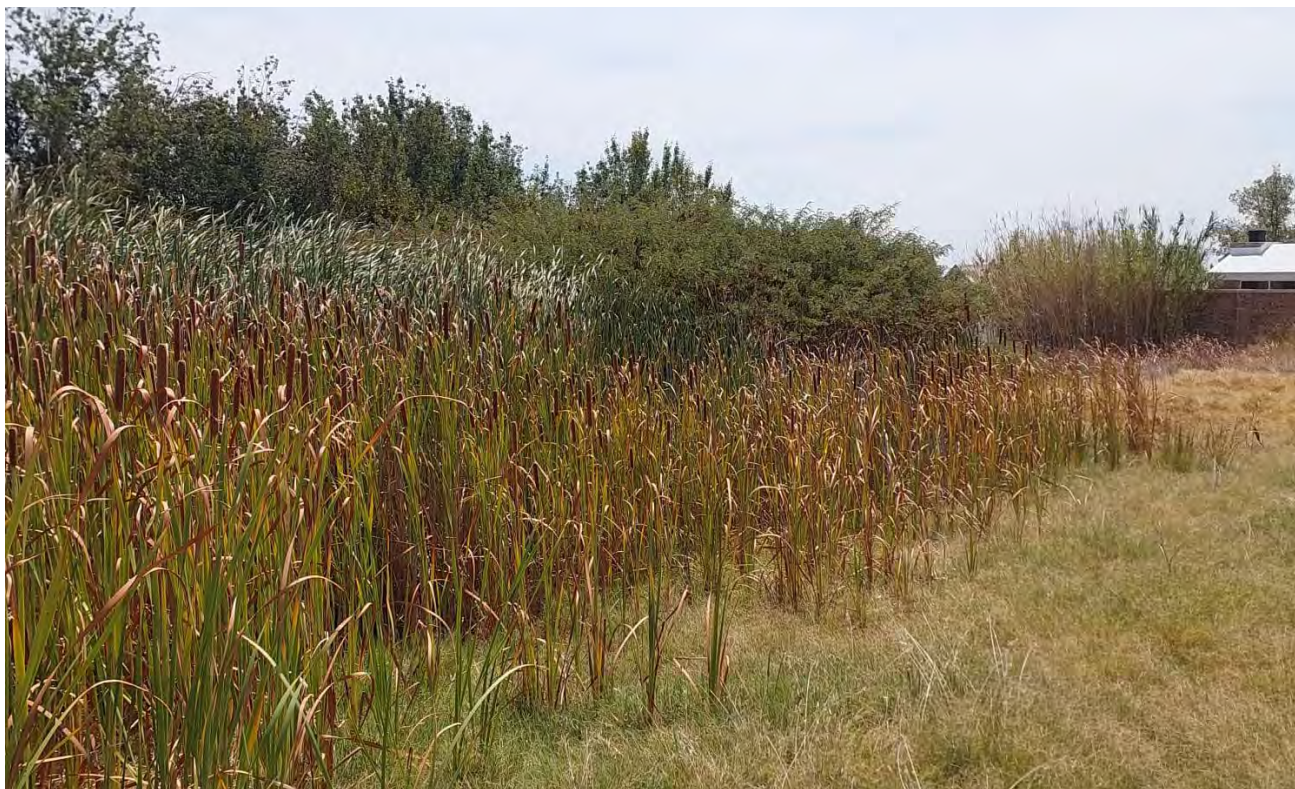
Seep Wetland 2 is in the northeastern corner of the site and is also groundwater-fed. Like Seep Wetland 1, water was visibly present at the surface and the soils in its central wet area exhibited dark, low-chroma, organic characteristics indicative of anaerobic wetland conditions. The wetland comprises a combination of *T. capensis*, *J. effusus*, *P. clandestinum*, *Cynodon dactylon* (Bermuda grass), *Cyperus polystachyos* (bunchy sedge), and *Sesbania* spp (Figure 5-14 & Figure 5-15).

Figure 5-14: Seep Wetland 2 is situated in the northeastern corner of the site. The foreground is dominated by *C. dactylon* grasses, followed by *T. capensis* and a *Sesbania* spp. (small trees). In the background, *P. alba* trees are visible on the left, while *P. australis* is present on the right.

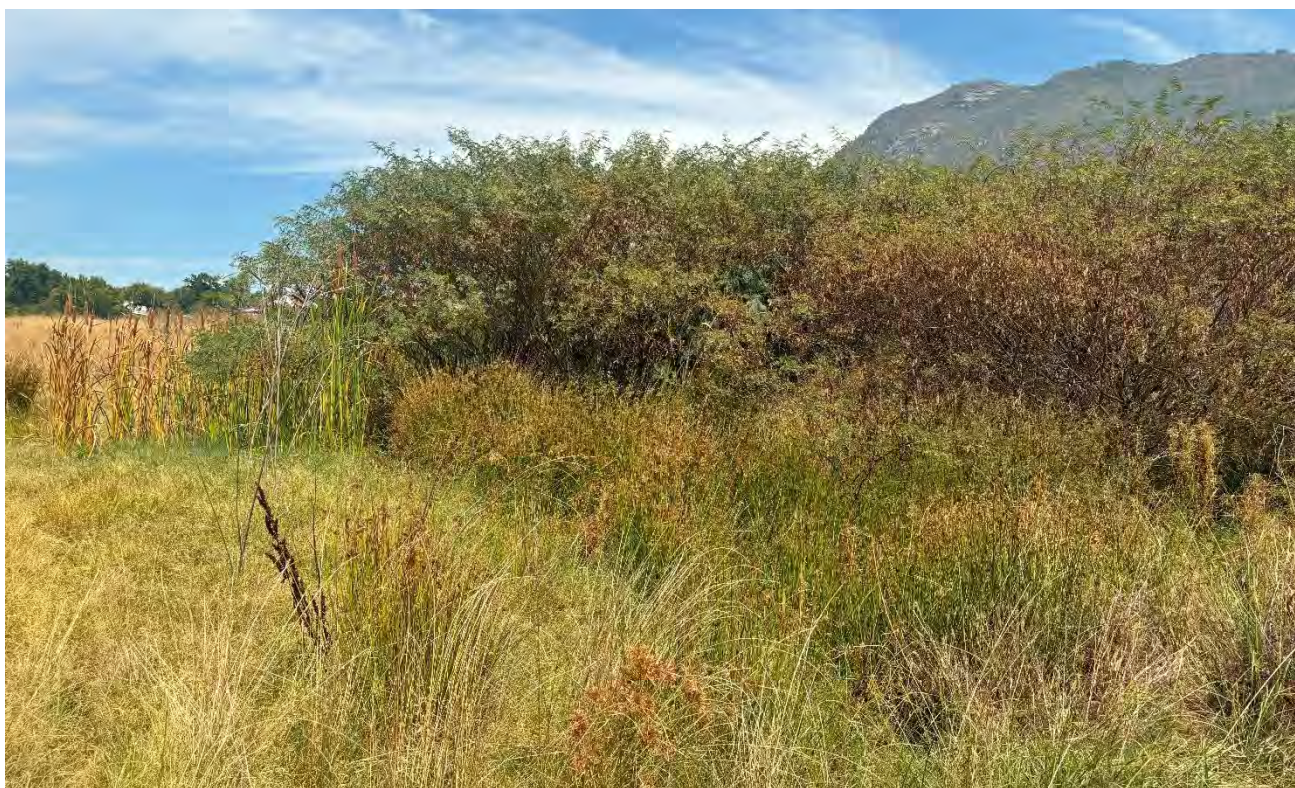
Figure 5-15: Seep Wetland 2 comprises dense areas of *C. polystachyos* (bunchy sedge) which can be seen just in front of the *Sesbania* spp (small tree) in this photo.

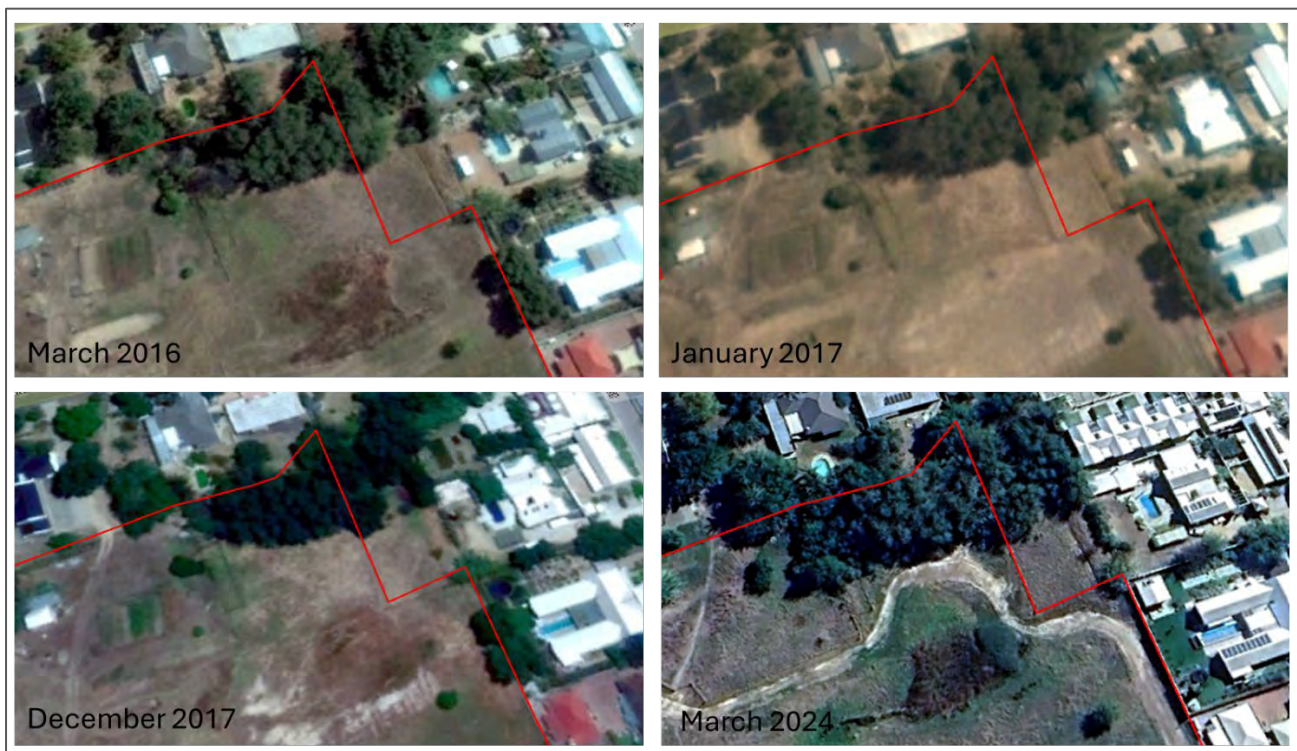
Figure 5-16: Aerial imagery of Seep Wetland 1 from 2016–2024 showing changes over time in response to disturbance.

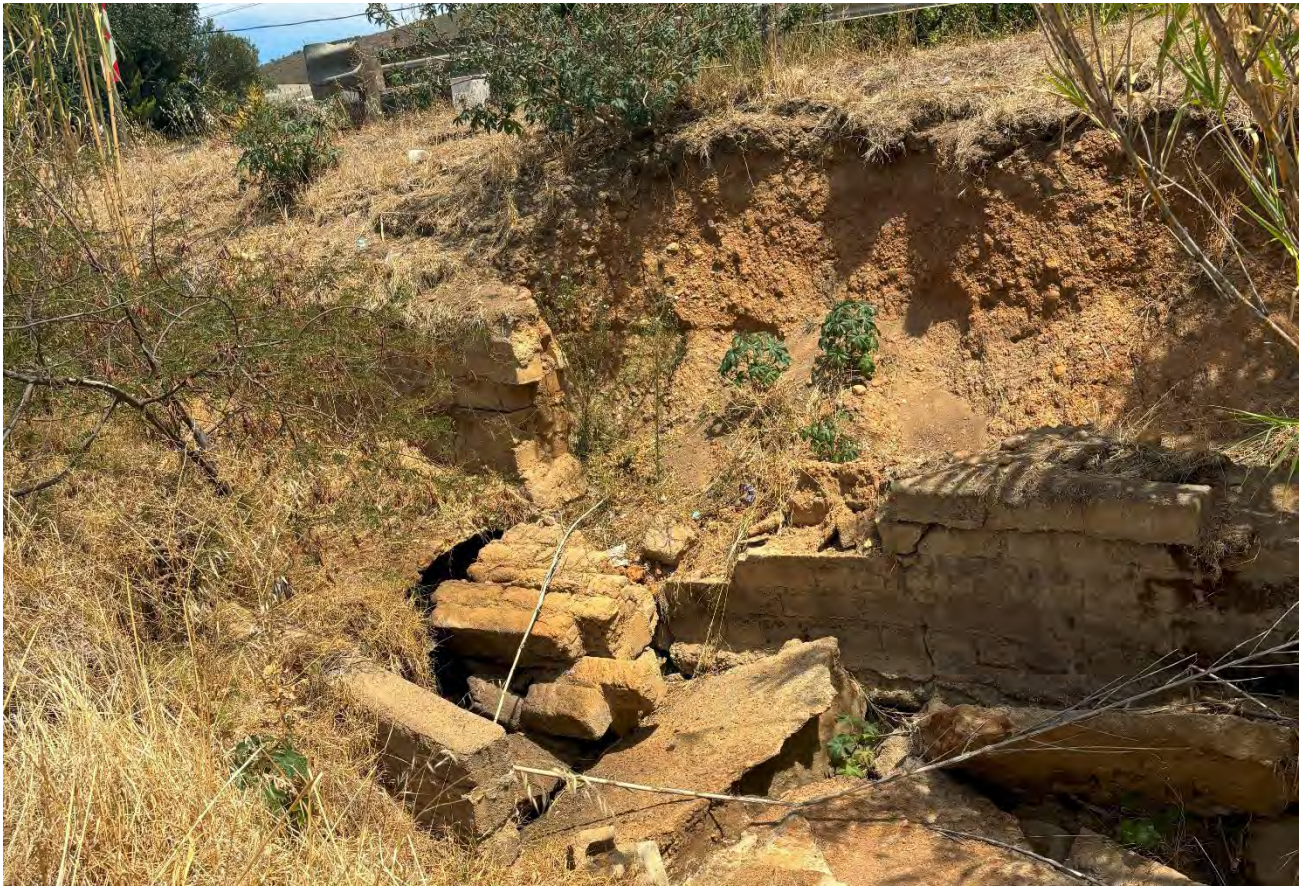
This stretch of the Krom River is deemed to be seriously modified in terms of riparian and instream habitat (**Table 5-8**). With the development of agricultural lands, the natural drainage line to the west of the road was channelized. It now crosses the road via an artificial stormwater channel before entering the northwestern boundary of the site. This channel has been severely modified and degraded, with clear signs of erosion (**Figure 5-17**). After flowing through the artificial stormwater channel, the Krom River is diverted underground via a pipeline for approximately 120 meters along the northern boundary of the site before re-emerging as a drainage line in a more natural, albeit significantly degraded, state (**Figure 5-18**). The original riparian vegetation has been severely compromised. Presently, portions of the river are overgrown with *Phragmites australis* (common reed) (**Figure 5-19**), which has replaced the expected natural riparian zone. Occasional *Searsia* shrubs were observed, along with *Populus alba* (white poplar) (**Figure 5-20**) and ornamental plant species such as oak trees (*Quercus* spp.) and *Schinus terebinthifolia* (Brazilian Pepper) trees. Where understorey vegetation is present, it comprises primarily *C. dactylon*. A pump installation was also observed immediately upstream of where the river transitions from its underground flow into the more natural channel (**Figure 5-21**).

Figure 5-17: Point at which the Krom River enters the proposed development site by means of a degraded stormwater channel. Bank stabilisation measures have collapsed and are currently blocking the stormwater pipeline.

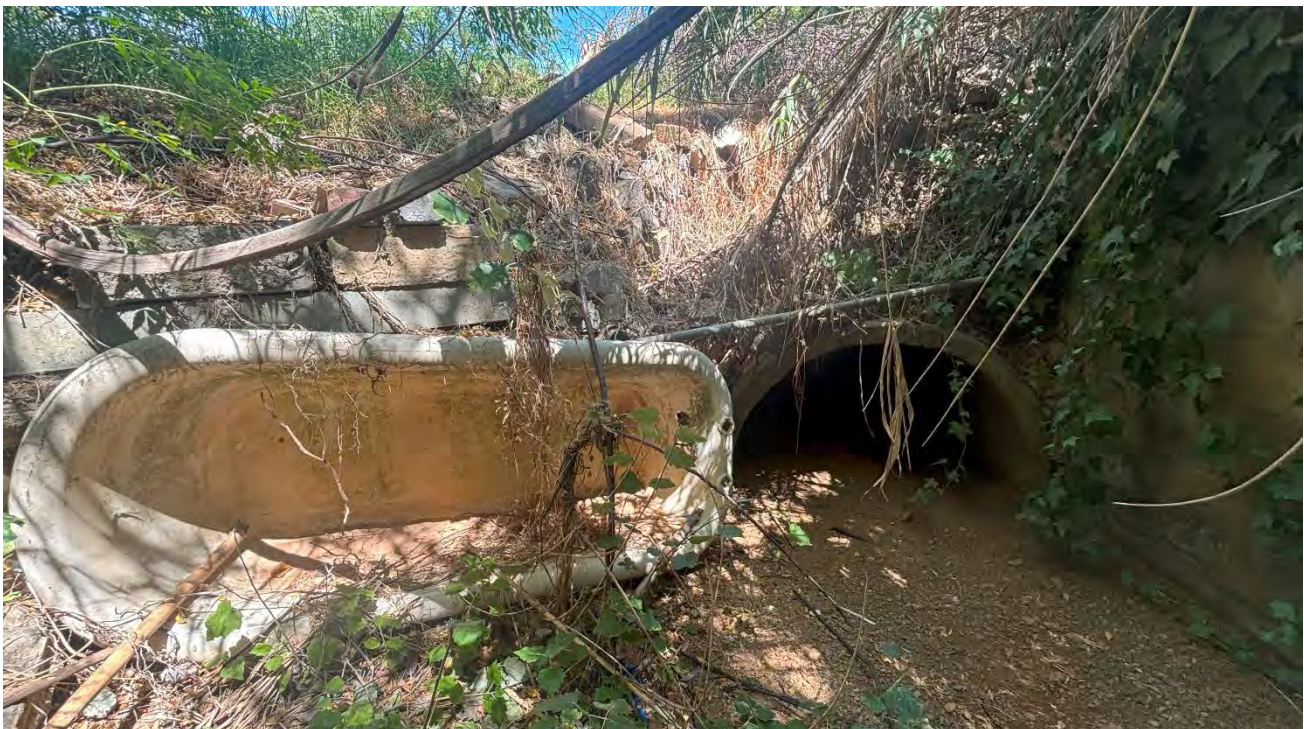
Figure 5-18: Point at which the Krom River emerges from the underground pipeline in the northern portion of the site. Rubble has been used for infill and bank stabilisation.

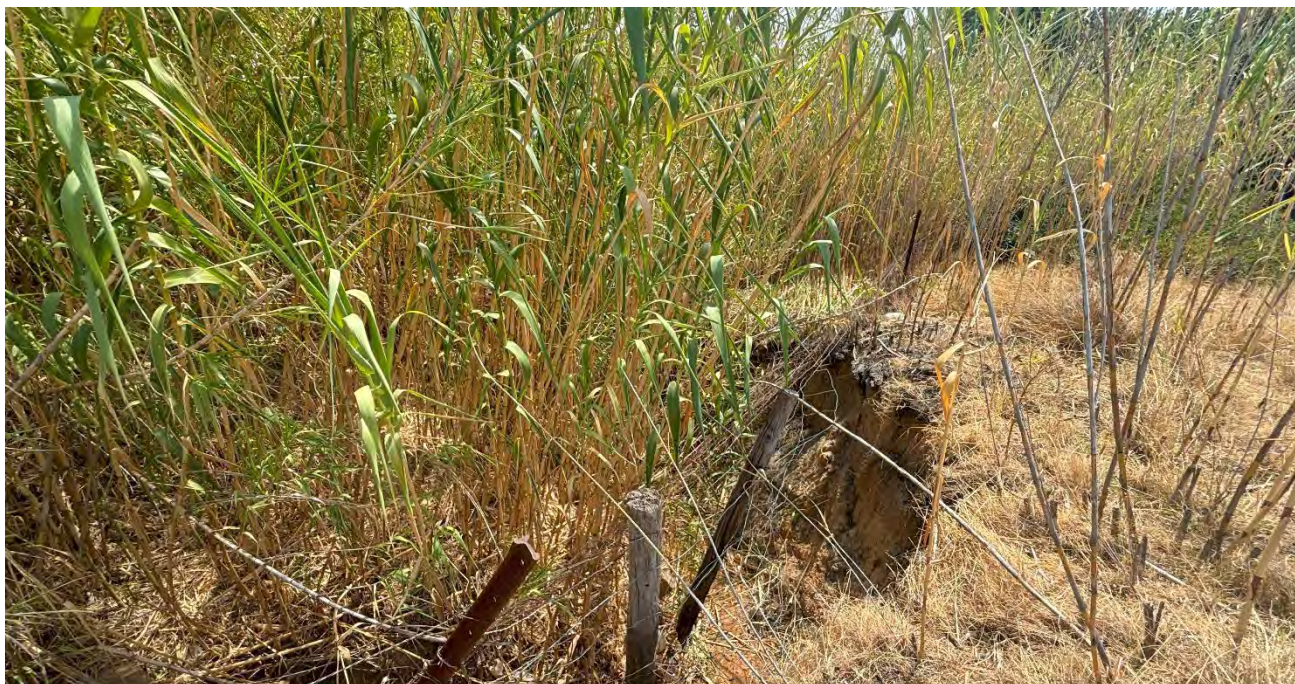
Figure 5-19: The Krom River is overgrown with *P. australis*, and the riparian channel is severely modified and eroded.

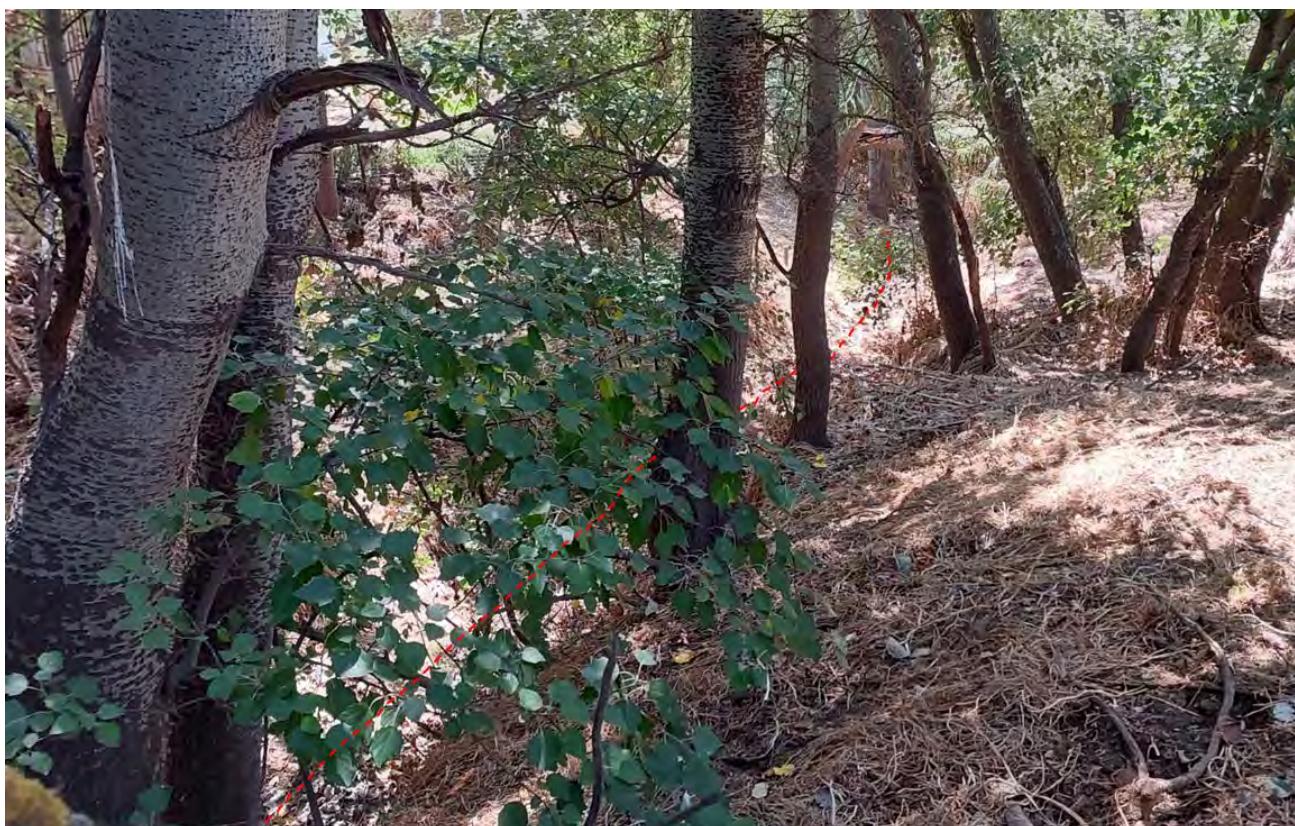
Figure 5-20: Portion of the Krom River downstream in the northern portion of the proposed development site. The riparian vegetation at this point comprises primarily *P. alba* trees.

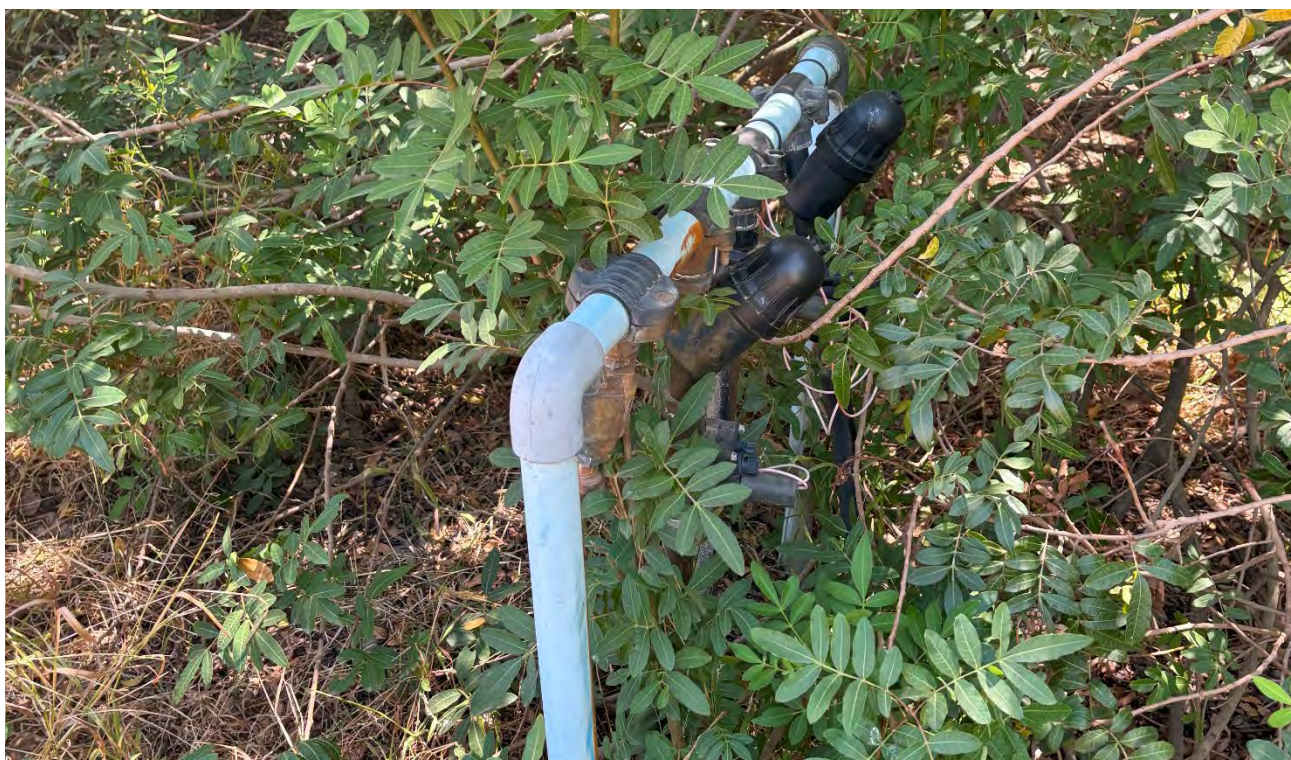
Figure 5-21: Pump installation noted upstream of the point where Krom River emerges from the underground pipe.
