Wetland Offset, Rehabilitation, and Management Plan

Erf 1486, Vermont, Western Cape Province

March 2026

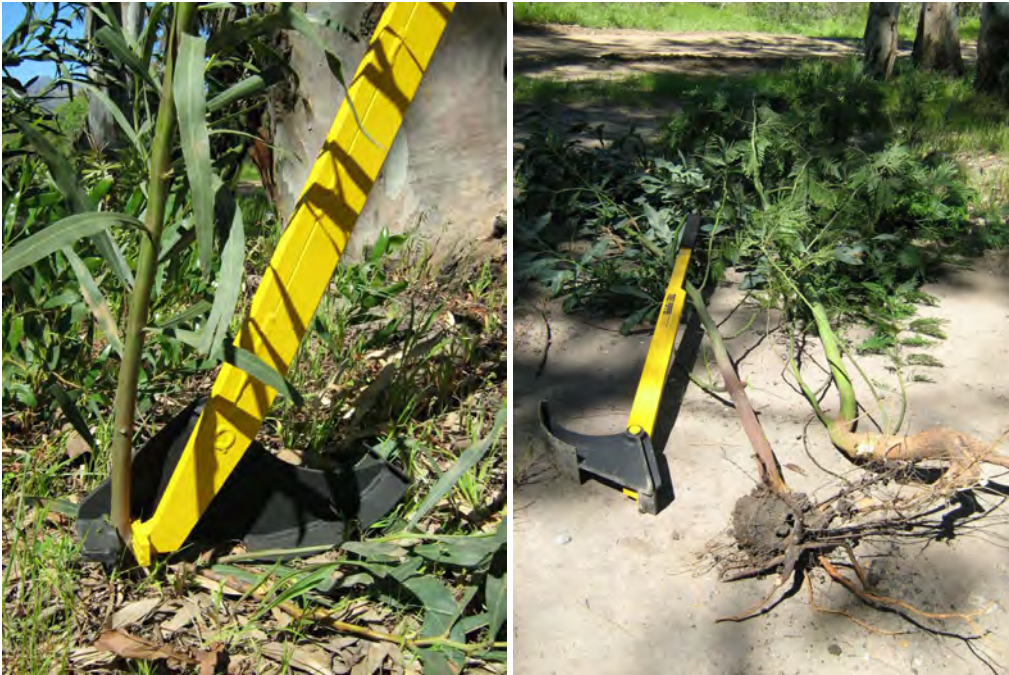
Figure A1: Tree-Popper

This technique is used for medium tree specimens and involves the use of an implement referred to as a "Tree-Popper". This tool consists of a base plate and a lever that are joined to form a small pair of jaws (**Figure A1**). The tree is placed in the jaws of the tool and the lever is used to pull the entire tree, including the roots, out. This tool is extremely useful for trees that are too large to be effectively removed by hand pulling yet are not yet large enough to require felling. The method to be used is similar as outlined for hand pulling, however the Tree-Popper is used instead of pulling.

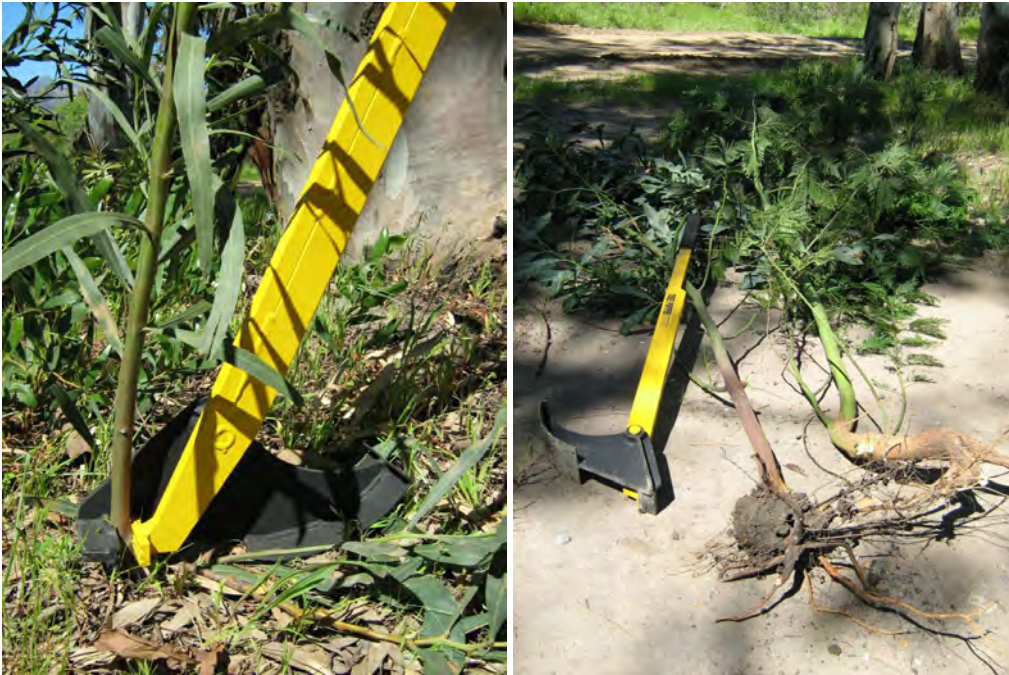
Figure A1: Tree-Popper

This technique is used for medium tree specimens and involves the use of an implement referred to as a "Tree-Popper". This tool consists of a base plate and a lever that are joined to form a small pair of jaws (**Figure A1**). The tree is placed in the jaws of the tool and the lever is used to pull the entire tree, including the roots, out. This tool is extremely useful for trees that are too large to be effectively removed by hand pulling yet are not yet large enough to require felling. The method to be used is similar as outlined for hand pulling, however the Tree-Popper is used instead of pulling.
