# Freshwater Risk and Impact Assessment

## Agricultural Development on Farm Rocklands 57/633, Hermanus

For: Lornay Environmental Consulting

November 2024

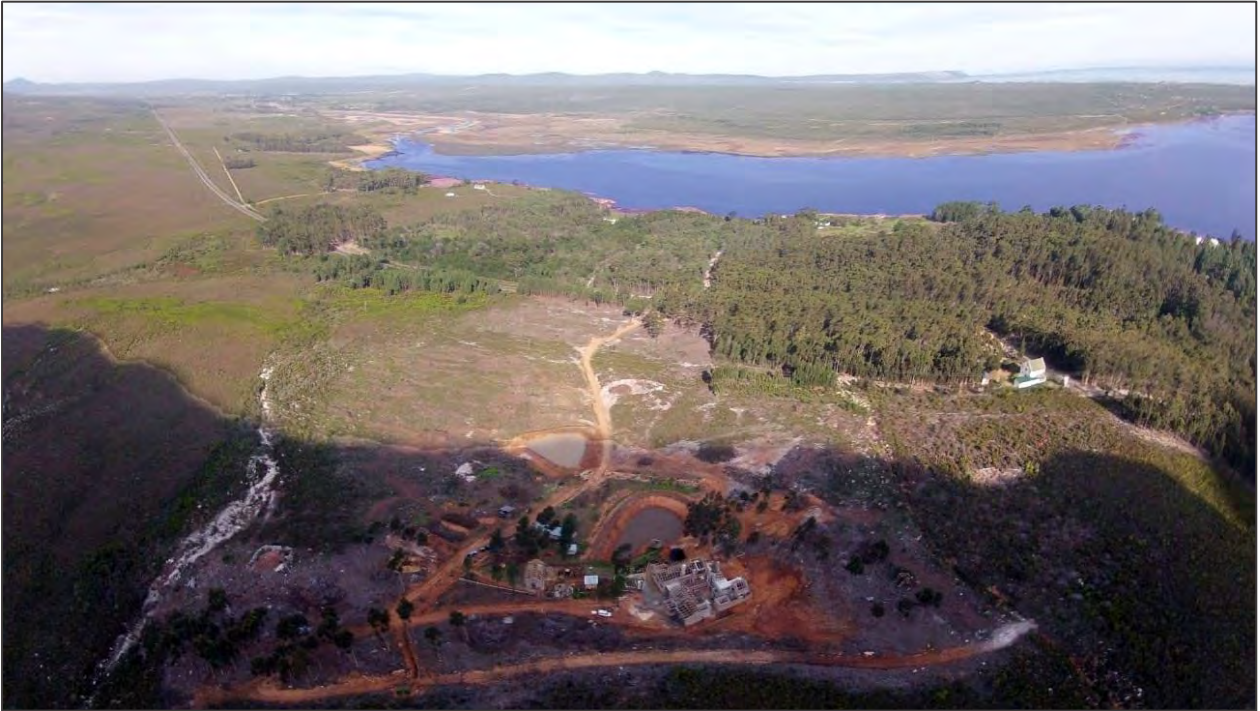
**Figure 1-3: Historic imagery from before activities took place.**

The historical imagery assessment concluded that there was unlikely to be a pristine, diverse indigenous community of wetland vegetation associated with the artificial Seep Wetland 2 prior to onsite agricultural activities (**Figure 1-3**). The site assessment confirmed similarly that this wetland area is unlikely to provide significant ecosystem services. Therefore, all ecosystem services associated with this wetland area both before and after the development of the orchard was found to be in a 'Moderately Low' to 'Very Low' category. The artificial seepage area likely provided, and currently provides, limited amounts of sediment trapping services. After the orchard was planted this area also provides a small amount of cultivated foods provisioning services.

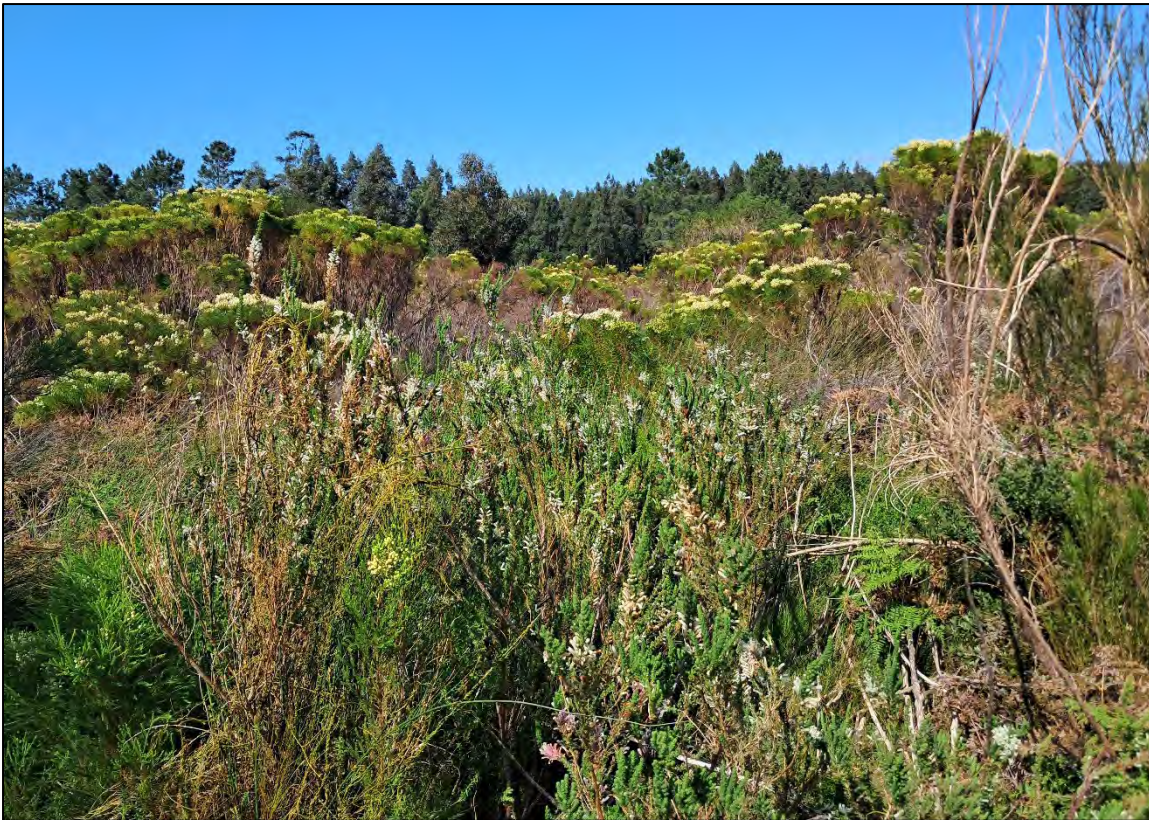
The wetland vegetation within the undisturbed or unimpacted portion of seep wetland 1 was in a near-pristine condition with a high level of biodiversity (**Figure 5-4 & Figure 5-5**), dominated by *Berzelia lanuginosa* (Button bush), interspersed with *Erica perspicua* (Prince of Wales heath), *Osmitopsis asteriscoides* (Swamp daisy), *Pteridium aquilinum* (Common bracken), *Psoralea pinnata* (Fountain bush), *Carpha glomerata* (Vlei sedge), *Pycnus polystachyos* (Manyspike flatsedge) and *Fuirena hirsuta* (Hairy hippo-sedge). The dominance of *Berzelia lanuginosa* indicates a lack of disturbance either due to a reduction in the fire frequency (the most significant factor) and historical removal of large game animals.

Figure 5-4: Undisturbed portion of Seep Wetland 1.

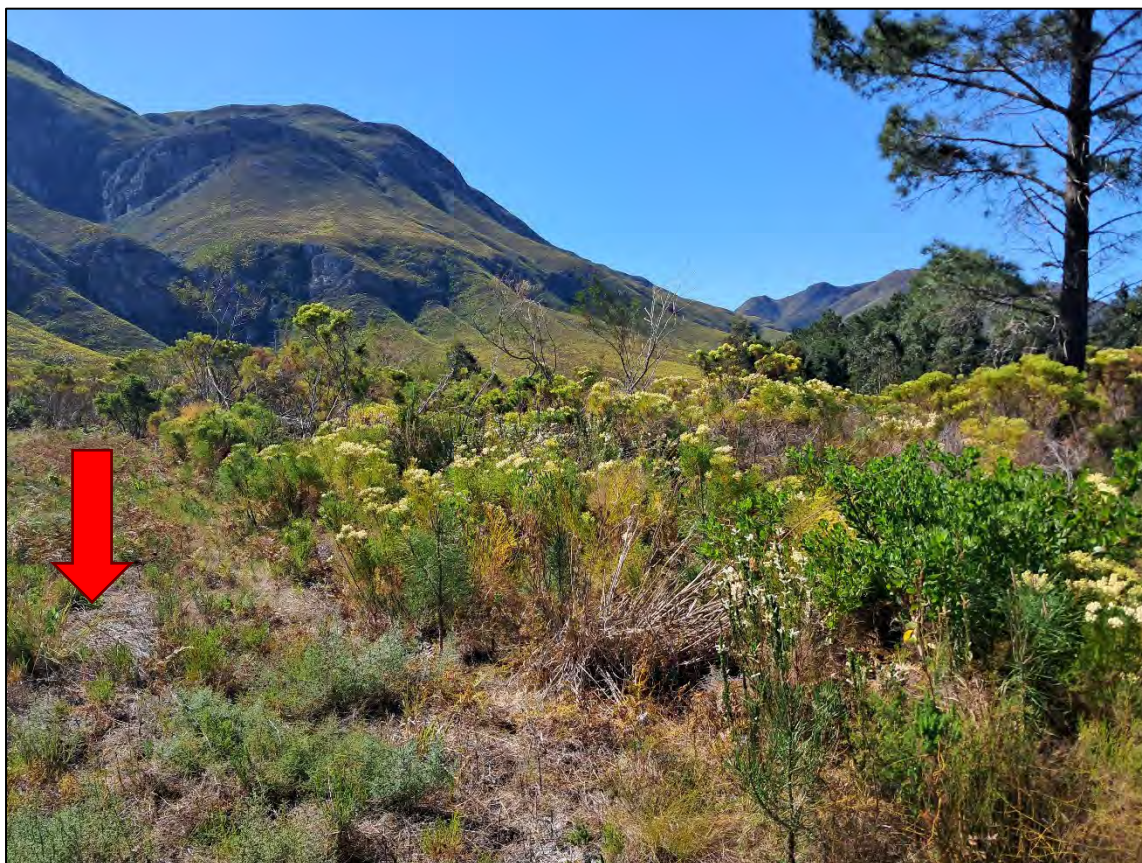
**Figure 5-5: Boundary between the undisturbed portion of Seep Wetland 1 (right), and the impacted portion of the wetland (indicated by red arrow).**

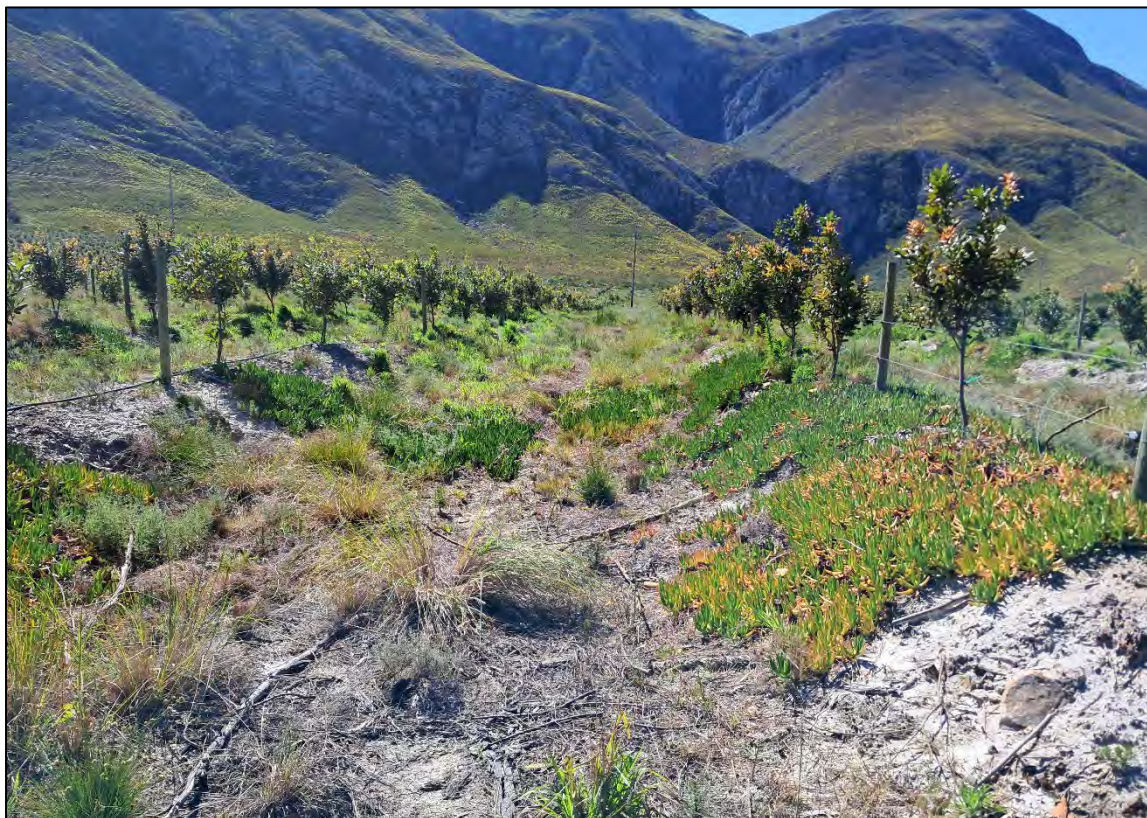
**Figure 5-6: Portion of Seep Wetland 1 within the macadamia nut orchard.**

Additionally, as far as possible, wetland vegetation should be allowed to recolonize in areas that have been cleared – as observed during the site assessment, wetland vegetation was already recolonizing to a degree. It is suggested that stormwater peak flow from the orchard is managed by establishing vegetated swales which discharge diffuse flow into seep wetland 1, where necessary.

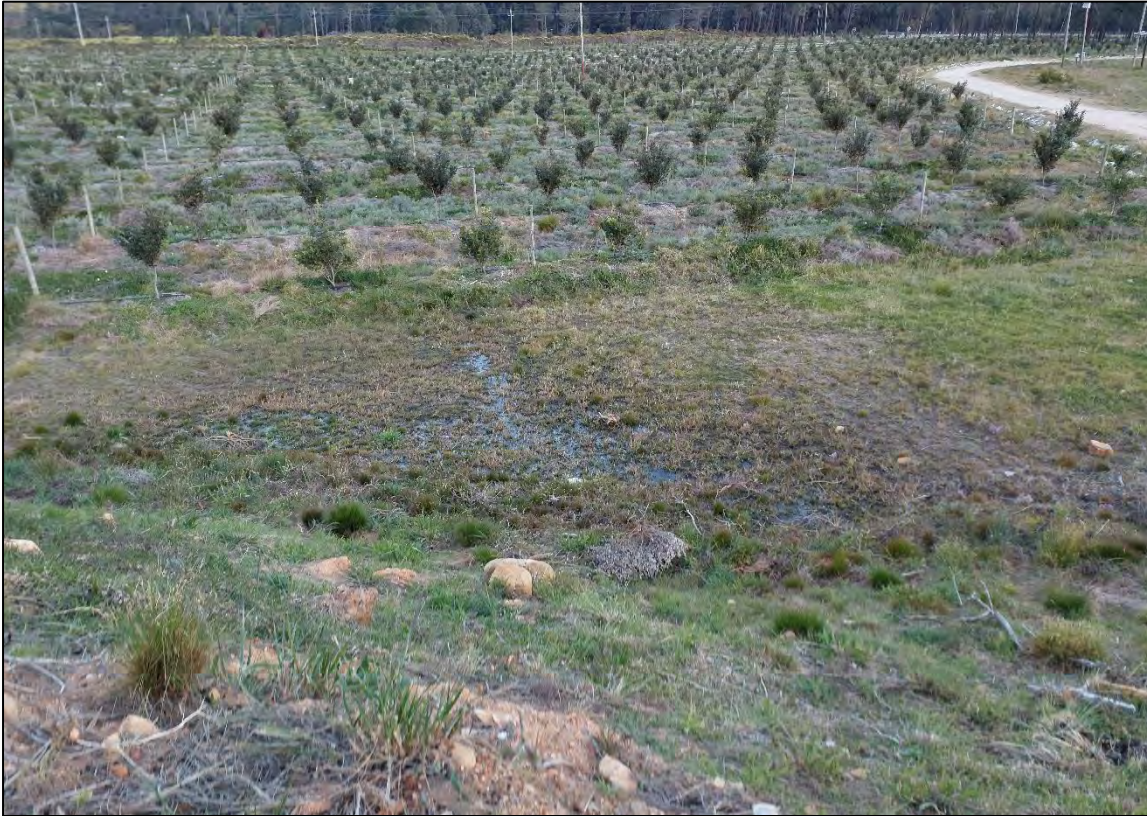
Figure 5-7: Portion of Seep Wetland 2 within the macadamia nut orchard.

| Impact 1: Wetland Habitat Disturbance in Seep Wetland 2 (seepage below dams) | | | | |
|---|---|---|---|---|
| Mitigation Measures | | It is recommended that the portion of the orchard coinciding with the Seep Wetland 2 remains fallow as far as possible. Dumping and littering in the orchard should be strictly prohibited. AIS, which might colonize disturbed areas and outcompete natural wetland vegetation, should be monitored for, and removed, during the ongoing management of the orchard. | | |

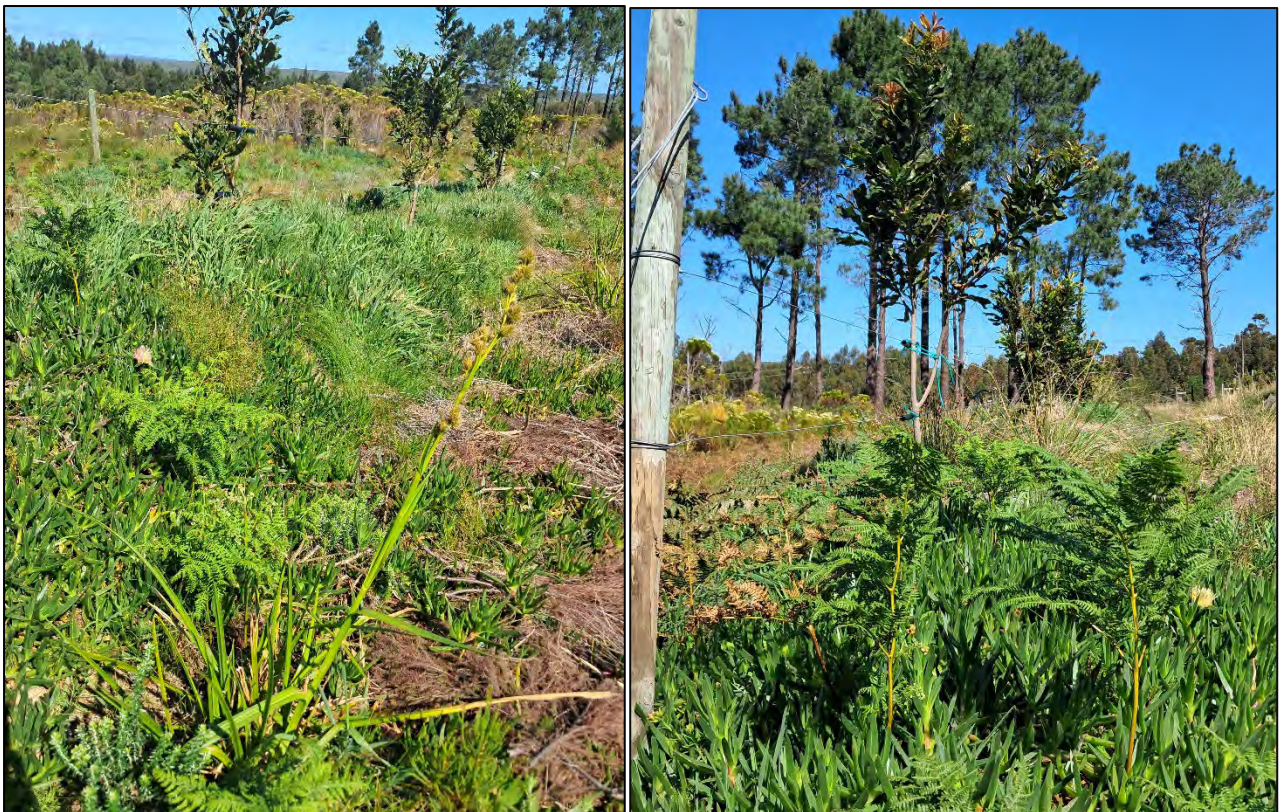
Figure 5-8: Wetland vegetation growing within the macadamia nut orchard, *Carpha glomerata* (left) and *Pteridium aquilinum* (right).

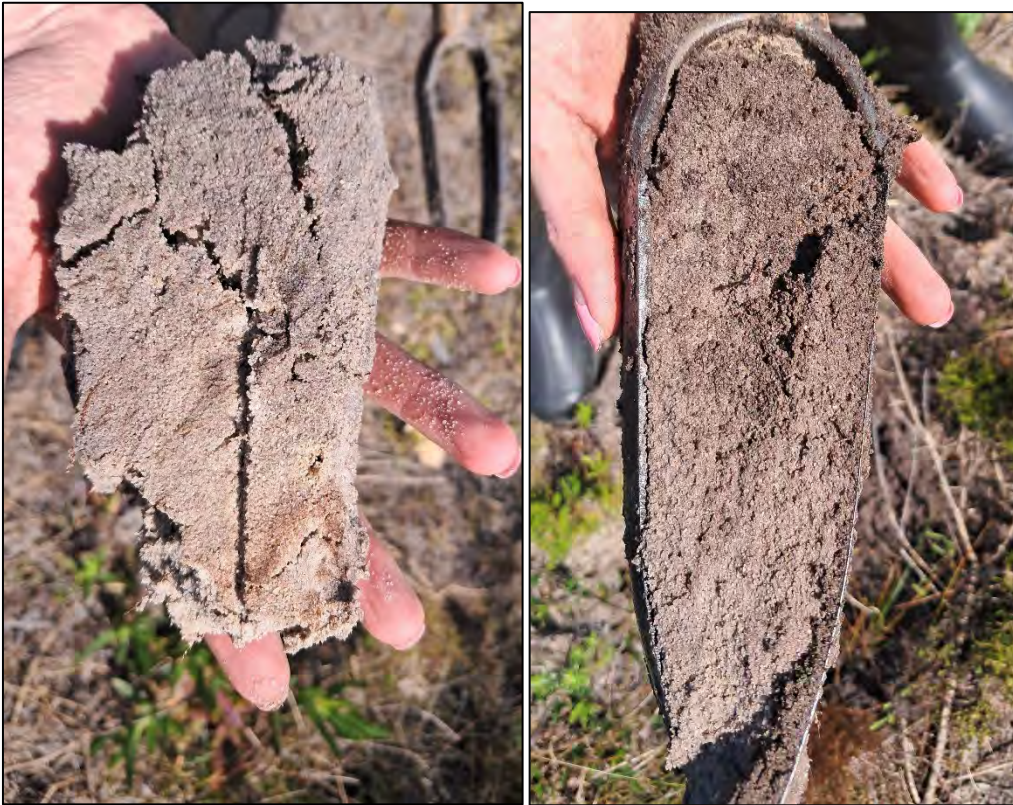
**Figure 5-9: Soil samples from the seep wetlands within the macadamia nut orchard exhibiting wetland characteristics such as organic streaking and mottles (left) and leaching (right).**

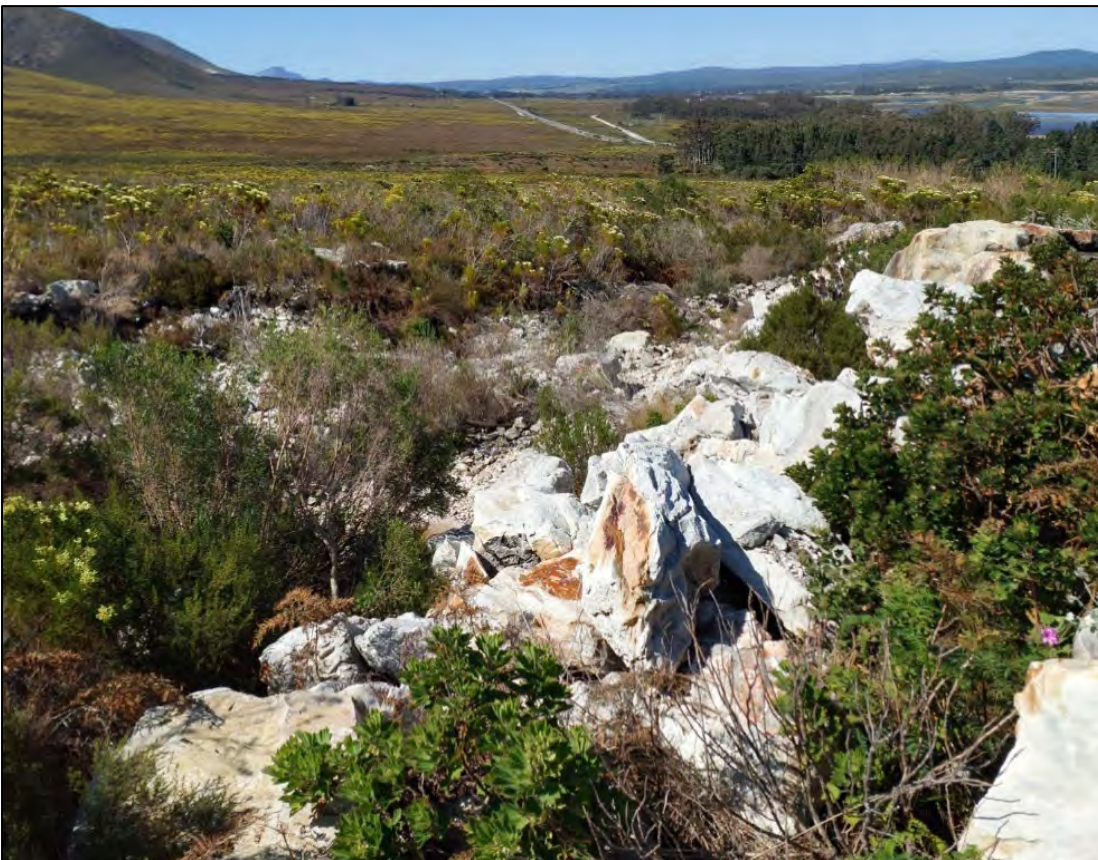
The riparian vegetation within Ephemeral Stream 1 was in a near-pristine condition with high diversity and was dominated by *Berzelia lanuginosa*, interspersed with *Wachendorfia thyrsiflora* (Marsh butterfly lily), *Elegia capensis* (Horsetail restio), *Schoenus compar* (Ivory veldrush) and *Passerina corymbosa* (Gonna bush) (**Figure 5-10–Figure 5-12**). The instream substrate mainly consisted of stones, gravel, bedrock and sand. The ephemeral stream was impacted by a dirt road crossing the channel (**Figure 5-13 & Figure 5-14**), previous flood events resulting in deposition of rocks and debris within the channel and riparian zone, and minimal erosion was evident.

**Figure 5-10: Ephemeral Stream 1.**

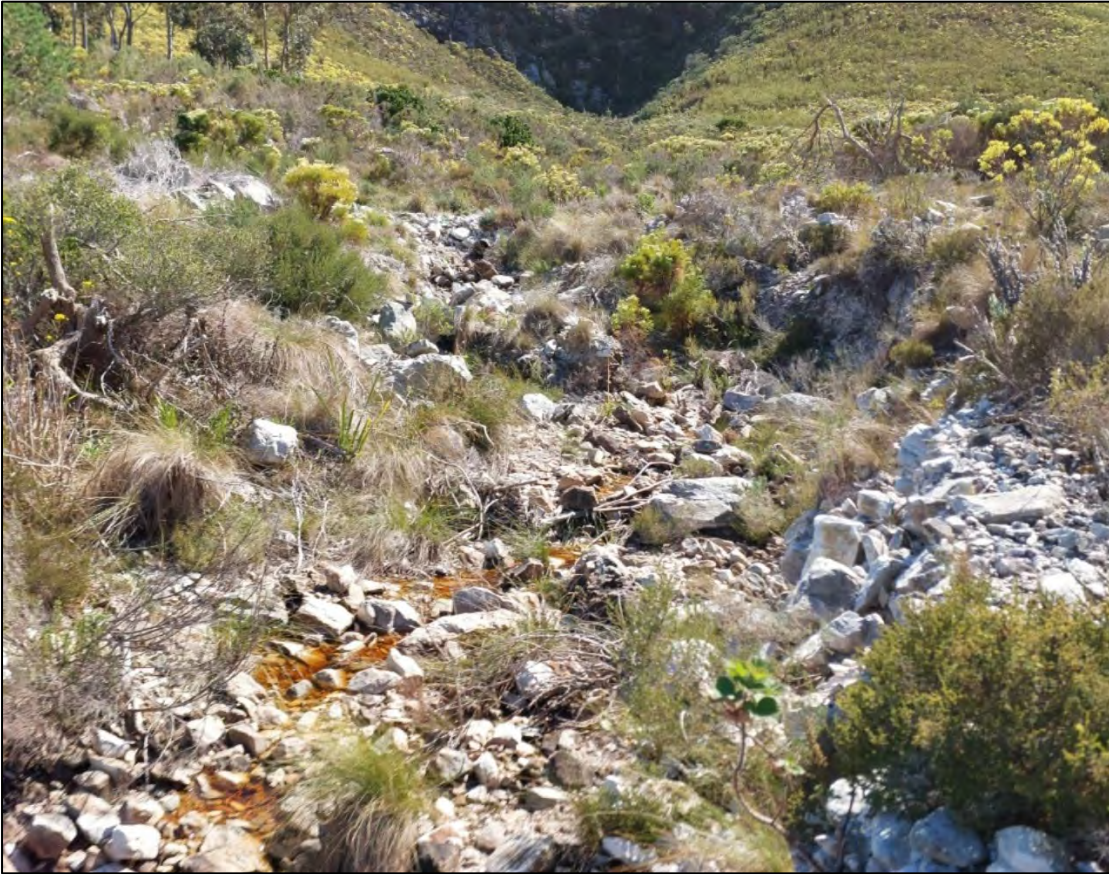
Figure 5-11: Overview of the riparian vegetation in Ephemeral Stream 1.

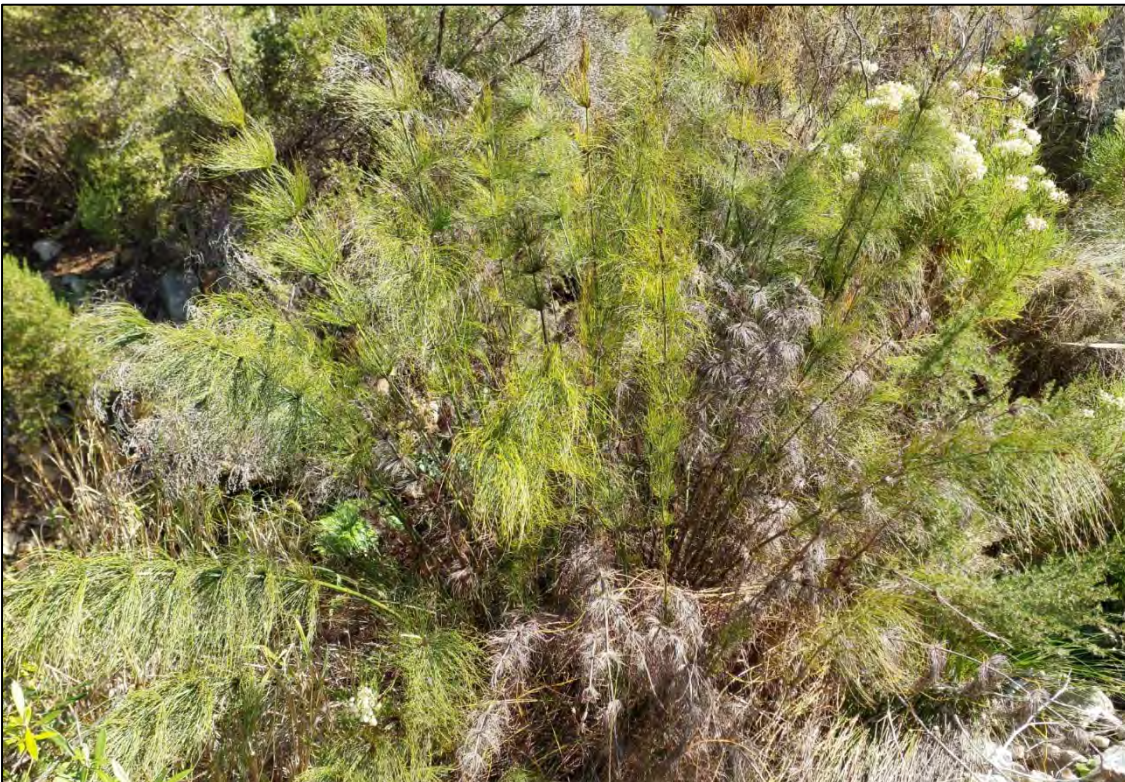
Figure 5-12: *Elegia capensis* and *Berzelia lanuginosa* identified in Ephemeral Stream 1.

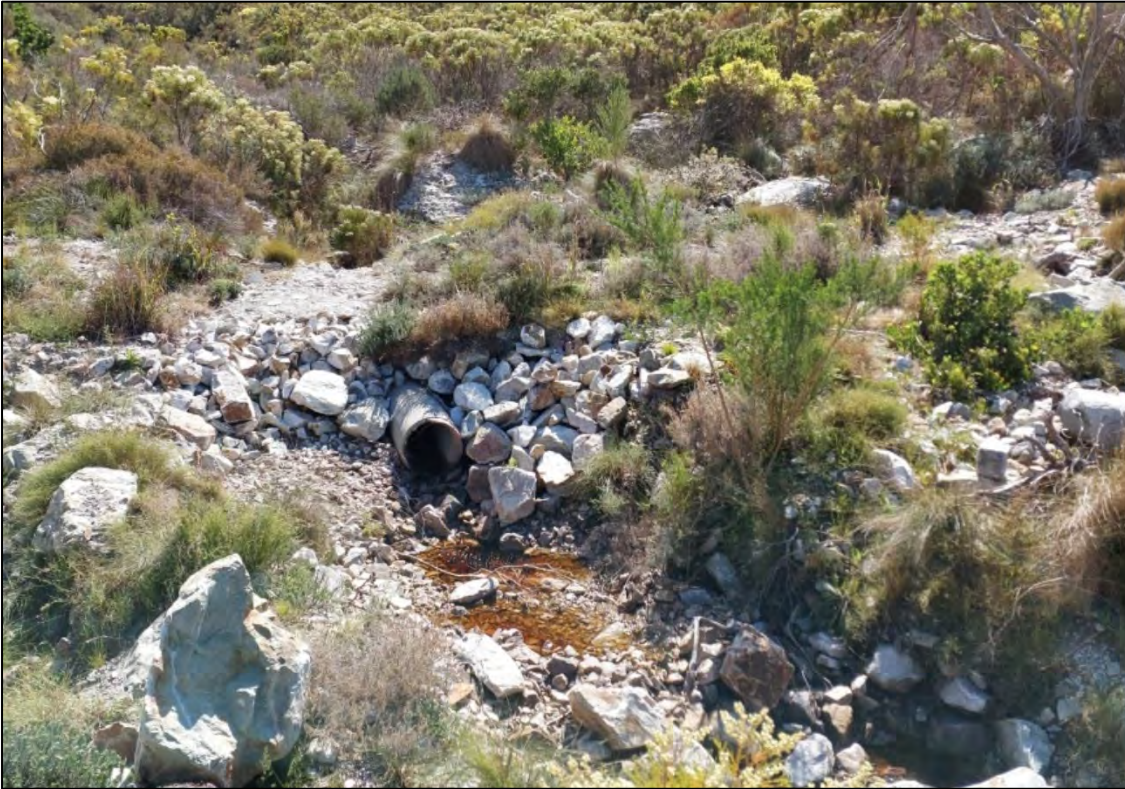
**Figure 5-13: Dirt Road crossing Ephemeral Stream 1.**

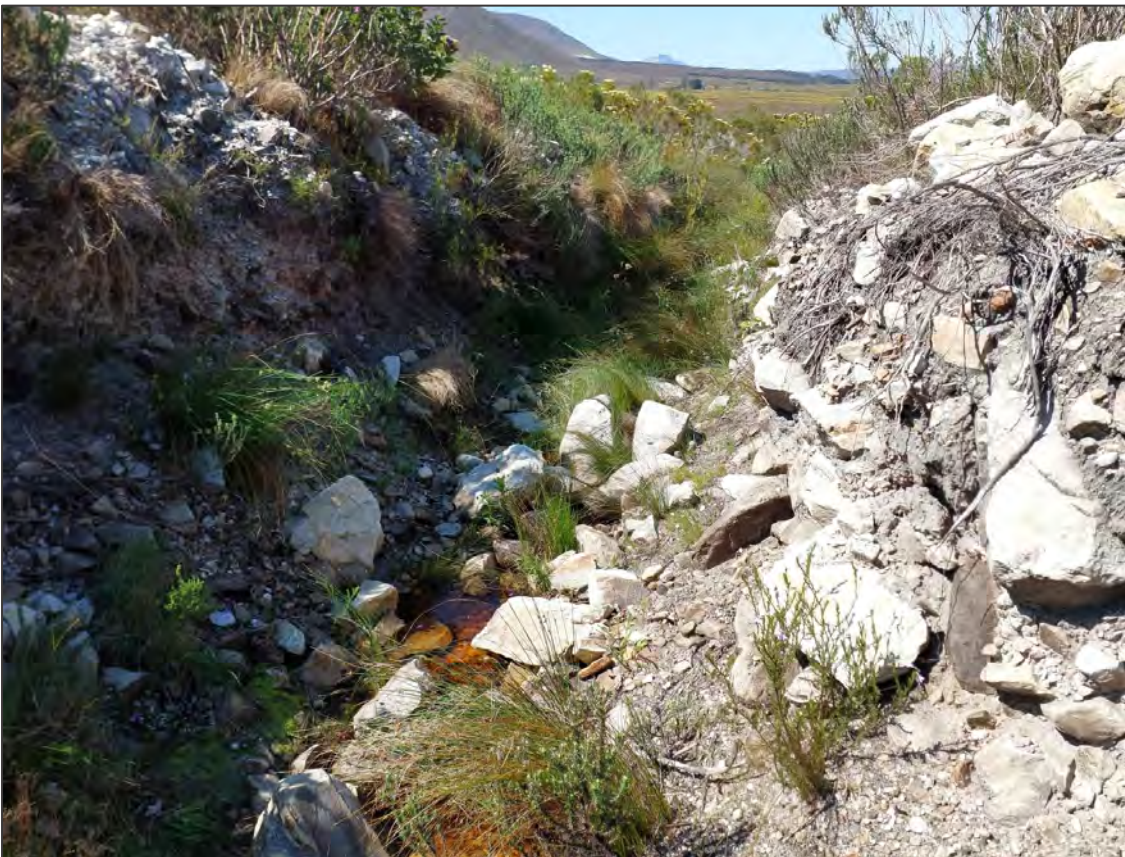
**Figure 5-14: Ephemeral Stream 1.**

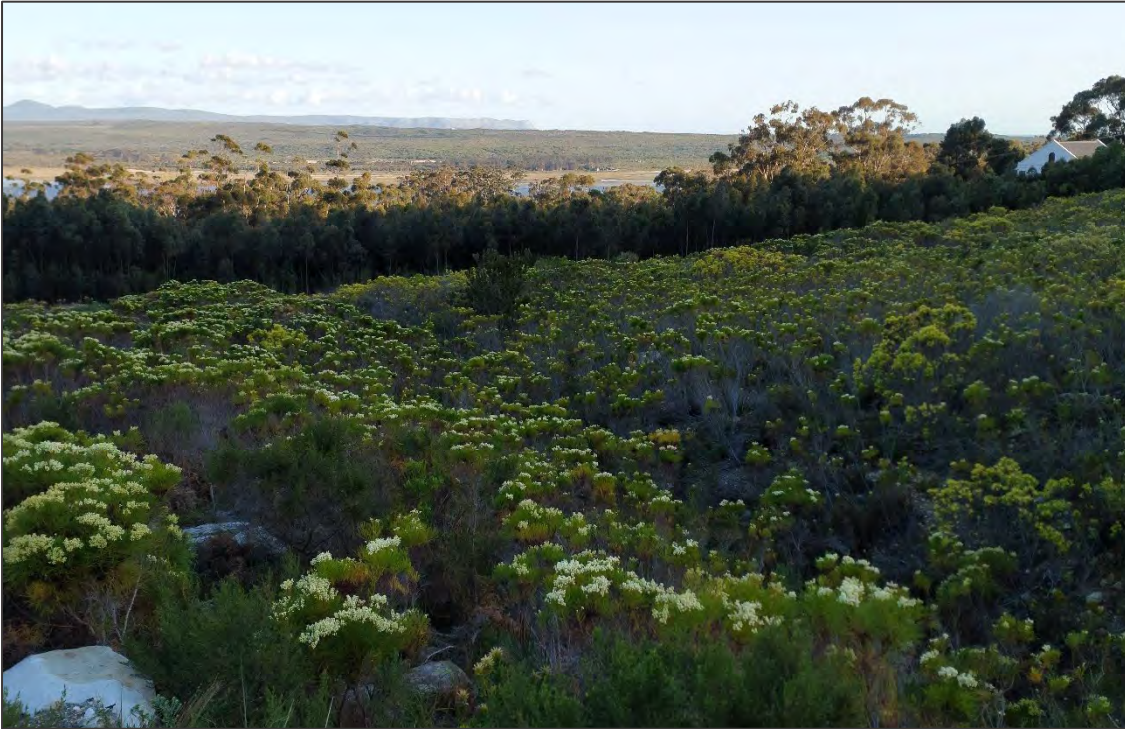
The riparian vegetation within Ephemeral Stream 2 was in a near-pristine condition, however with lower riparian diversity than Stream 1. Stream 2 was dominated by *Berzelia lanuginosa*, interspersed with *Passerina corymbosa* (**Figure 5-15**). The substrate mainly consisted of stones, gravel and sand. Some erosion was evident. The stream was impacted by a dirt road crossing the channel (**Figure 5-17**).

Figure 5-15: Overview of the riparian vegetation in Ephemeral Stream 2, dominated *Berzelia lanuginosa*.

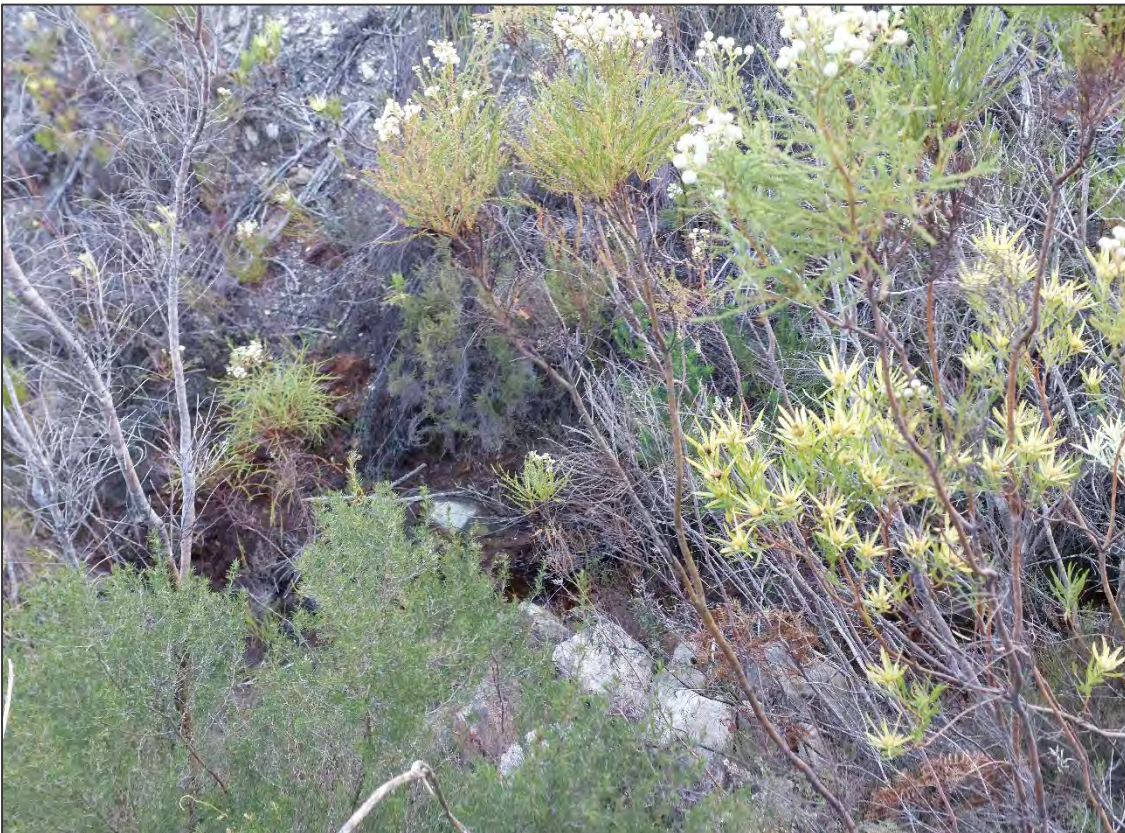
Figure 5-16: Stream channel of Ephemeral Stream 2.

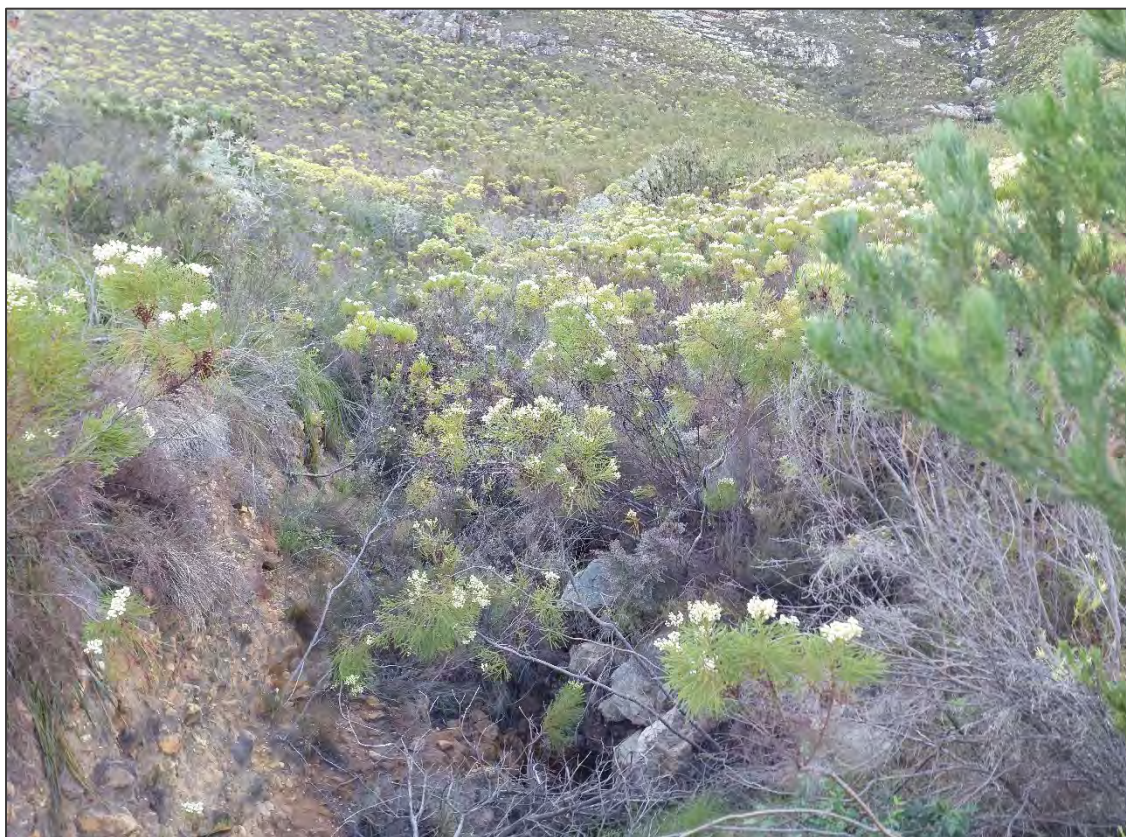
**Figure 5-17: Ephemeral Stream 2.**
