**WETLAND DELINEATION AND SPECIALIST COMMENT RELATING TO  
THE PROPOSED RESIDENTIAL DEVELOPMENT ON ERF 1486,  
VERMONT, WESTERN CAPE**

**FINAL REPORT**

**20 July 2025**

Freshwater Consulting

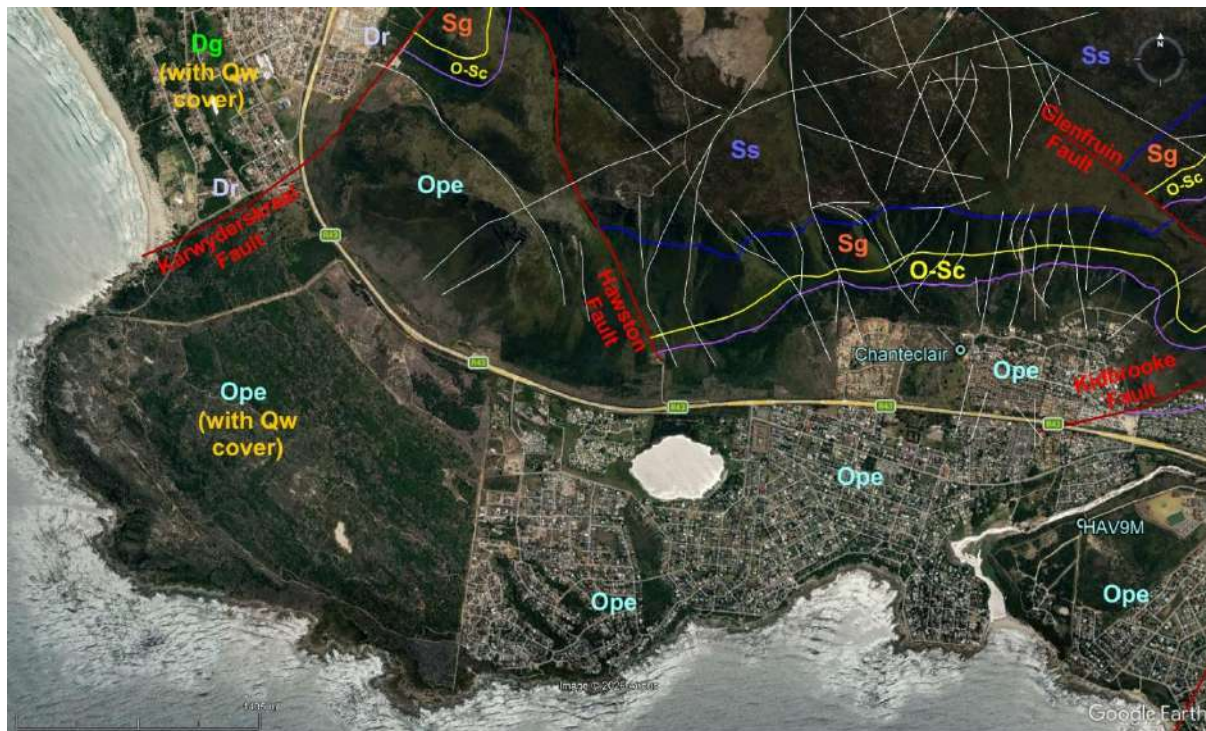
**Figure 2.2: Map showing the fractures within the broader Vermont study area** Abbreviations are as follows: “Ope” = Peninsula Formation, “O-Sc” = Cedarberg Formation, “Sg” = Goudini Formation, “Ss” = Skurweberg Formation, “Dr” = Rietvlei Formation (all TMG), “Dg” = Gydo Formation (Bokkeveld Group) and “Qw” = Waenhuiskrans Formation (Bredasdorp Group). Source: D. Blake, Umvoto.

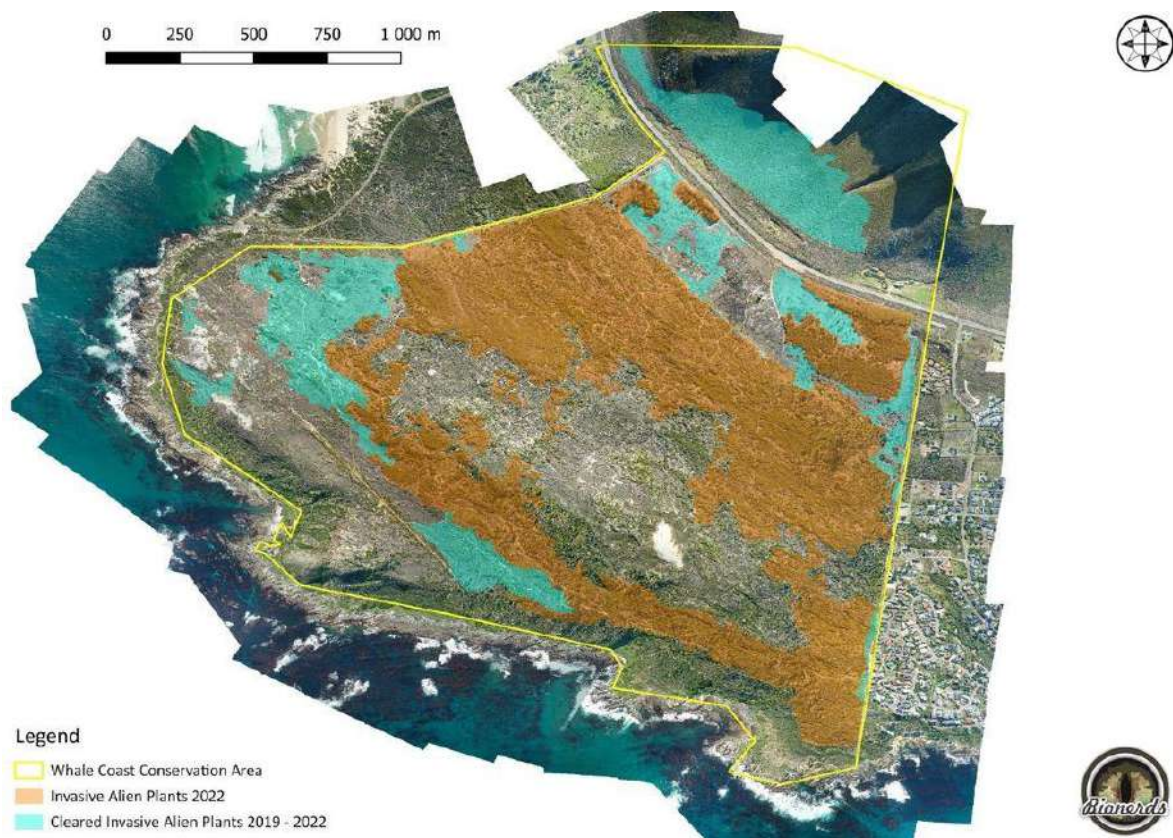
**Figure 2.3: Map showing the extent of alien invasive plants cleared between 2019 and 2022, relative to the remaining extent as of 2022. Source: PAMP 2020.**

Since the preparation of the above map (Figure 2.3), alien vegetation clearing efforts have intensified considerably. Most of the back-dune area between the R43 and the parallel dune system has now been cleared, with the exception of a small remaining stand that is currently being cleared. The extent of this recent clearing and the resulting recovery of the landscape are illustrated in the photographs below (Figure 2.4, Figure 2.5 and Figure 2.6).

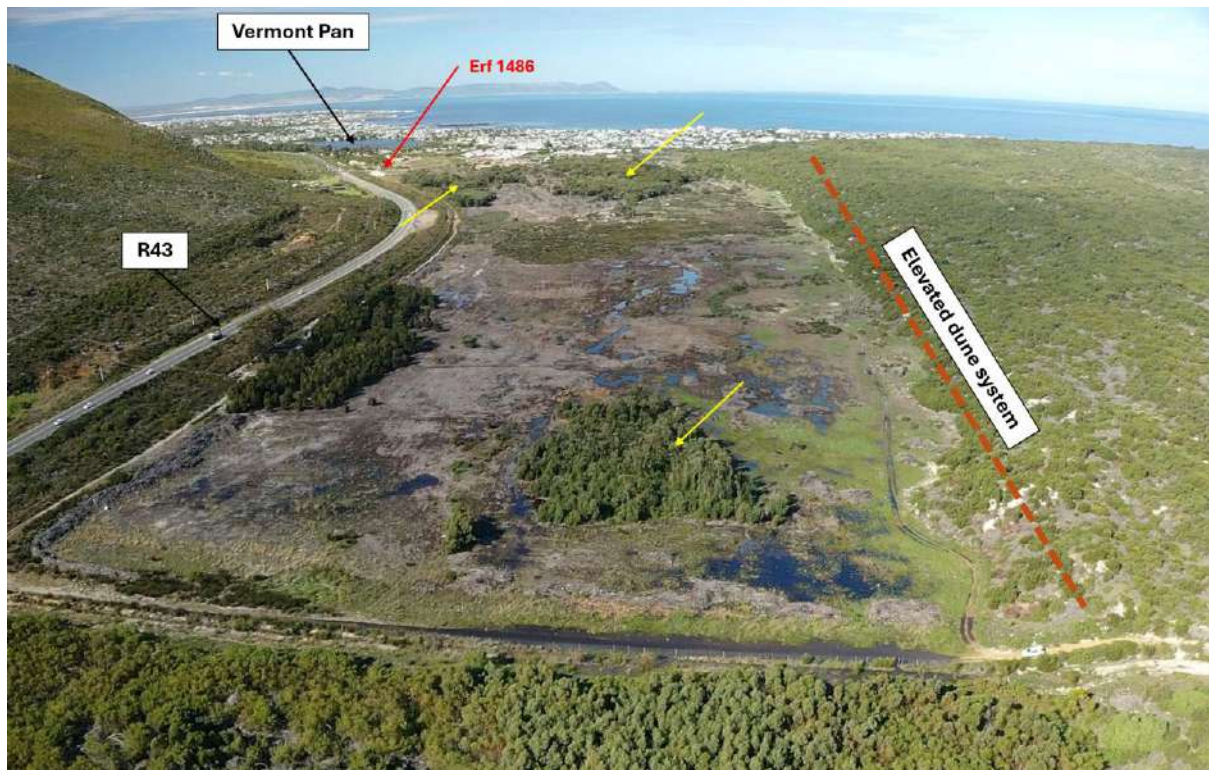
**Figure 2.4: Drone image showing the extent of alien clearing within the dune back area located between the R43 (left) and the dune system (right). Note: This image was taken in July 2024. The aliens noted within the reserve (marked with yellow arrows) have since been removed. Drone image courtesy of Michael Raimondo.**

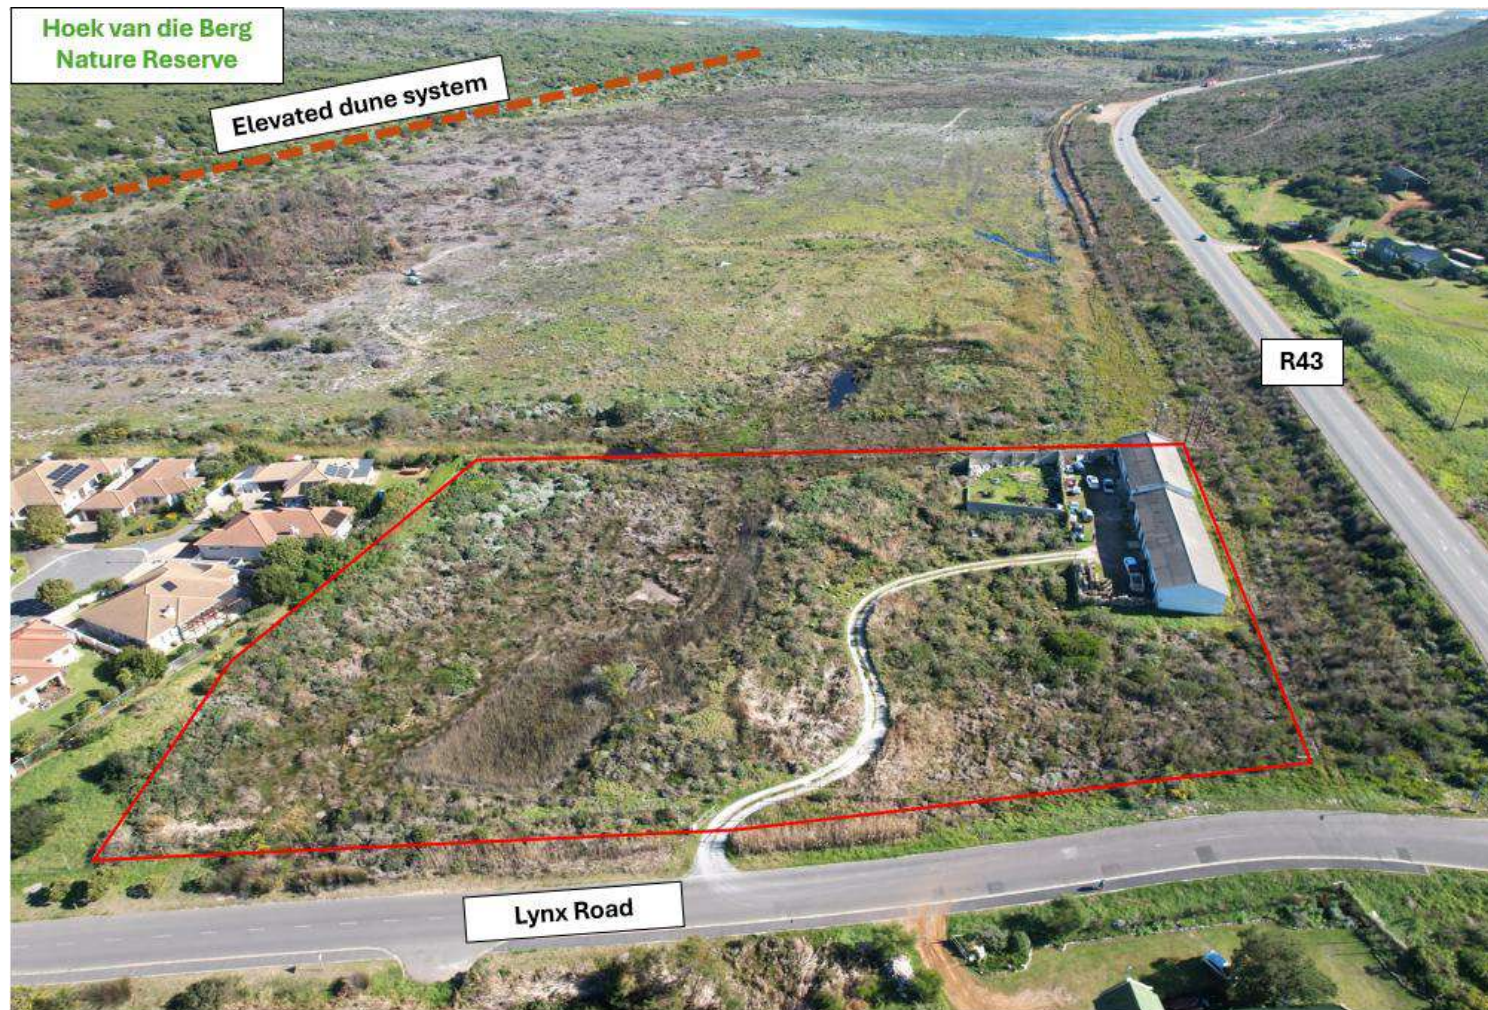
Figure 2.6: Drone image of erf 1486 (foreground) in relation to the Hoek van die Berg Nature Reserve in the middle to background of the image i.e. upslope view. Note the extensive alien clearing having taken place between the R43 (located on the right-hand side of the image) and the first set of dunes (on the left-hand side of the image). Drone imagery taken on 7 July 2026, courtesy of Marco Cornelius, Overstrand Municipality.

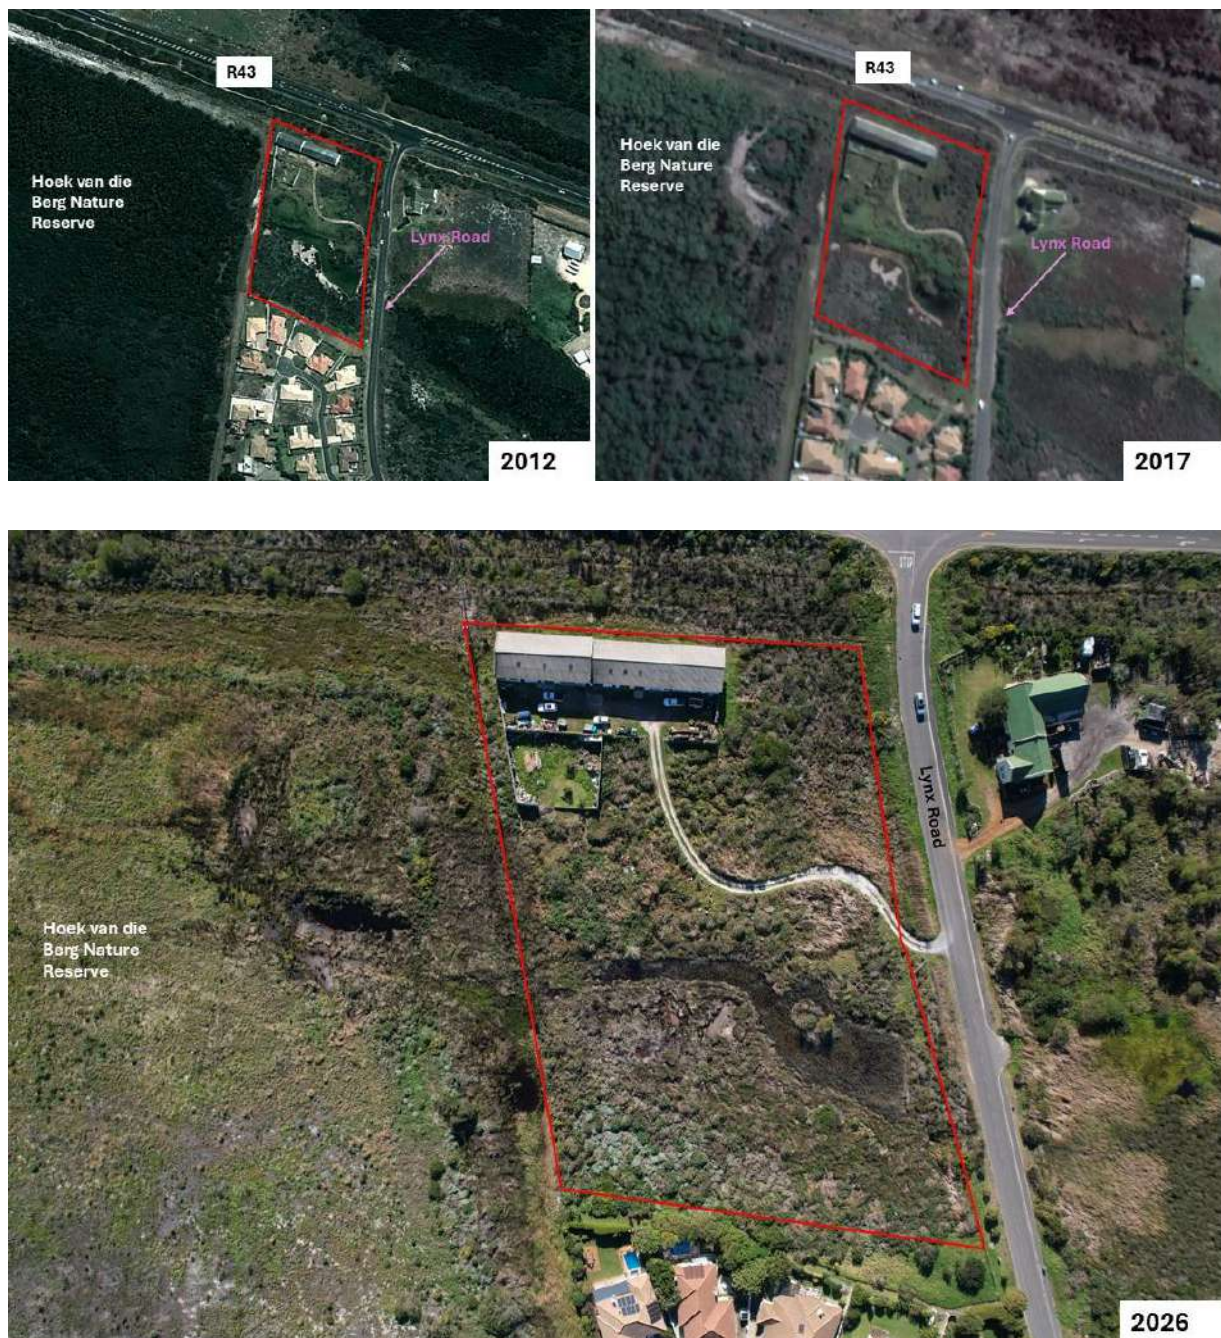
Figure 2.7: A series of historic imagery of erf 1486.

Historic aerial imagery provides useful insight into landscape changes that may have influenced the extent and condition of wetland habitat in the vicinity of Erf 1486, with the earliest available imagery dating to 1938 (Figure 2.7). Based on the available imagery, Erf 1486 appears to have remained relatively undisturbed between 1938 and 1986.

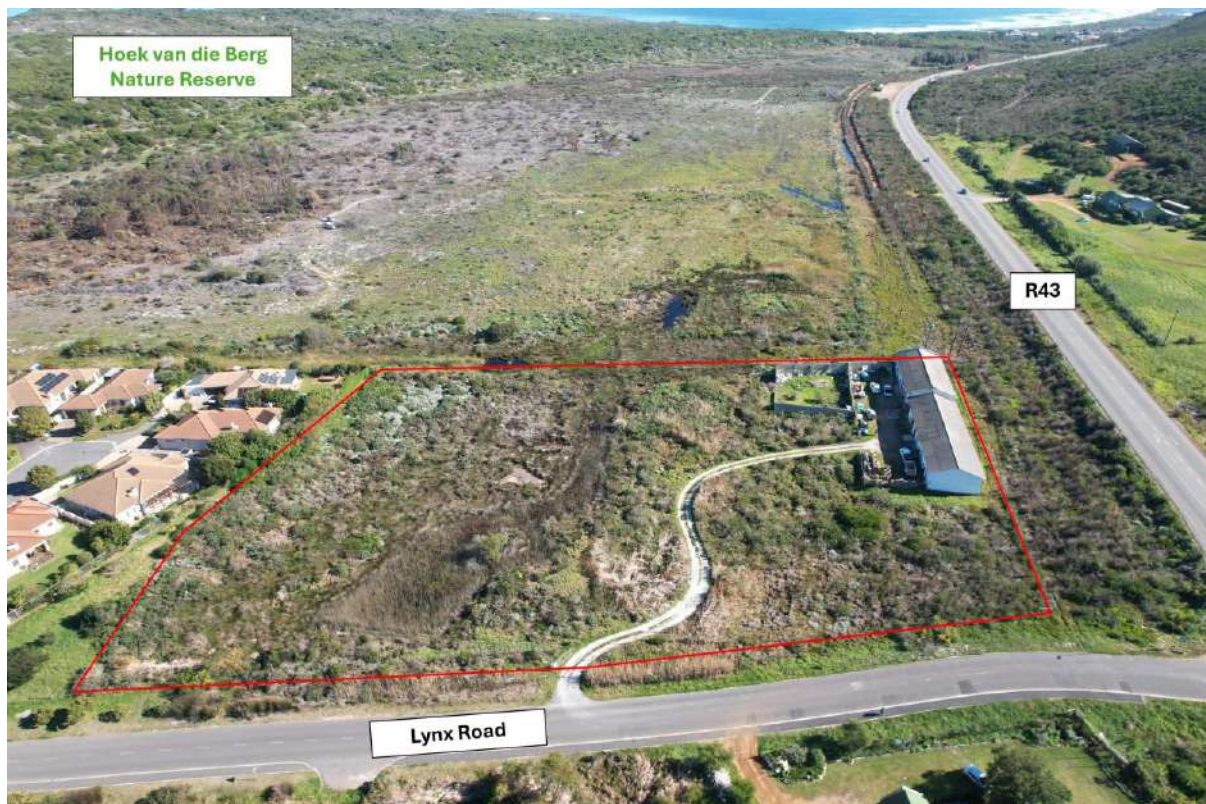
**Figure 2.9: Upslope view of the ecological corridor, showing Erf 1486 in the foreground (red boundary line) and the Hoek van die Berg Nature Reserve in the background. Drone imagery captured on 7 July 2026, courtesy of Marco Cornelius, Overstrand Municipality.**

Erf 1486 occurs within a particularly important and constrained portion of this corridor. It effectively forms a bottleneck in the corridor network, particularly in relation to wetland-linked connectivity between the upper extent of the valley-bottom wetland within Hoek van die Berg Nature Reserve and Vermont Pan (Figure 2.9 and Figure 2.10). Any proposed development within this narrow corridor should therefore be carefully considered to ensure that it does not compromise ecological

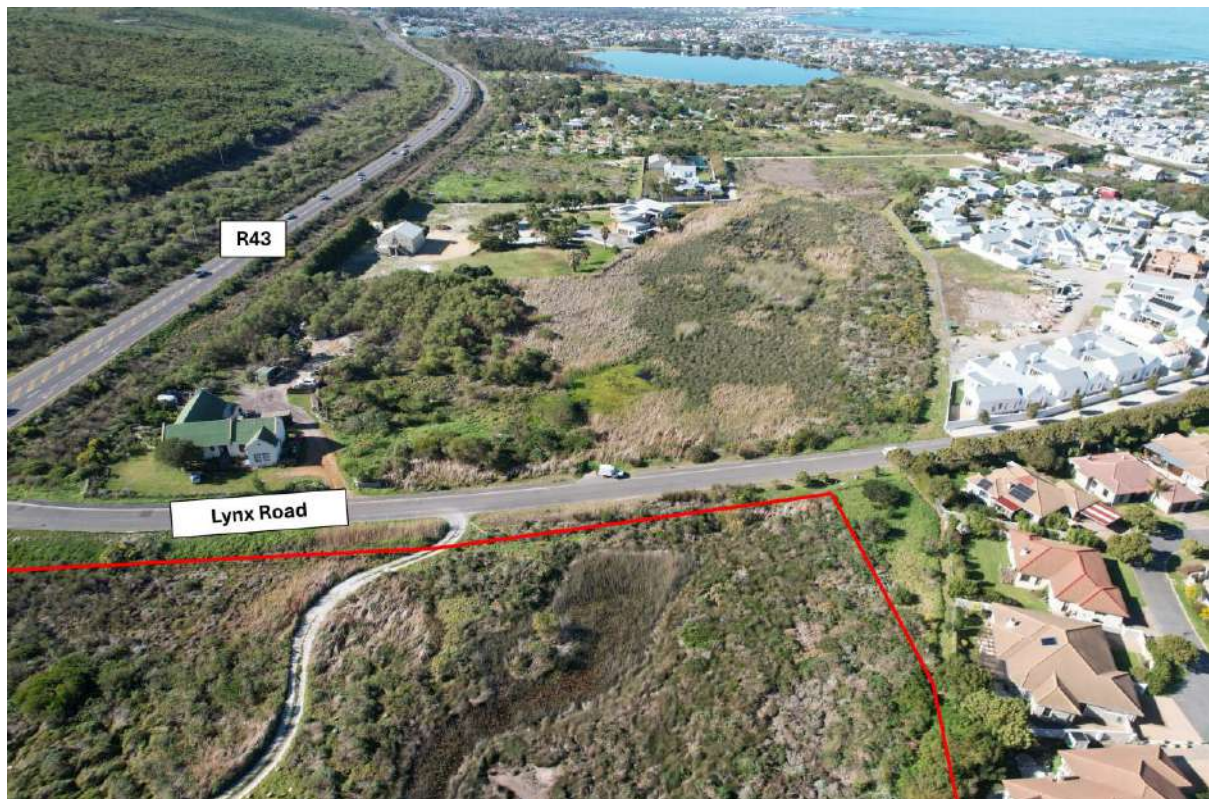
**Figure 2.10: Downslope view of the ecological corridor, showing Erf 1486 in the foreground (red boundary line) and Vermont Pan in the background. Drone imagery captured on 7 July 2026, courtesy of Marco Cornelius, Overstrand Municipality.**

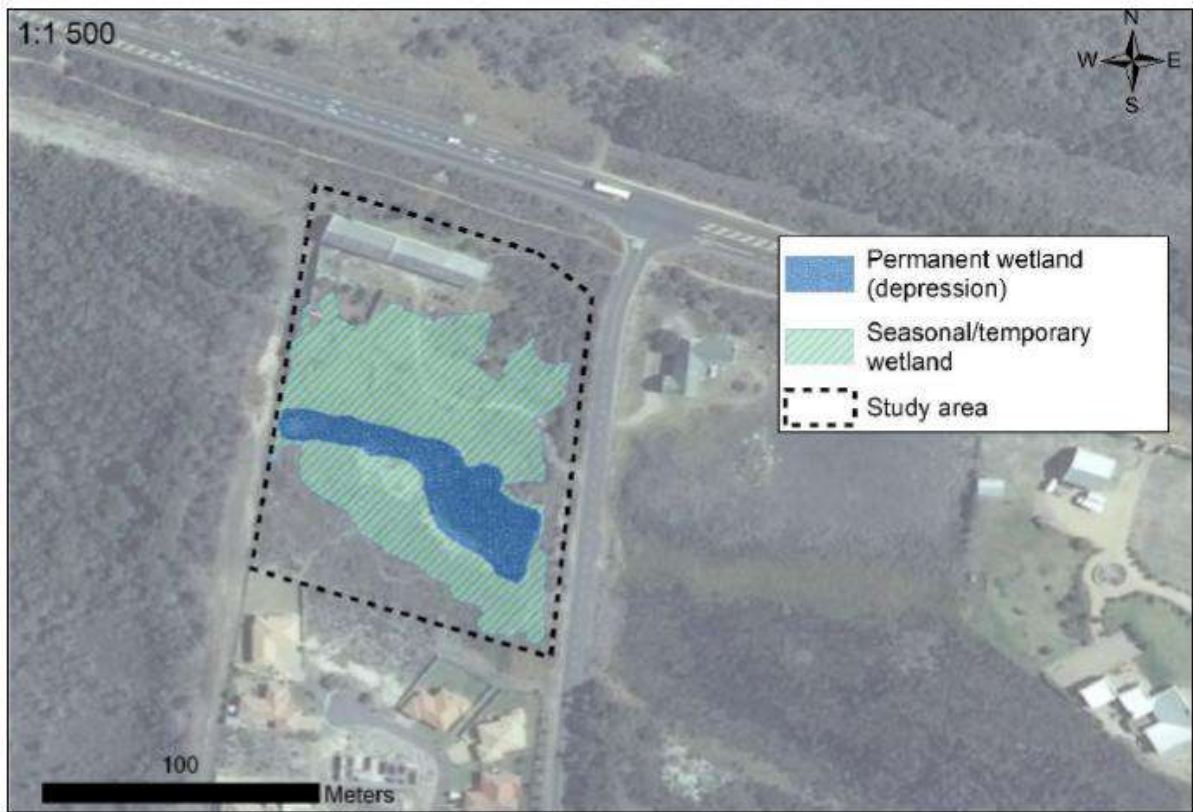
Figure 3.2: Wetland delineated as per Gericke and Moore (2018).

Based on the findings of the previous studies, it is clear that both permanent and seasonal wetland habitats occur on Erf 1486. Notably, however, the delineated extent of this wetland habitat has varied between the different assessments, as illustrated in Figure 3.1 (Job and Ratcliff 2006), Figure 3.2 (Gericke and Moore, 2018), Figure 3.3 (van Zyl et al 2023) and Figure 3.4 (Steytler 2025). Several of the studies also identified ecological buffers or development setbacks around the wetland. Job and Ratcliffe (2006) recommended a 30 m buffer, while the more recent aquatic assessments undertaken by EnviroSwift and Delta Ecology between 2018 and 2025 did not explicitly prescribe a specific buffer width. The latest Final Basic Assessment Report (FBAR) for erf 1486, however, refers to a 32 m regulated area around the wetland only.

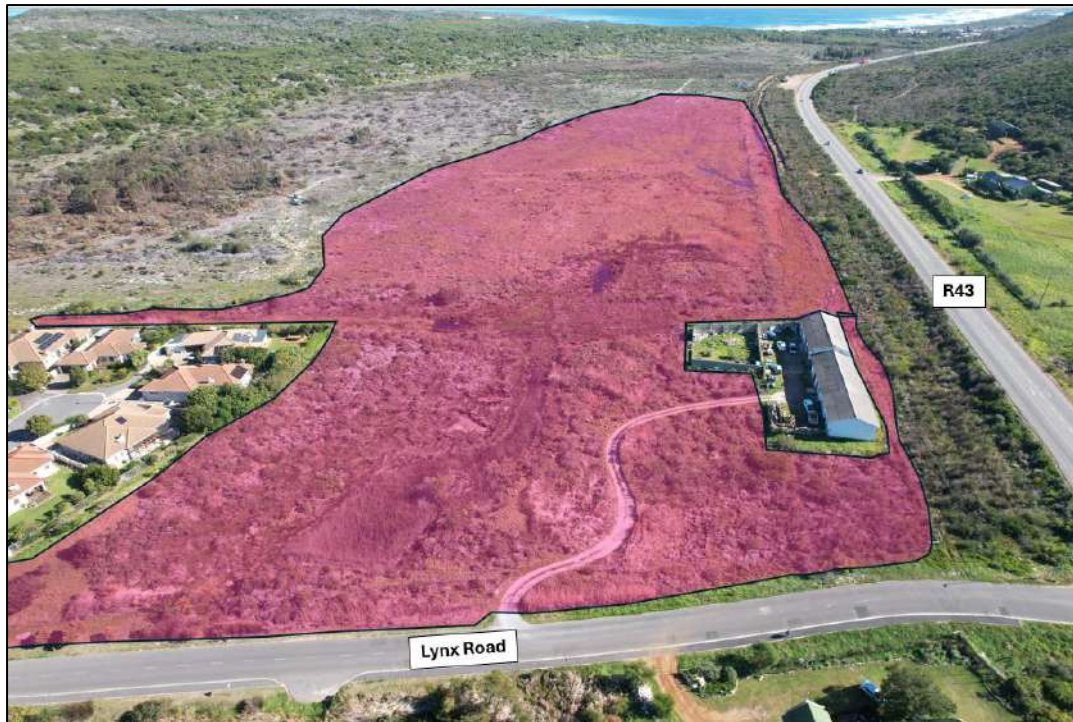
**Figure 3.5: Map showing the delineated wetland extent (pink) within the broader study area as per the July 2026 site visit. Note: the boundaries of the upper edges of the wetland on the nature reserve are of low confidence, considering the limited vegetation recovery since the recent alien clearing efforts. Considering that the focus was only upstream of Lynx Road, the wetland boundary does not extend downstream within this map.**

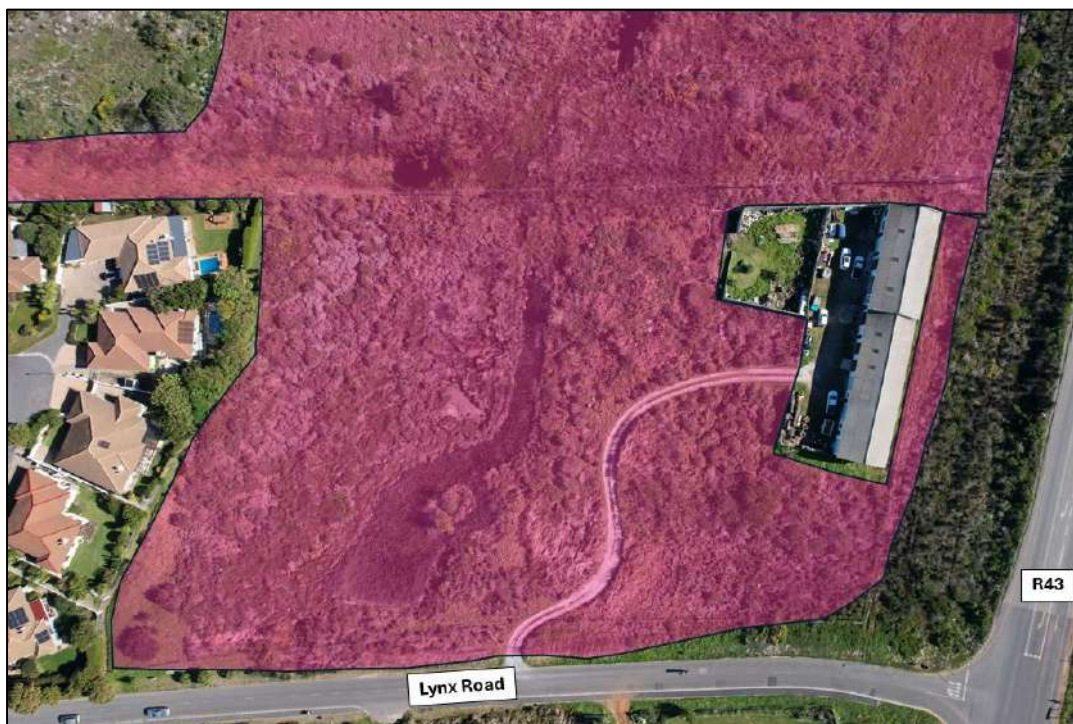
**Figure 3.6: Map showing the delineated wetland boundary (pink) with a focus on erf 1486 as per the July 2026 site visit. Considering that the focus was only upstream of Lynx Road, the wetland boundary does not extend downstream within this map.**

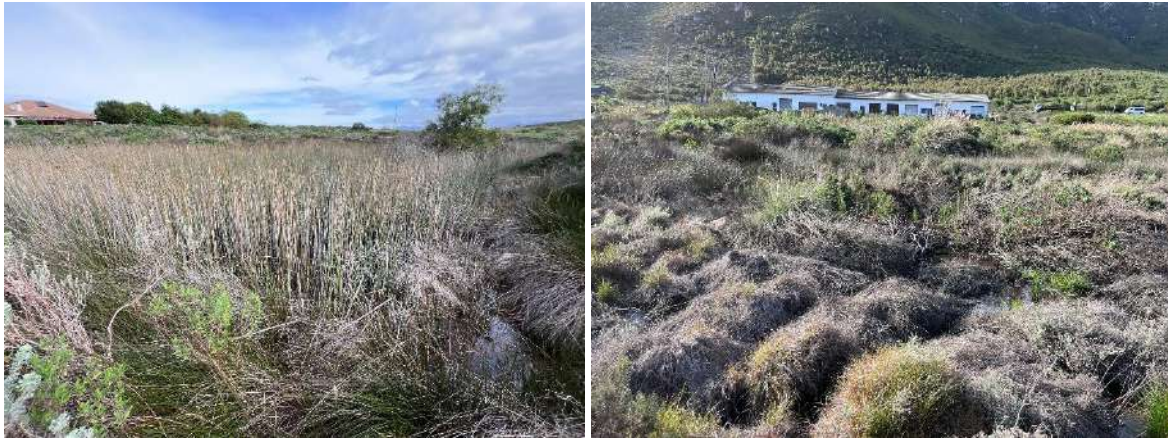
**Figure 3.7: Photos of the permanently saturated portion of the wetland on erf 1486. Left: excavated pond which appears to be permanently saturated and permanently inundated. Right: View across the permanently saturated portion of the wetland taken from the southern portion of the wetland towards the R43.**

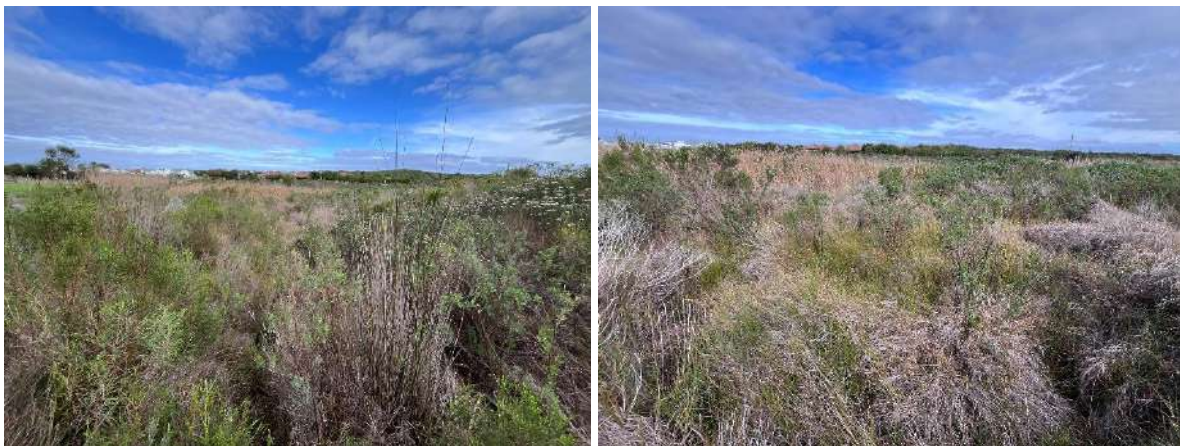
**Figure 3.8: Images of the seasonal wetland that is seasonally inundated looking south towards the existing residential dwellings located on the southern boundary of erf 1486.**

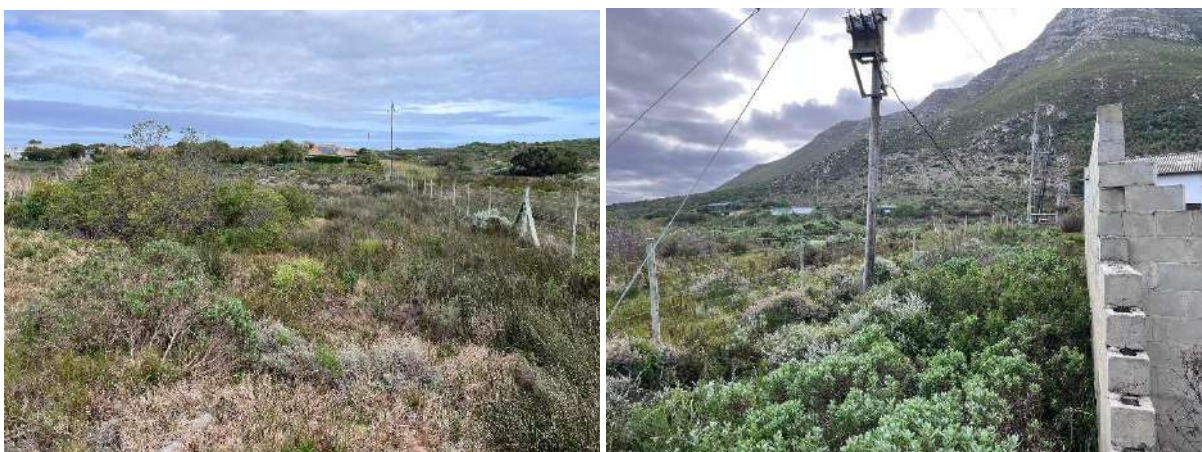
**Figure 3.9: Images taken on the western boundary of erf 1486 showing the permanently saturated portion of the wetland (left) and the seasonally saturated portion of the property immediately adjacent to the derelict building (right).**

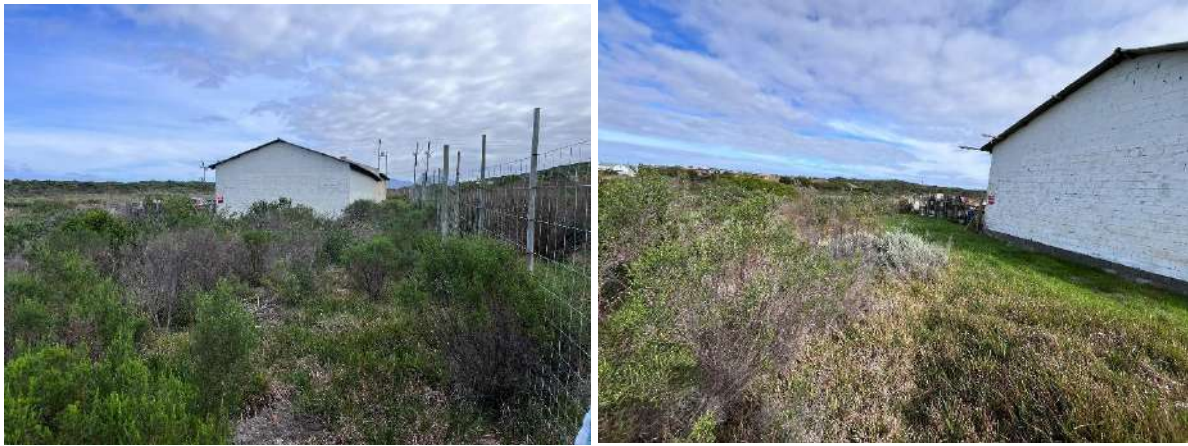
**Figure 3.10: Images of the seasonal to temporary margin of the wetland on the northernmost section of erf 1486 (immediately south of the R43).**

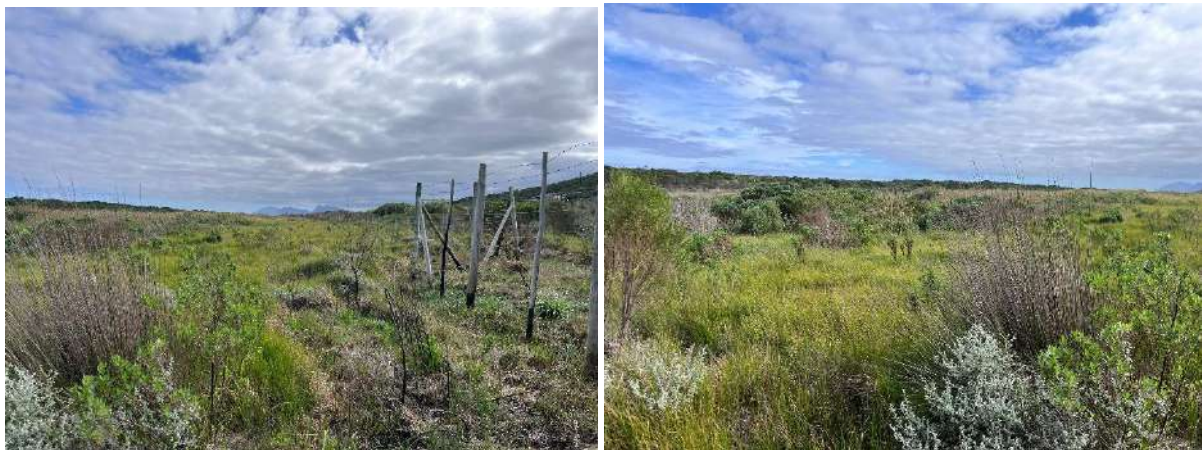
To provide additional supporting evidence and to assist in validating and interpreting the extent of wetland habitat within and around Erf 1486, the area immediately upslope of the property, within the adjoining Hoek van die Berg Nature Reserve, was also investigated. Clear vegetation and soil indicators consistent with wetland conditions were observed in this area, as illustrated in Figure 3.11 and Figure 3.12.

**Figure 3.11: Images of the wetland habitat (top portion) on the nature reserve property immediately west of erf 1486 and immediately south of the R43. The main dwelling is situated behind.**

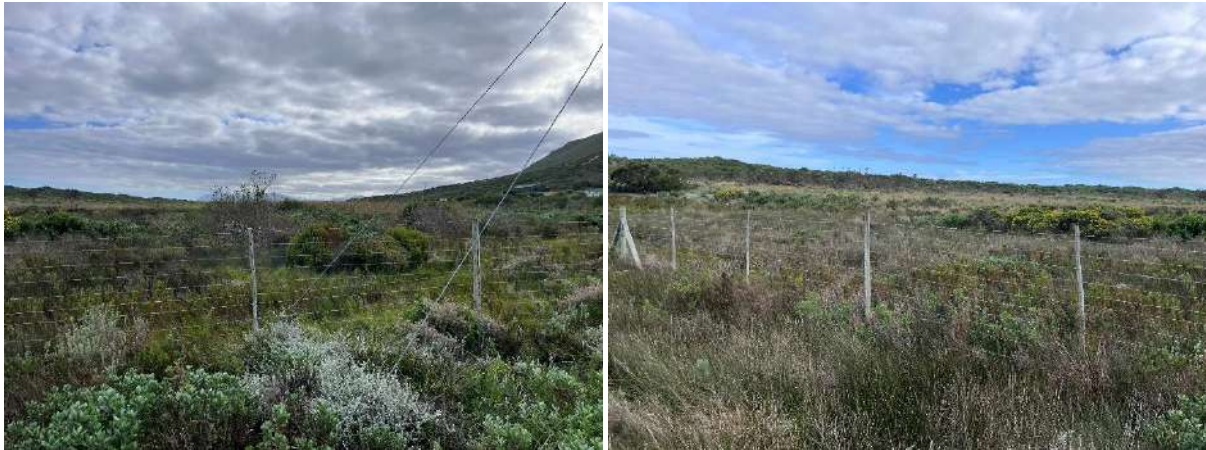
**Figure 3.12: Wetland habitat immediately west of erf 1486 (adjacent to the derelict building) (left). The wetland core is visible in the image on the right.**

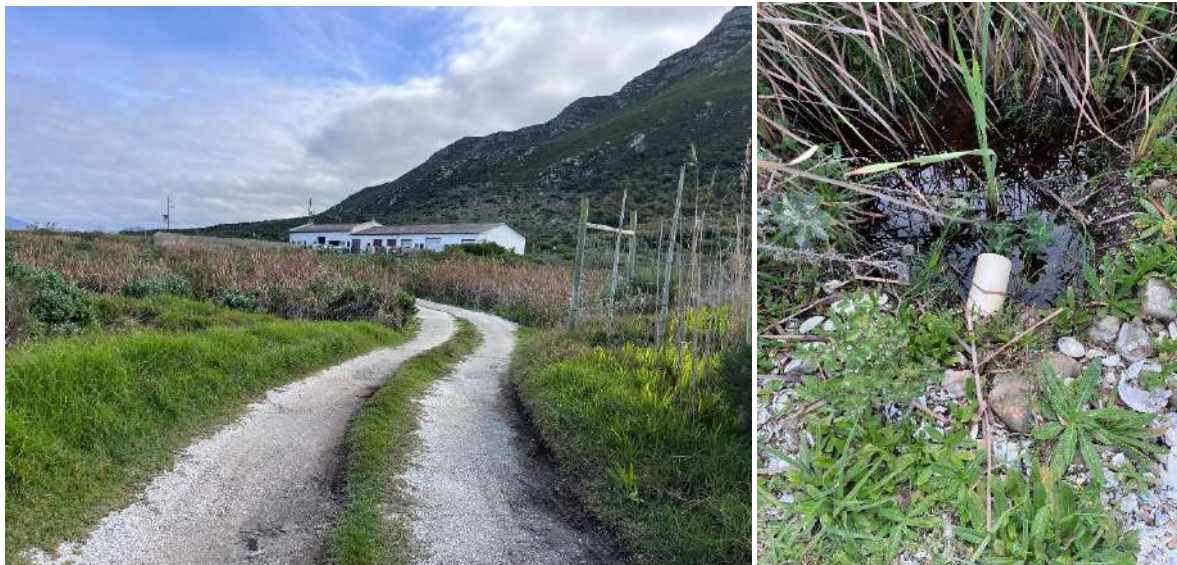
**Figure 3.13: Images showing the entrance road from Lynx Road to the main dwelling on erf 1486 (left). This road contains numerous pipes to allow water to flow underneath it.**

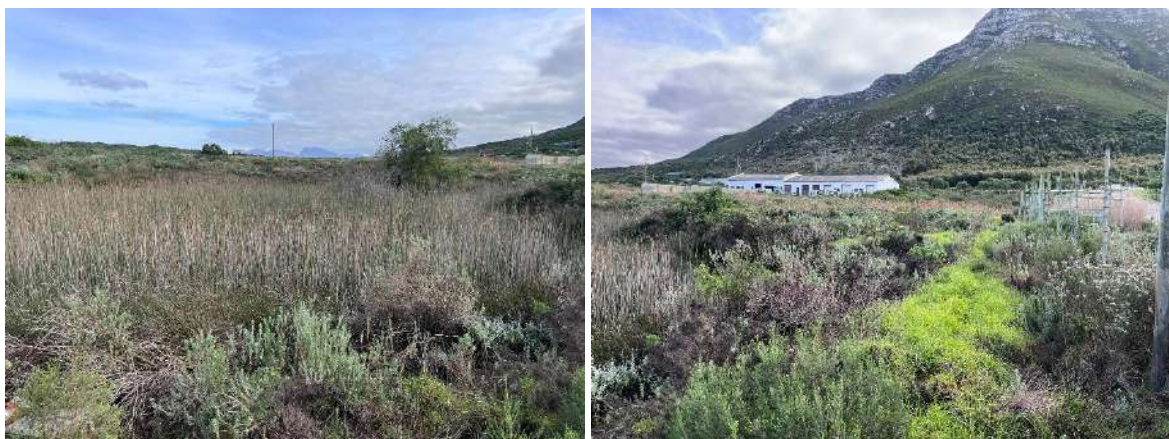
**Figure 3.14: Images showing the excavated pond within the lowest portion of the property (left) and with dumped material creating a berm (see area dominated by lush green kikuyu grass in the right-hand image).**

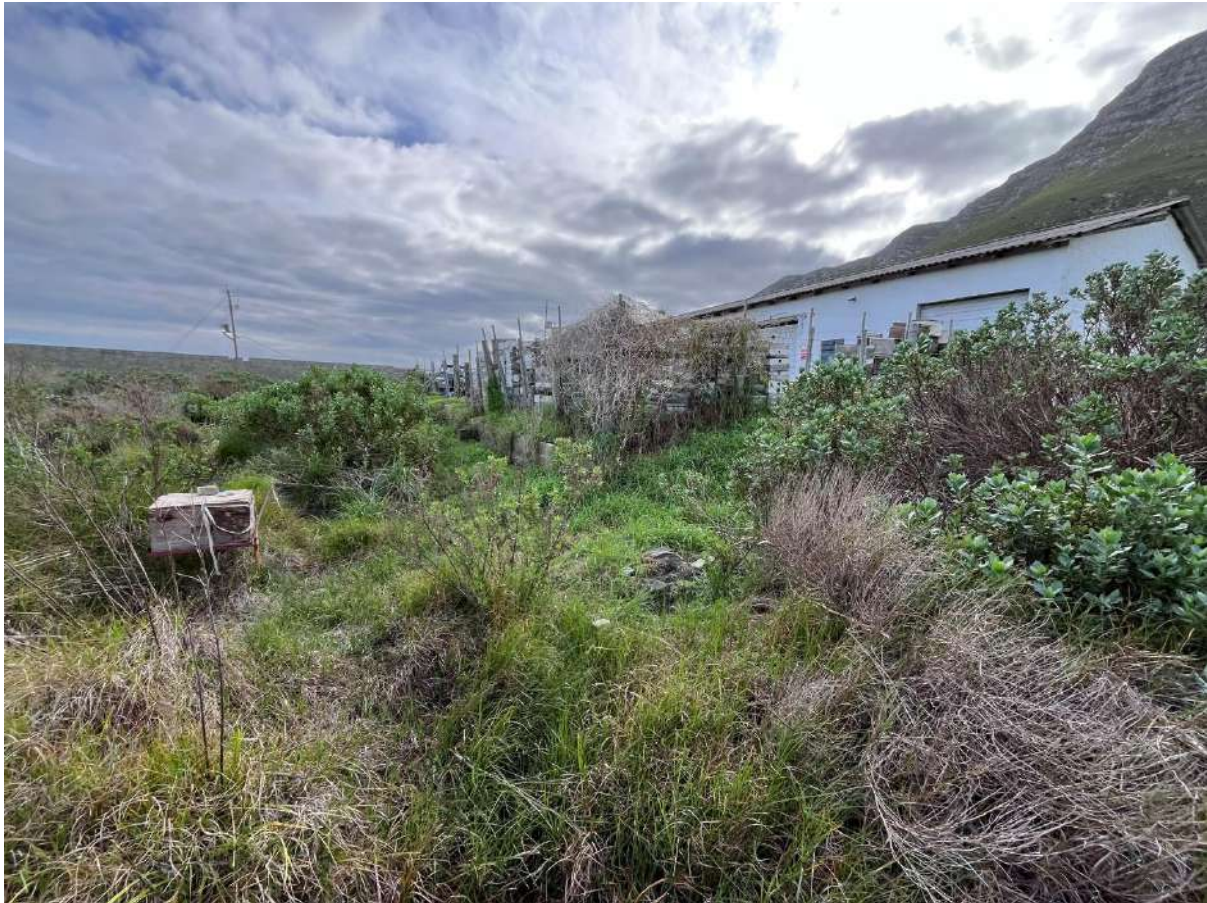
**Figure 3.15:** Image showing the main dwelling located on the northwestern portion of the property. The area to the south of this dwelling was surrounded by inundated soils at the time of the site visit.

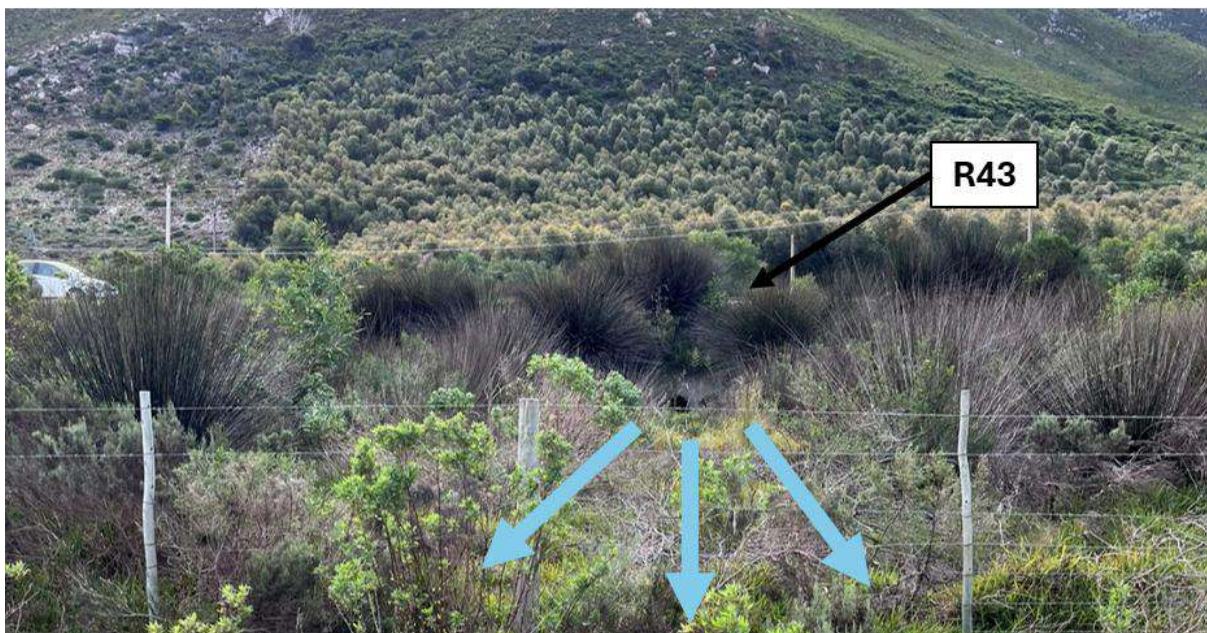
**Figure 3.16:** Image of a stormwater culvert underneath the R43 draining the upper catchment and discharging flows towards erf 1486.

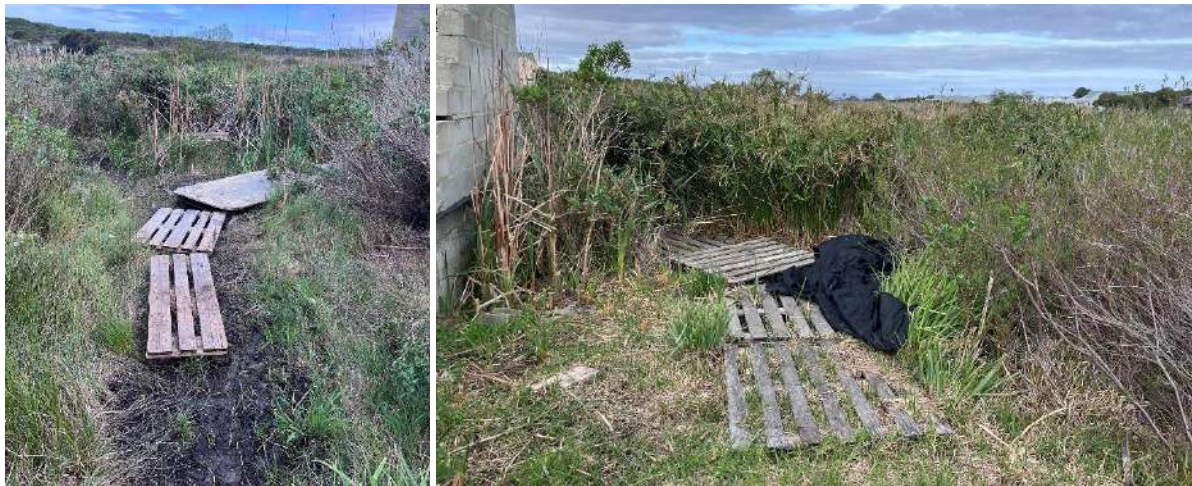
**Figure 3.17: Evidence of muddy conditions with the placement of wooden crates around the property.**

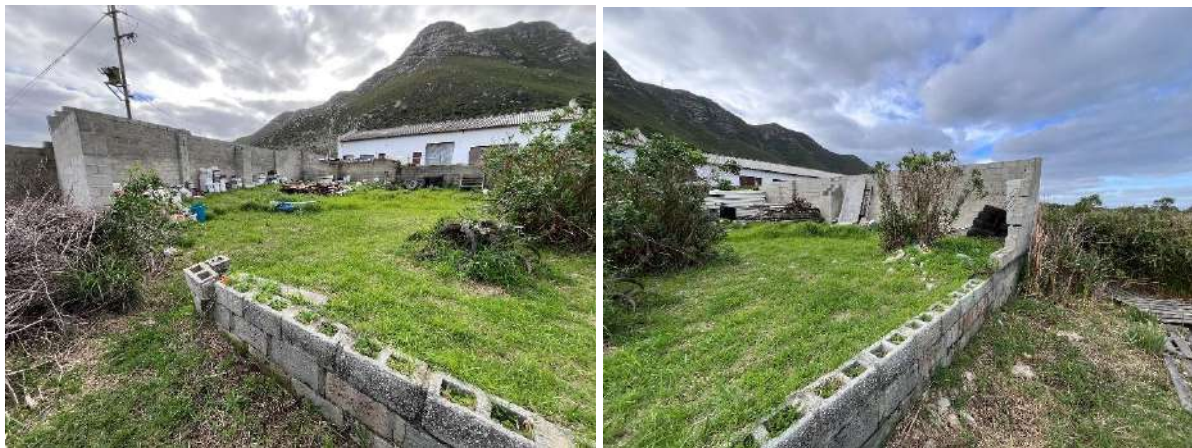
**Figure 3.18: A derelict building associated with the main dwelling that was built within the wetland.**

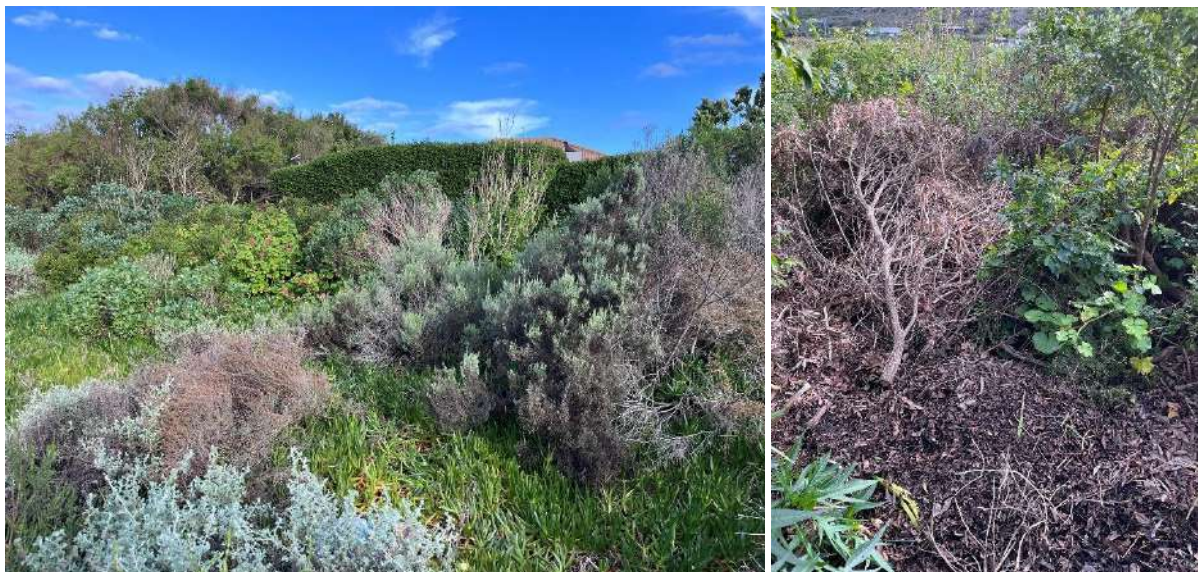
**Figure 3.19: Evidence of dumped garden refuse and the presence of garden escapees in the southwestern corner of erf 1486.**

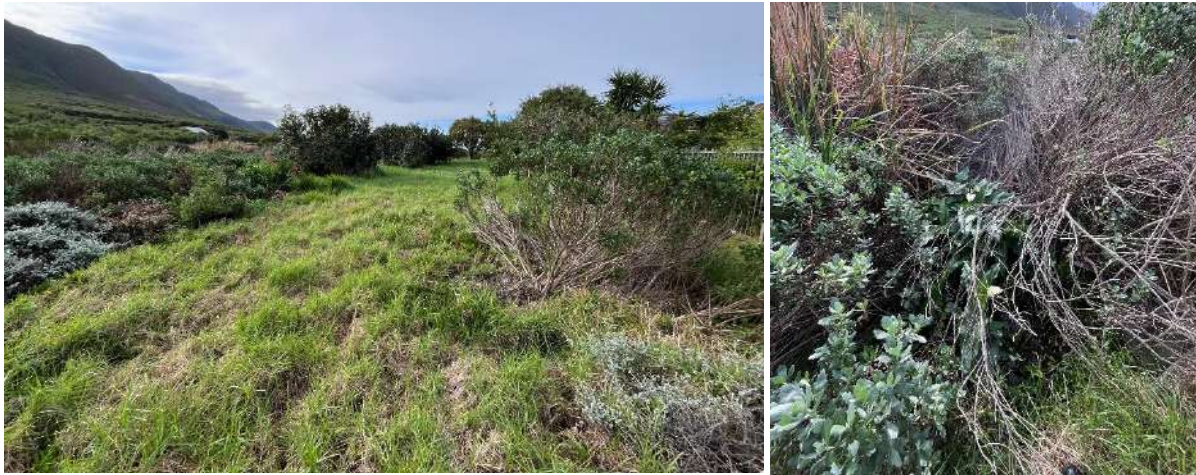
**Figure 3.20: Images of the municipal erf 2317 located along the southeastern boundary of erf 1486. It is dominated by Kikuyu grass. There is also a stormwater discharge point draining into the wetland immediately upslope of Lynx Road.**

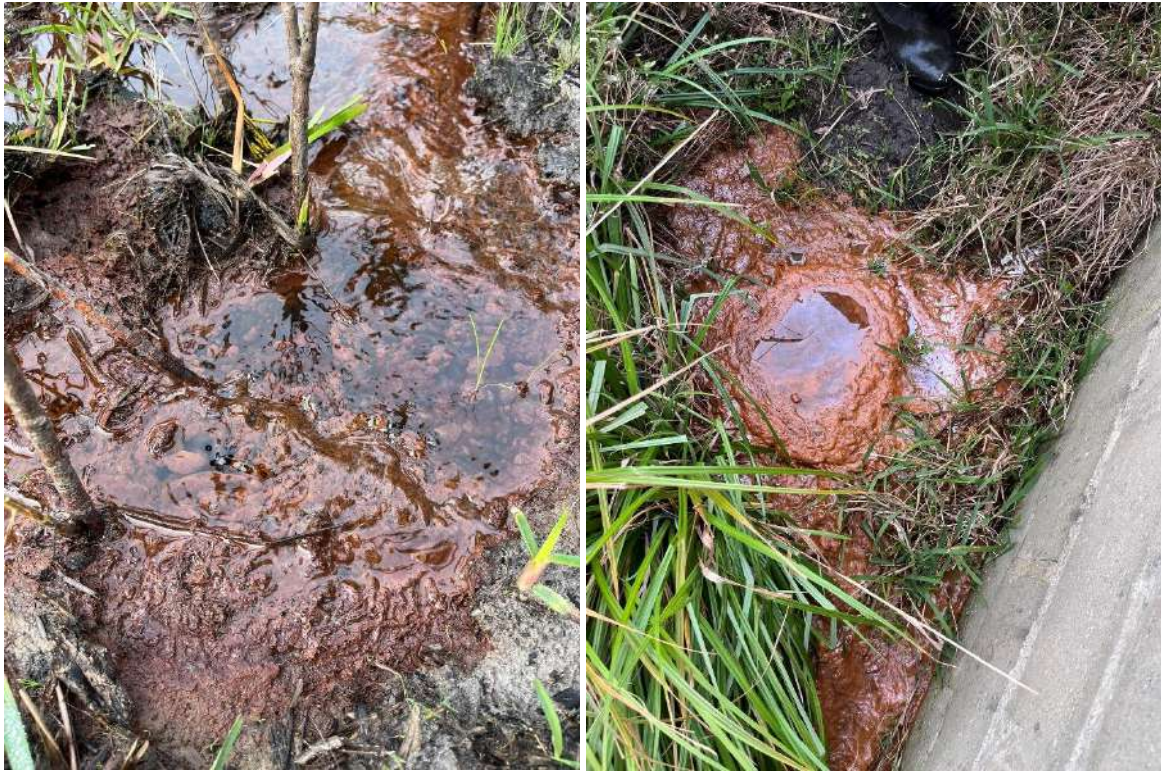
Furthermore, during the field assessment, three locations exhibiting iron-rich deposits were observed along the boundary between Erf 1486 and the adjoining nature reserve (Figure 3.21). The associated bubbling and trickling seepage is consistent with groundwater discharge and may reflect interaction between groundwater derived from the Peninsula Aquifer and the overlying sandy aquifer. According to D. Blake (Umvoto, pers. comm.), iron-rich sludge and staining can develop where acidic, iron- and manganese-bearing groundwater interacts with more alkaline, carbonate-bearing dune sediments and is subsequently exposed to more oxidising conditions. These geochemical changes promote the precipitation of iron oxides and hydroxides, which may accumulate around spring and seepage outlets.

**Figure 3.21: Images of two springs noted during the site visit. Left: bubbling spring noted immediately upslope of erf 1486 on the nature reserve. Right: slow bubbling spring immediately adjacent to the derelict building on erf 1486.**
