**WETLAND DELINEATION AND SPECIALIST COMMENT RELATING TO  
THE PROPOSED RESIDENTIAL DEVELOPMENT ON ERF 1486,  
VERMONT, WESTERN CAPE**

**FINAL REPORT**

**20 July 2025**

Freshwater Consulting

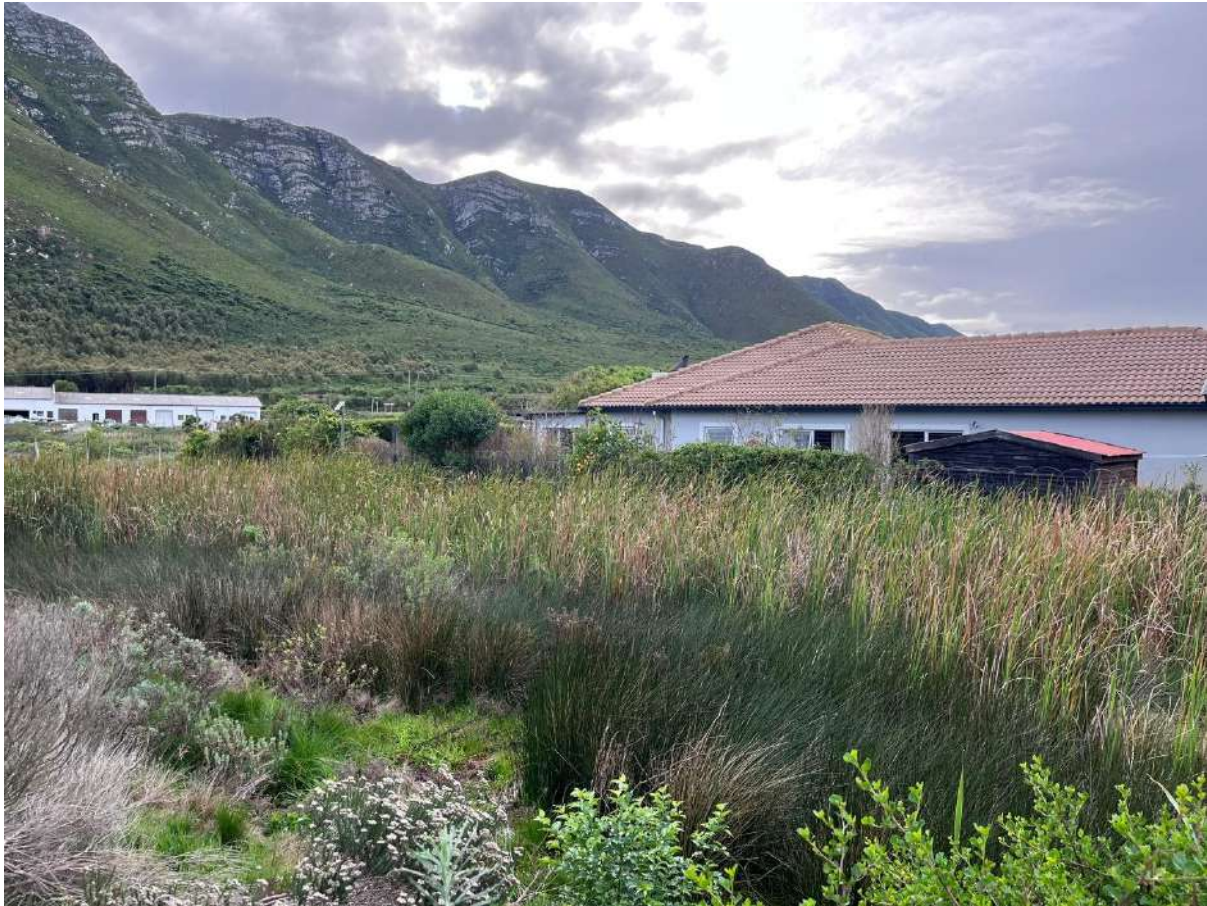
**Figure 3.22: Image of the previous dry road along the eastern boundary of the nature reserve that is now dominated by dense stands of *Typha capensis* following alien clearing.**

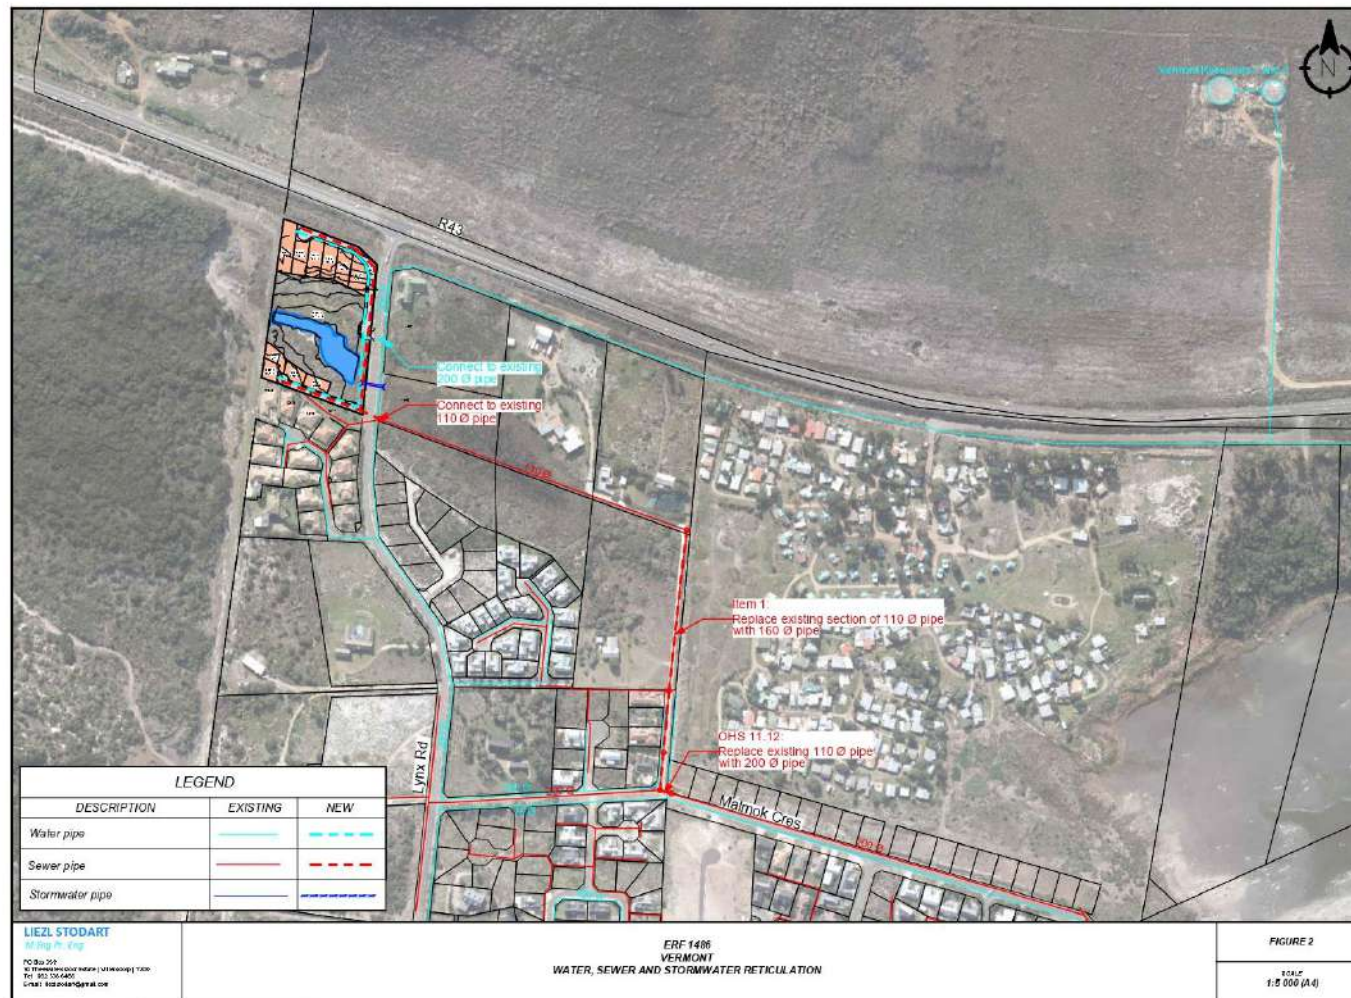
Figure 4.2: Map showing the location of existing and newly proposed potable water and sewage pipelines to accommodate the proposed development on erf 1486. Source: Louwrens (2025)

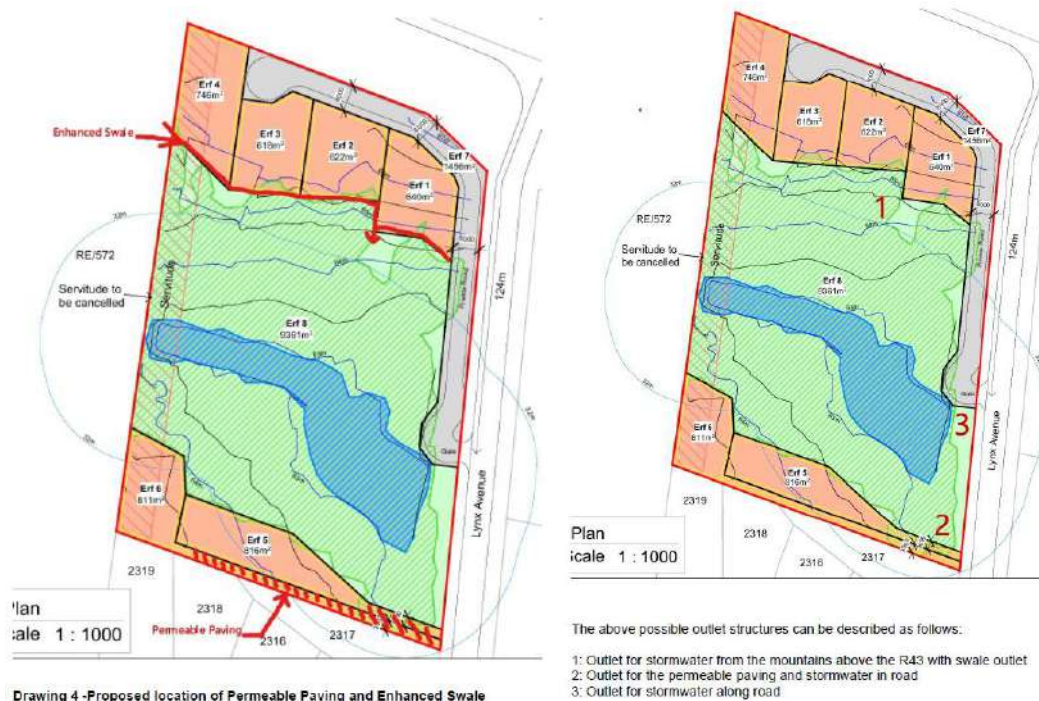
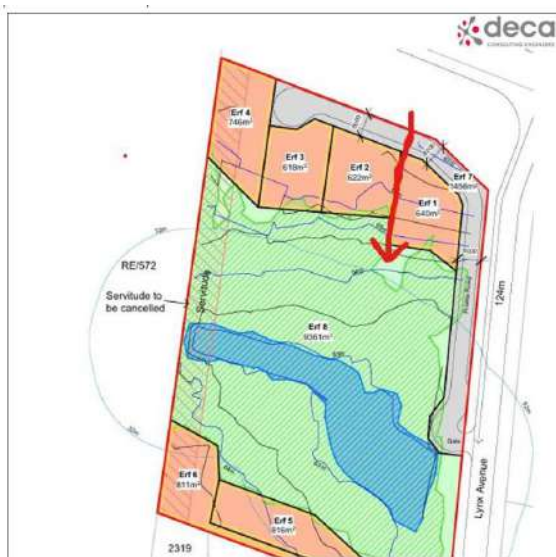
- **An enhanced swale** designed to capture and convey runoff generated from Erven 1–4.
- **Permeable paving** to promote infiltration and reduce the volume and rate of surface runoff.
- **Three stormwater discharge outlets**, all located within, or in very close proximity to, the wetland extent delineated by Van Zyl et al. (2023).
  - Outlet 1 will convey stormwater originating from the mountain slopes north of the R43 via a swale. The outlet will discharge into a small area mapped as non-wetland

Figure 4.3: A series of images taken from the proposed stormwater management plan for the proposed development on erf 1486. Source: Deca (2026).

- Vegetated swales must be utilised rather than concrete drains or underground stormwater pipes in order to encourage infiltration, particularly next to roadways.

- Sheet runoff from hardened surfaces must be intercepted and the treatment and infiltration of runoff must be promoted.
- Sediment traps should be incorporated into stormwater drains / swales upstream of all discharge points into the wetland.

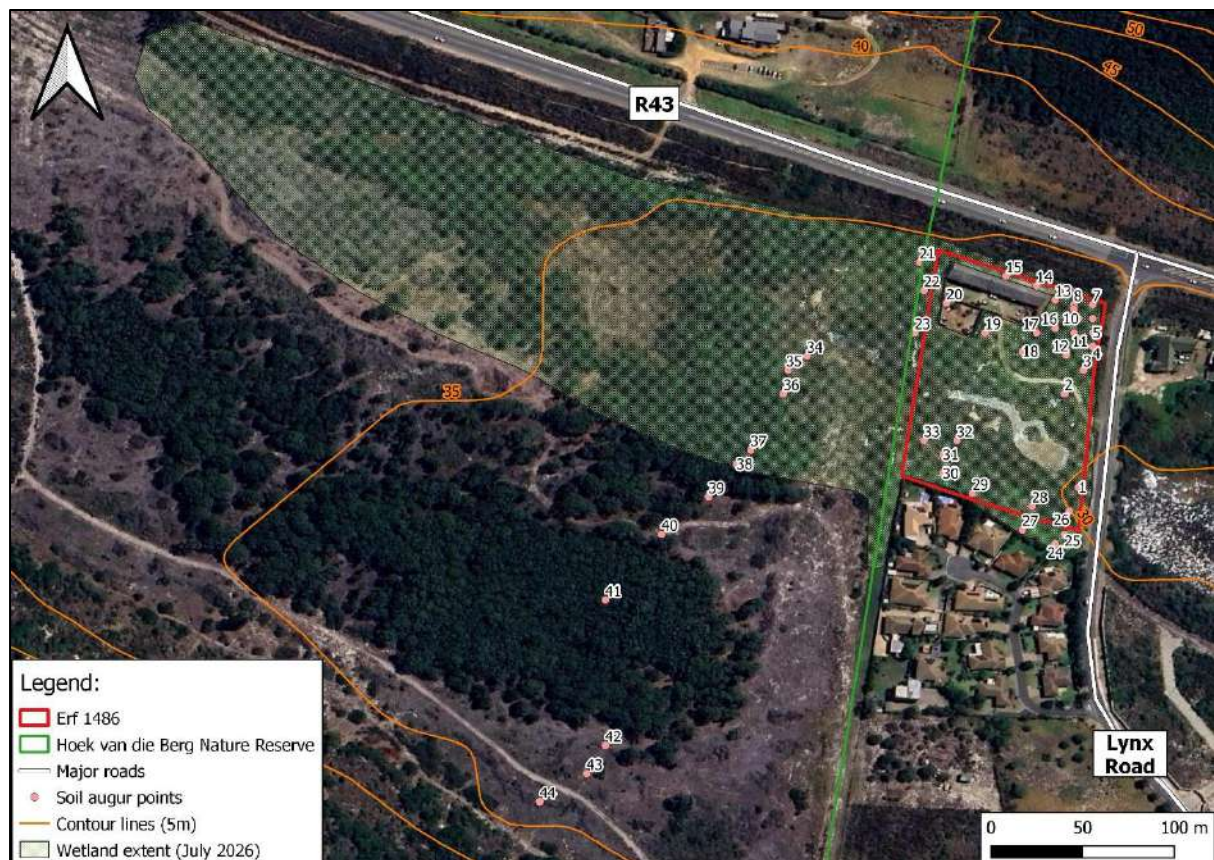
**Figure 9.1: Map showing the locations where soil auguring was undertaken as part of the wetland delineation exercise in July 2026. Considering that the focus was only upstream of Lynx Road, the wetland boundary does not extend downstream within this map.**

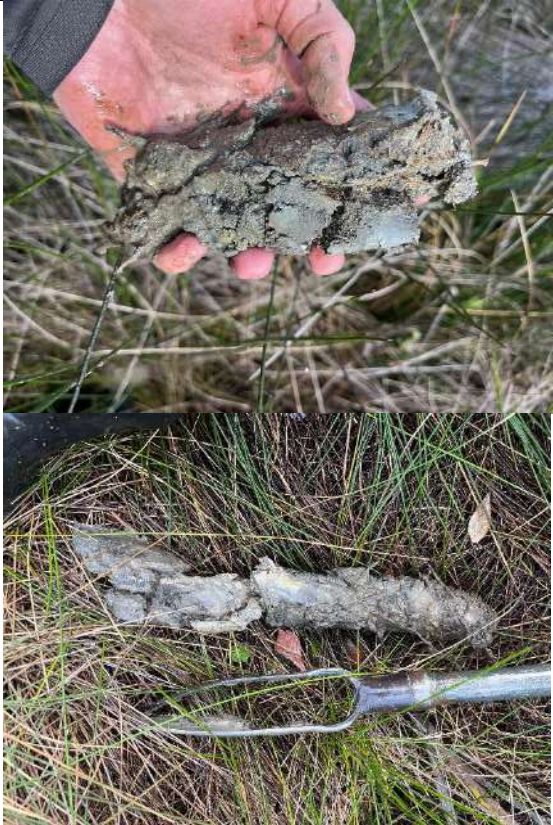
| SAP | Location description | Vegetation | Soils | Other notes | Habitat type | Photo(s) |
|---|---|---|---|---|---|---|
| 1 | Downstream of the dug-out pond, auguring took place within the flowing water immediately upslope of the road culvert on Lynx Road | Dominated by <i>Juncus kraussii</i> , arum lilies and pockets of <i>Typha capensis</i> within the wet core, whereas the drier banks of the pond are <i>Senecio halimifolius</i> | 0-15cm: mix of organics, root mass and sand<br>15-50cm: washed out/gleyed clays comprising very fine silt (Gley 1 3/N) | Lowest point on the property; iron-rich bacteria located on the plants within and adjacent to the channel | Permanent wetland | |

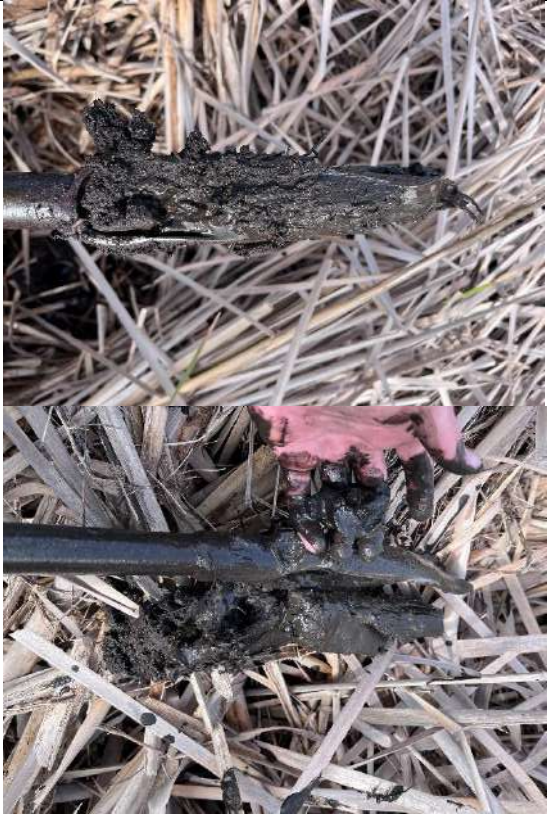
| SAP | Location description | Vegetation | Soils | Other notes | Habitat type | Photo(s) |
|---|---|---|---|---|---|---|
| 2 | Downslope of the entrance road within a dense <i>Typha capensis</i> stand | <i>Typha capensis</i> dominated with sparse <i>Nidorella</i> spp and <i>Juncus krausii</i> and kikuyu grass along road verge | 0-20cm: sponge-like organic matter<br>20-60cm: 10YR 2/1 highly organic loamy soils with increasing clay content further down the soil profile | Strong sulphur/egg smell; saturated soils throughout the profile; water ingress at 5cm | Permanent wetland | |

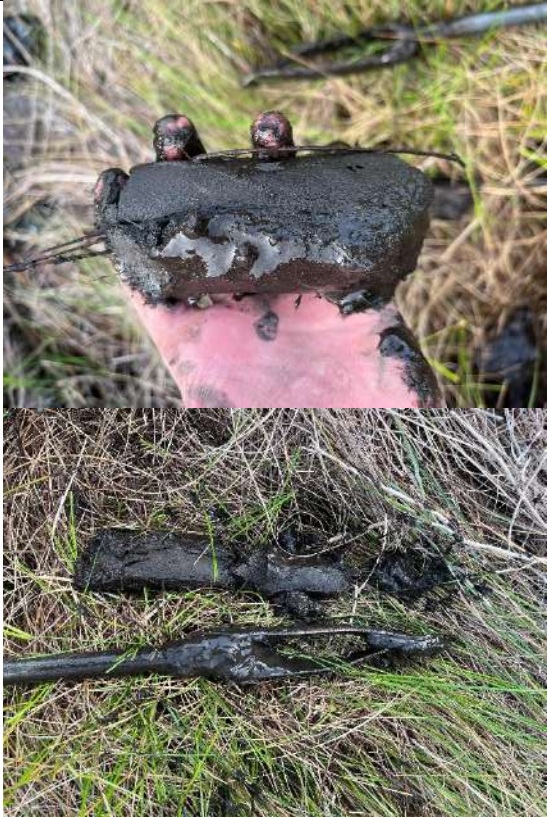
| SAP | Location description | Vegetation | Soils | Other notes | Habitat type | Photo(s) |
|---|---|---|---|---|---|---|
| 3 | Upslope of access road | Grass-like sedge that transitions into <i>Typha capensis</i> stands further south | 0-60cm: fine silty sands with high organic content (10YR 2/1) | Inundated at the surface and saturated throughout the profile | Permanent wetland | |

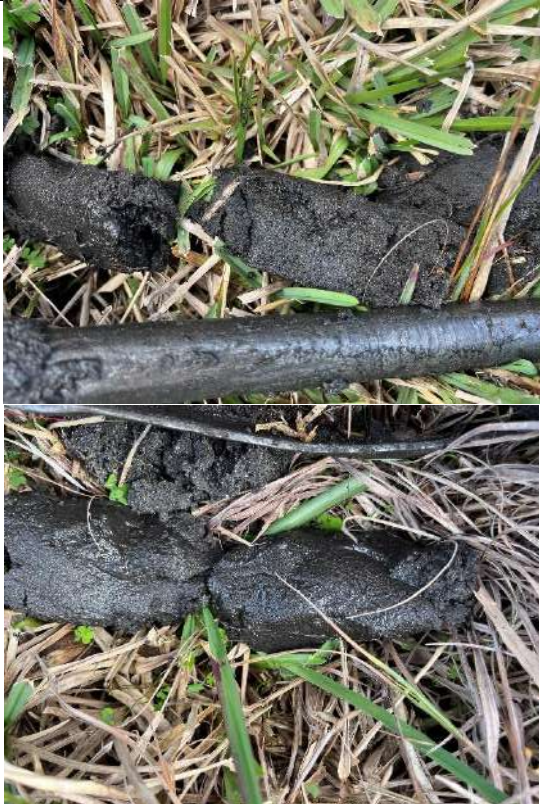
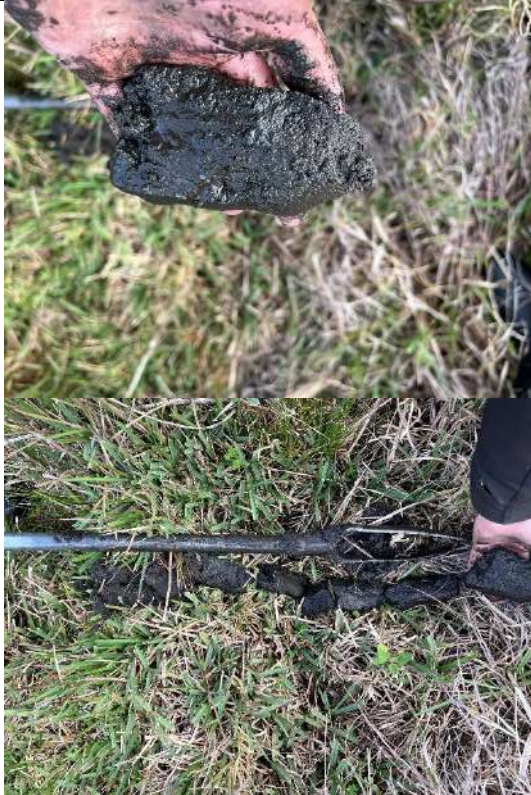
| SAP | Location description | Vegetation | Soils | Other notes | Habitat type | Photo(s) |
|---|---|---|---|---|---|---|
| 4 | Adjacent to the eastern fence line along Lynx Road | Buffalo grass; grass-like sedge interspersed with <i>Plecostachys serpyllifolia</i> , | 0-70cm: dark grey/black fine sands with high organic content (10YR 2/1) | Mostly damp to saturated from 20- 30 cm; no streaking | Permanent wetland | |

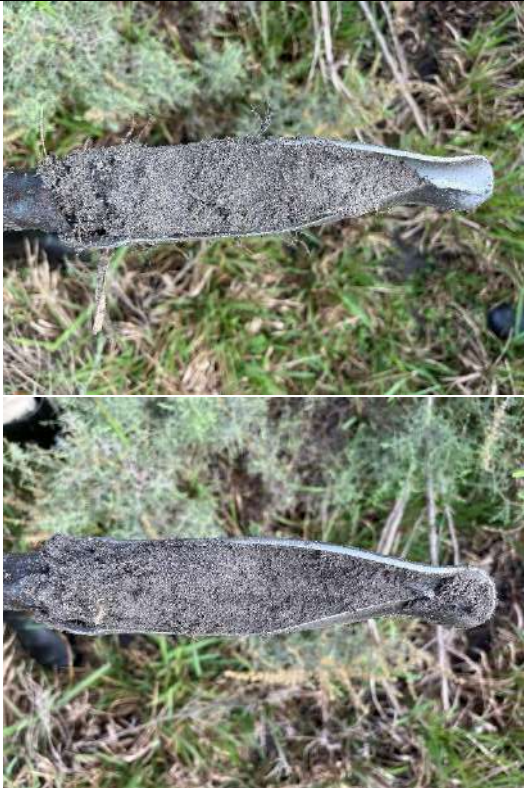
| SAP | Location description | Vegetation | Soils | Other notes | Habitat type | Photo(s) |
|---|---|---|---|---|---|---|
| 5 | Adjacent to the eastern fence line along Lynx Road | Dominated by Buffalo grass and interspersed with <i>Passerina corymbosa</i> , <i>Ficinia</i> spp, <i>Seriphium plumosum</i> , grassy sedge, sparse <i>Metalasia muricata</i> and <i>Passerina corymbosa</i> | 0-60cm: dark grey fine sands (10 YR 2/1) | Increased moisture/damp with increasing depth; streaking at approx. 30cm with 1 or 2 small mottles | Seasonal wetland | |

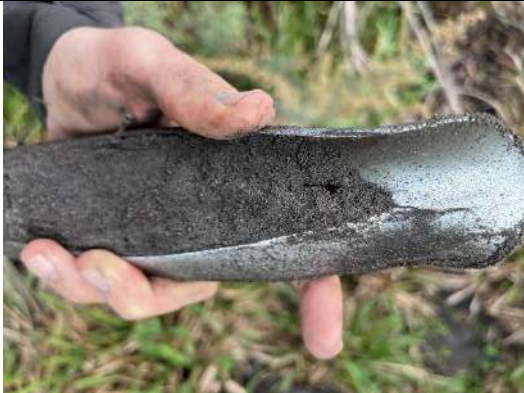
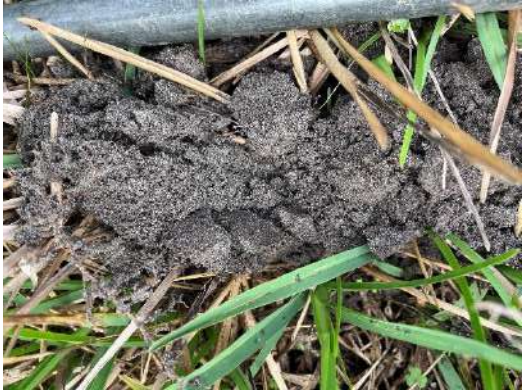
| SAP | Location description | Vegetation | Soils | Other notes | Habitat type | Photo(s) |
|---|---|---|---|---|---|---|
| 6 | Adjacent to the eastern fence line along Lynx Road | Groundcover comprises of dense buffalo grass but several interspersed shrubs occur which are <i>Metalsia muricata</i> and <i>Passerina corymbosa</i> | 0-60cm: 10YR 2/1.5 fine grey sands<br>@60cm: bleached light grey sands (10YR 5/1) | Slightly damp but largely dry; streaking at around 35cm | Seasonal wetland | |

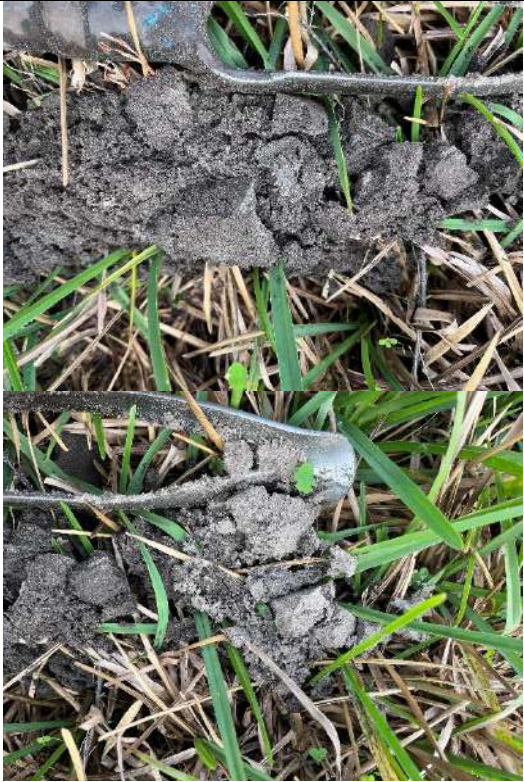
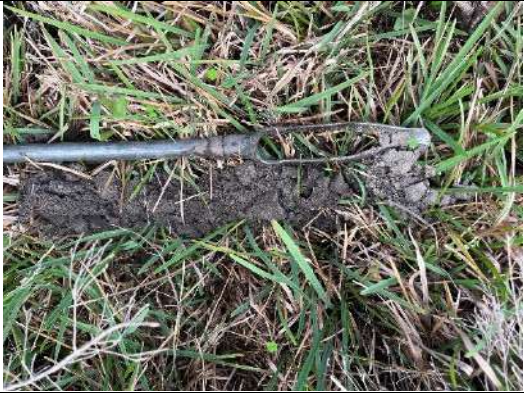
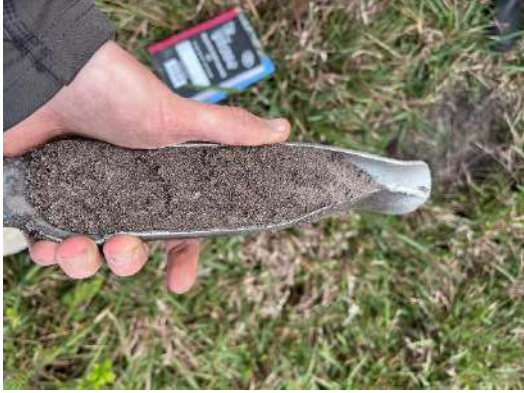
| SAP | Location description | Vegetation | Soils | Other notes | Habitat type | Photo(s) |
|---|---|---|---|---|---|---|
| 7 | Near the northeastern corner of the property | Dense buffalo grass with tufts of grassy sedge; interspersed with <i>Passerina corymbose</i> | 0-35cm light grey sands (dry) (10YR 2/1)<br>35-60cm: light/bleached grey fine sands (10YR 3.5/1) | Streaking between 30 and 40cm; increased effort to augur at depth – which is likely because of the finer sands relative to the coarse sands in the top of the profile | Seasonal to temporary wetland | |

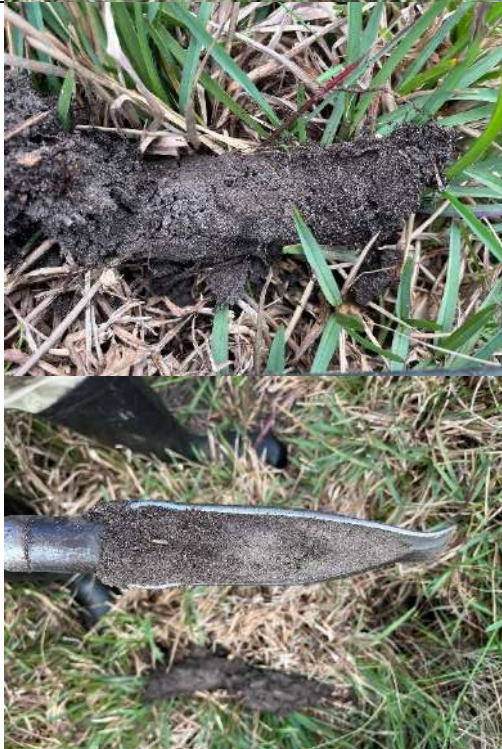
| SAP | Location description | Vegetation | Soils | Other notes | Habitat type | Photo(s) |
|---|---|---|---|---|---|---|
| 8 | Along the northern boundary of the site | Thick buffalo grass and grassy sedge; interspersed with scattered <i>Helichrysum</i> , <i>Nidorella</i> and <i>Passerina corymbose</i> ; 1 <i>Searsia</i> spp | 0-8cm organics and roots<br>8-35cm dry light grey sands (10YR 2/1)<br>35-60cm bleached grey sands (10YR 3.5/1) | Streaking between 30 and 40cm | Seasonal to temporary wetland | |

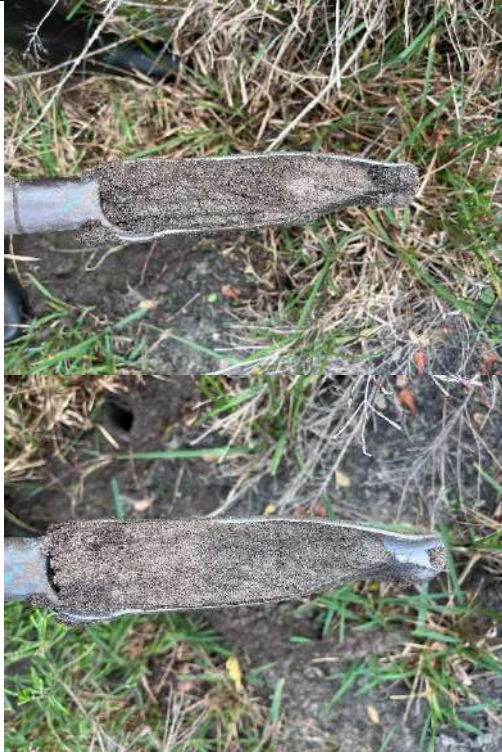
| SAP | Location description | Vegetation | Soils | Other notes | Habitat type | Photo(s) |
|---|---|---|---|---|---|---|
| 9 | Downslope of SAP8, but upslope of the Searsia stand | Dense buffalo grass with isolated arum lilies, <i>Passerina corymbose</i> and renosterbos | 0-10cm organic root/biomass and some brown sands<br>10-40cm: dry grey sands (10YR 2/1)<br>40-60cm: grey sands (10YR 3/1) | Streaking between 35 and 45cm | Seasonal to temporary wetland | |

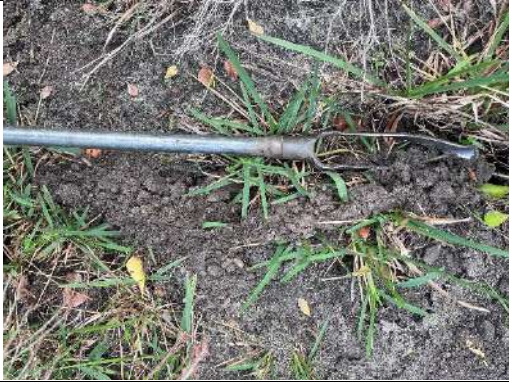
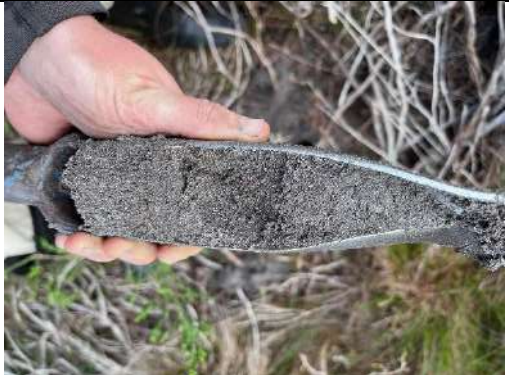
| SAP | Location description | Vegetation | Soils | Other notes | Habitat type | Photo(s) |
|---|---|---|---|---|---|---|
| 10 | | Dominated by the grassy sedge and buffalo grass, and interspersed with <i>Nidorela</i> and <i>Passerina corymbose</i> | 0-5cm: biomass/roots<br>5-25cm: grey sands (10YR 2/1)<br>25-50cm light grey sands (10YR 3.5/1) | Damp from 30cm onwards;<br>Sparse olive brown mottles at 25cm | Seasonal wetland | |

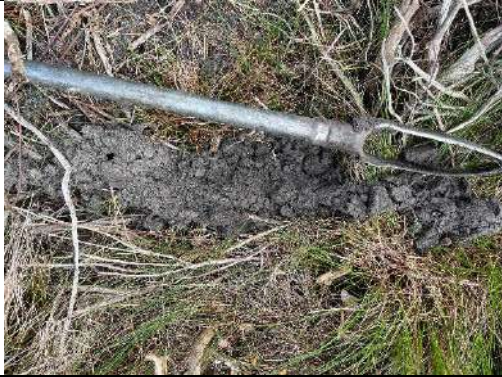
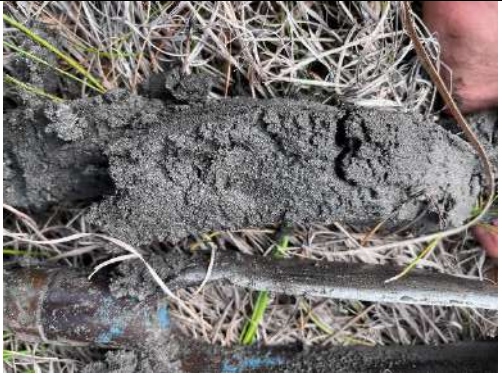
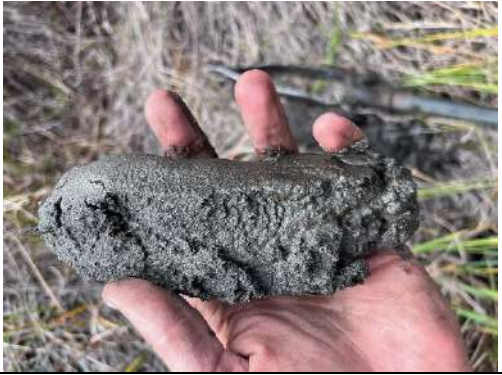
| SAP | Location description | Vegetation | Soils | Other notes | Habitat type | Photo(s) |
|---|---|---|---|---|---|---|
| 11 | Upslope of a small dug-out | Grassy sedge dominated and interspersed with Nidorella and renosterbos | 0-10cm dry light grey sands<br>10-30cm: damp grey sands 10YR 2/1<br>30-50cm: dark grey sands (10YR 2/1) (saturated from 40cm) | Dry at surface, then damp and then saturation at depth | Seasonal wetland | |

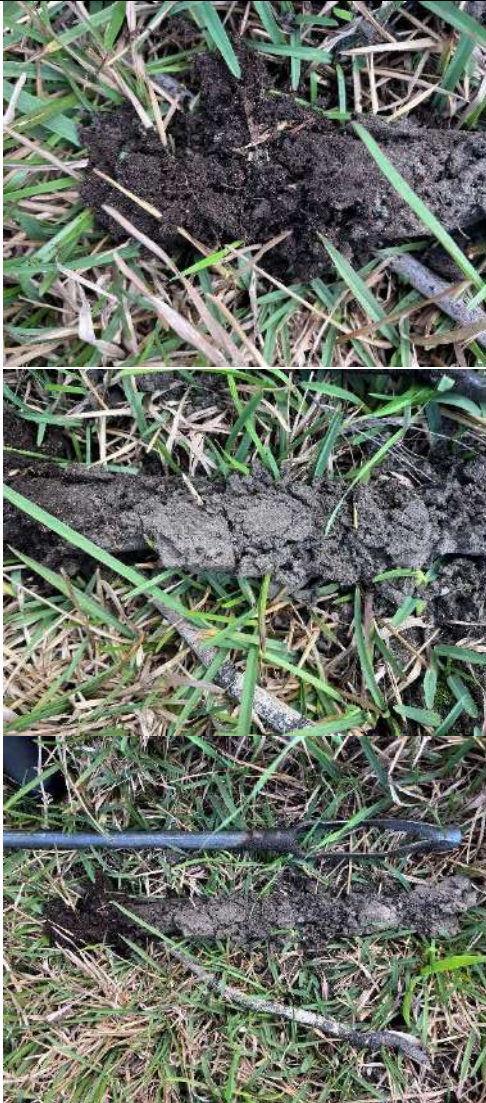
| SAP | Location description | Vegetation | Soils | Other notes | Habitat type | Photo(s) |
|---|---|---|---|---|---|---|
| 13 | Near northern fence of erf 1486, approx. 4m east of the white building | Buffalo grass (dominant), with sparse cobra lilies, <i>Passerina corymbose</i> and <i>Searsia</i> | 0-15cm: organics<br>15-35cm: dark grey sands (10YR 3/1)<br>35-50cm: very light grey/bleached sands (10YR 5/1) | Rubble at 50cm | Seasonal to marginal wetland | |

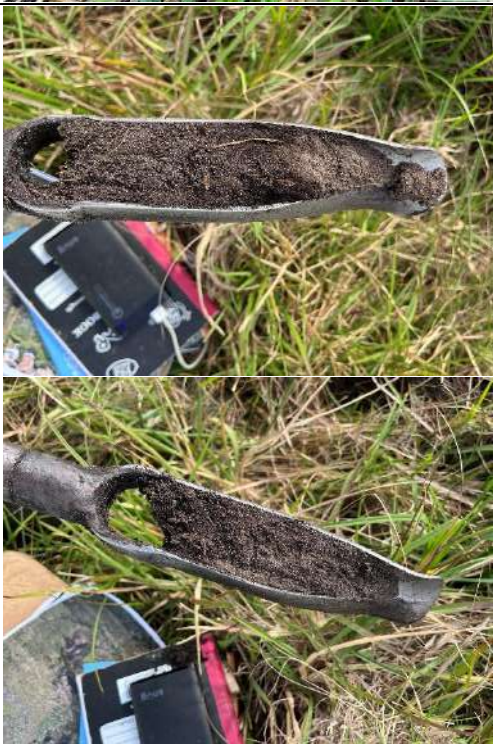
| SAP | Location description | Vegetation | Soils | Other notes | Habitat type | Photo(s) |
|---|---|---|---|---|---|---|
| 14 | Located between the white dwelling and the fence line on the northern boundary | Mix of kikuyu, grassy sedge and buffalo grass | 0-25cm: light grey sands (10YR 3/1)<br>25-50cm: bleached light grey sands (10YR 3/1) | Dry sands between 0 and 25cm, after which, damp until 50cm | Seasonal to marginal wetland | |

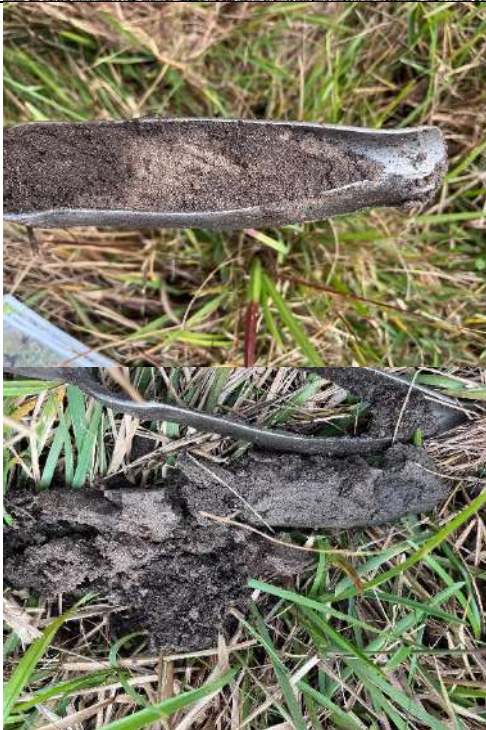
| SAP | Location description | Vegetation | Soils | Other notes | Habitat type | Photo(s) |
|---|---|---|---|---|---|---|
| 15 | Downslope of the stormwater culvert below R43 entering erf 1486. Site between building and northern fence line | Mix of kikuyu, grassy sedge and buffalo grass | 0-20cm: dark grey sands (10YR 2/1)<br>20-50cm: bleached light great sands (10YR 3/1) | Mottles at 25-30cm; dry sands between 0 and 20cm; damp between 20 and 50cm | Seasonal wetland | |

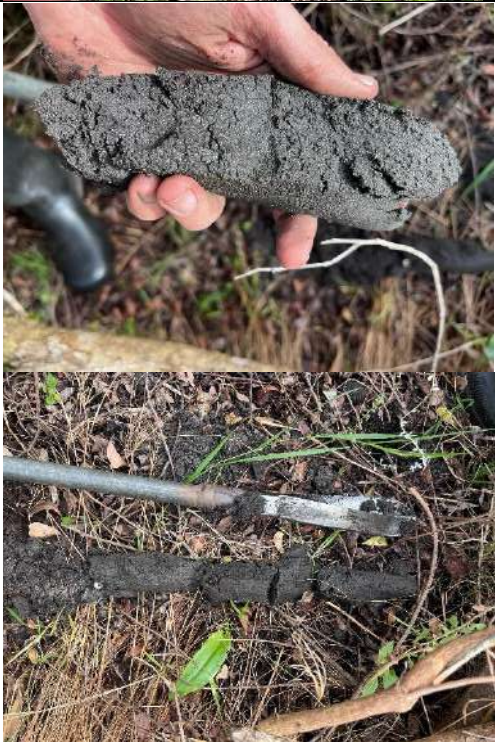
| SAP | Location description | Vegetation | Soils | Other notes | Habitat type | Photo(s) |
|---|---|---|---|---|---|---|
| 16 | East of the main dwelling between tall Searsia trees | <i>Fuirena hirsuta</i> ; <i>Passerina corymbosa</i> and <i>Senecio halimifolius</i> ; sparse cobra lily, and <i>Nidorella</i> spp | 0-10cm: organics<br>10-25cm: grey sands 10YR 2/1 (damp)<br>25-50cm: grey sands 10YR 2/1 (saturated) | Damp until 25cm, after which saturation from 25cm; no streaking | Seasonal to marginal wetland | |

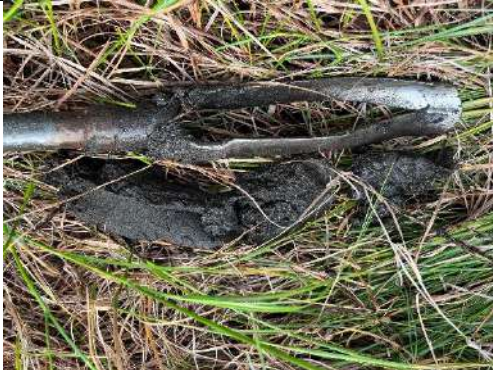
| SAP | Location description | Vegetation | Soils | Other notes | Habitat type | Photo(s) |
|---|---|---|---|---|---|---|
| 17 | Next to the crates located southeast of the dwelling | Grassy sedge;<br><i>Senecio halimifolius</i> ;<br><i>Nidorella</i> ;<br><i>Fuirena hirsuta</i> | 0-50cm dark grey sands | Damp between 0 and 10cm, after which saturation | Seasonal to permanently saturated wetland | |

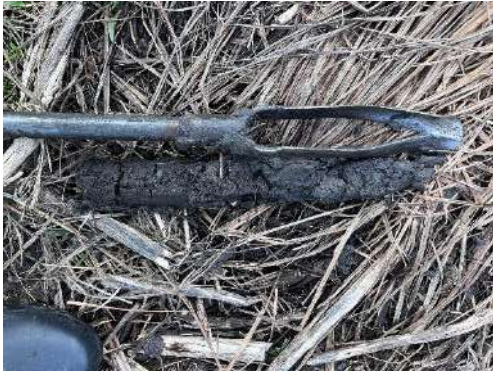
| SAP | Location description | Vegetation | Soils | Other notes | Habitat type | Photo(s) |
|---|---|---|---|---|---|---|
| 18 | Near beehives with some bricks scattered around | Grassy sedge;<br><i>Fuirena hirsuta</i> and<br><i>Nidorella</i> | 0-25cm: dark grey sands (10YR 2/1)<br>25-50cm: lighter grey sands (10YR 3/1) | Saturated soils throughout | Seasonal to permanently saturated wetland | |

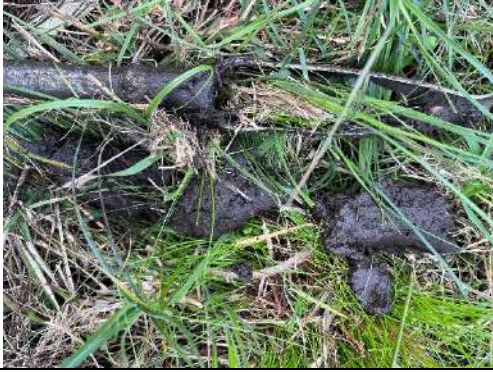
| SAP | Location description | Vegetation | Soils | Other notes | Habitat type | Photo(s) |
|---|---|---|---|---|---|---|
| 19 | Between derelict building and access road | Grassy sedge;<br><i>Juncus krausii</i> ;<br><i>Senecio halimifolius</i> | 0-50cm organic dark grey/black sands (10YR 2/1) | Saturated soils throughout | Seasonal to permanently saturated wetland | |

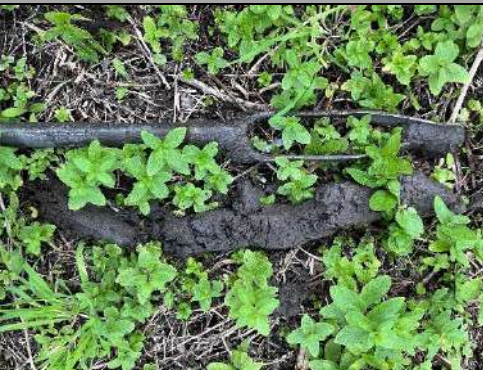
| SAP | Location description | Vegetation | Soils | Other notes | Habitat type | Photo(s) |
|---|---|---|---|---|---|---|
| 20 | Within the derelict building platform | Mint, kikuyu, isolated Typha stand | 0-10cm: dark black organics<br>10-50cm: dark grey sands (10YR 3/1) | Several points within the derelict building had underlying rubble, but SAP 20 did not | | |

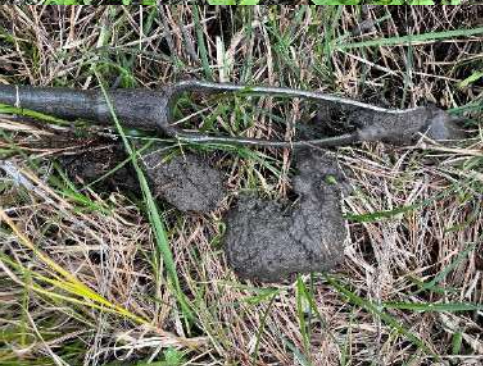
| SAP | Location description | Vegetation | Soils | Other notes | Habitat type | Photo(s) |
|---|---|---|---|---|---|---|
| 21 | West of erf 1486 fence on reserve (at top nearest R43) | Grassy sedge; Nidorella | 0-5cm: organics<br>5-50cm grey sands (10YR 3/1) | Saturated throughout | Seasonal to permanently saturated wetland | |

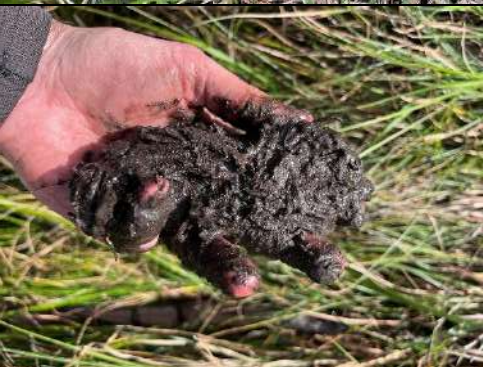
| SAP | Location description | Vegetation | Soils | Other notes | Habitat type | Photo(s) |
|---|---|---|---|---|---|---|
| 22 | West of erf 1486 fence on reserve (west of derelict building) | Grassy sedge; <i>Orphium frutescens</i> ; <i>Senecio halimifolius</i> ; <i>Fuirena hirsuta</i> | 0-50cm: dark grey sands (10YR 2/1) | Inundated at the surface; saturated throughout | Seasonal to permanently saturated wetland | |

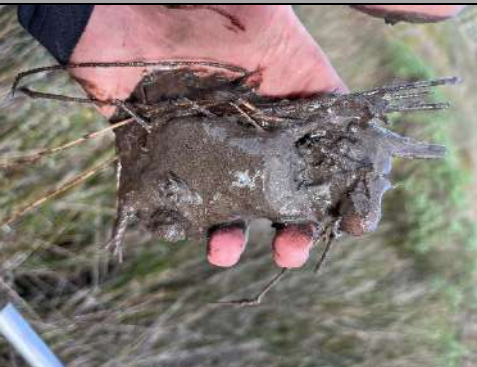
| SAP | Location description | Vegetation | Soils | Other notes | Habitat type | Photo(s) |
|---|---|---|---|---|---|---|
| 23 | West of erf 1486 fence on reserve (southwest of derelict building) | <i>Juncus</i> spp;<br><i>Orphium frutescens</i> ;<br><i>Nidorella</i> ;<br><i>Plecostachys</i> ;<br><i>Cotula</i> | 0-50cm: dark grey sands (10YR 2/1) | Inundated at the surface; saturated throughout | permanently saturated wetland | |

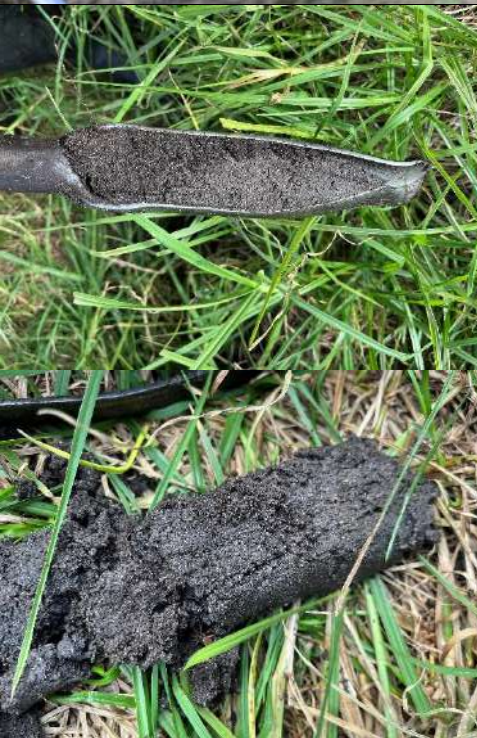
| SAP | Location description | Vegetation | Soils | Other notes | Habitat type | Photo(s) |
|---|---|---|---|---|---|---|
| 24 | On erf 2317 (municipal land) nearest southeastern set of houses | Kikuyu | 0-20cm: dark grey/black sands (10YR 2/1)<br>20-50cm: light grey/bleached sands (10YR 3/1) | Damp throughout; no streaking | Seasonal wetland | |

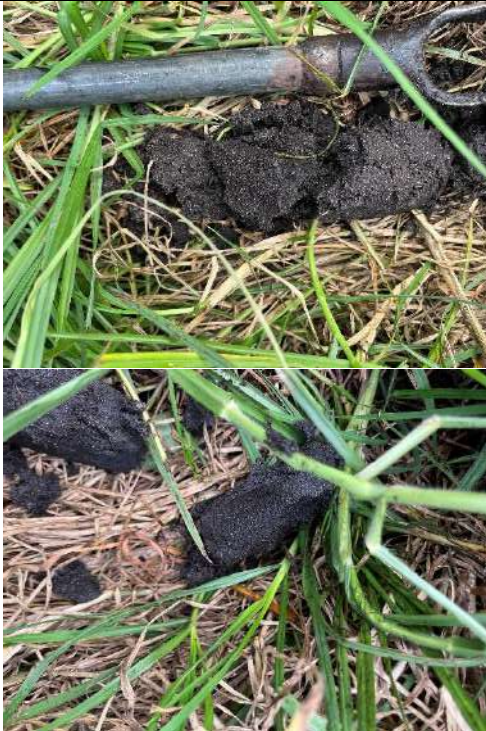
| SAP | Location description | Vegetation | Soils | Other notes | Habitat type | Photo(s) |
|---|---|---|---|---|---|---|
| 25 | South of stormwater discharge point into wetland | Kikuyu and planted milkwood trees | 0-20cm: dark grey/black sands (10YR 2/1)<br>20-50cm: light grey/bleached sands (10YR 3/1) | Damp throughout; no streaking | Seasonal wetland | |

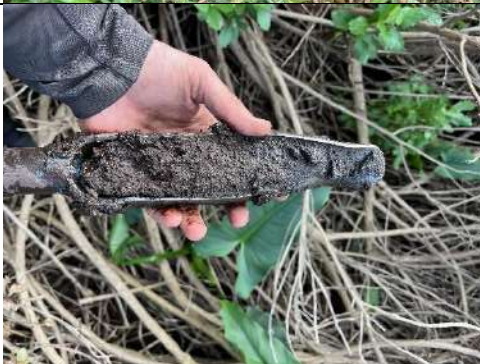
| SAP | Location description | Vegetation | Soils | Other notes | Habitat type | Photo(s) |
|---|---|---|---|---|---|---|
| 26 | Approx. 2.5m upslope of stormwater discharge point into permanent wetland | Arum lilies; Senecio halimifolius | 0-20cm: loamy brown organics (feels like a sponge) 10YR 2/2<br>20-50cm: dark grey sands 10YR 2/1 | saturated throughout; water ingress at 10cm | Seasonal to permanently saturated wetland | |

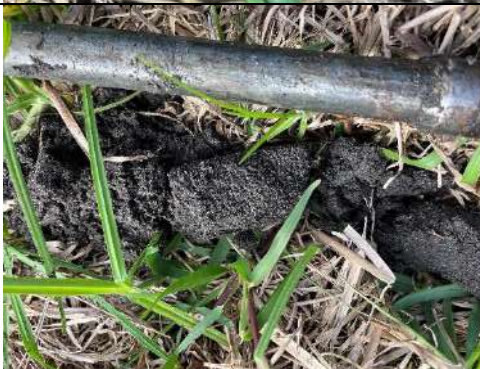
| SAP | Location description | Vegetation | Soils | Other notes | Habitat type | Photo(s) |
|---|---|---|---|---|---|---|
| 27 | On erf 2317 (municipal land) nearest houses | Dominated by kikuyu grass, but includes buffalo, 1 helichrysum | 0-40cm: coarse dark grey sands (10YR 2/1)<br>40-50cm: coarse light grey sands (10YR 2.5/1) | Damp between 0 and 40cm; saturated from 40 to 50cm | Seasonal wetland | |

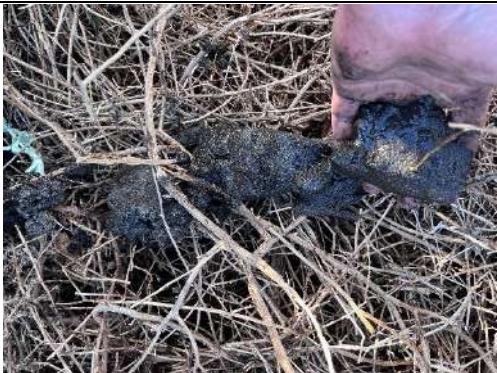
| SAP | Location description | Vegetation | Soils | Other notes | Habitat type | Photo(s) |
|---|---|---|---|---|---|---|
| 28 | North of SAP27 towards the permanently saturated wetland | Helichrysum;<br>arum lily;<br>Senecio halimifolius;<br>Nidorella;<br><i>Fuirena hirsute</i> | 0-20cm: dark grey loamy sands 10YR 2/1 (damp)<br>20-50cm: dark grey sands 10YR 2/1 (saturated) | Saturated from 20cm onwards | Seasonal to permanently saturated wetland | |

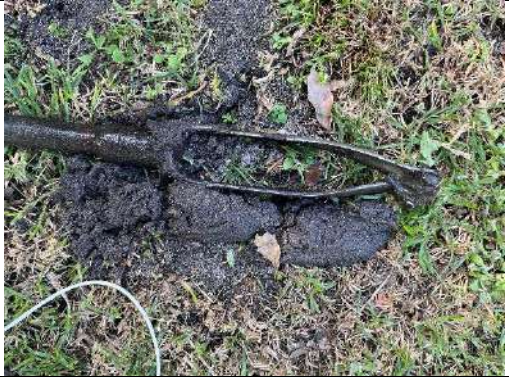
| SAP | Location description | Vegetation | Soils | Other notes | Habitat type | Photo(s) |
|---|---|---|---|---|---|---|
| 29 | Along southern boundary of erf 1486 | Mowed kikuyu grass; Sencio halimifolius, Searsia | 0-20cm: Coarse grey sands 10YR 2/1 (damp)<br>20-50cm: Coarse grey sands 10YR 2/1 (saturated) | Seems to be coarse sands up until 35cm, after which finer sands; strong egg smell; saturation from 20cm onwards | Seasonal to permanently saturated wetland | |

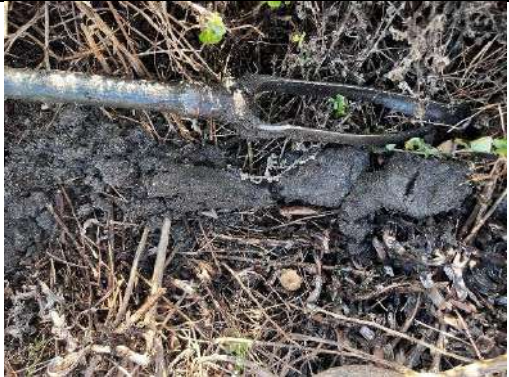
| SAP | Location description | Vegetation | Soils | Other notes | Habitat type | Photo(s) |
|---|---|---|---|---|---|---|
| 30 | Towards southwestern boundary of erf 1486 | Helichrysum; Senecio halimifolius; <i>Seriphium plumosum</i> | 0-25cm: dark grey sands (10YR 2/1) damp<br>25-50cm: dark grey sands (10YR 2/1) saturated | Water ingress at 35/40cm | Seasonal wetland | |

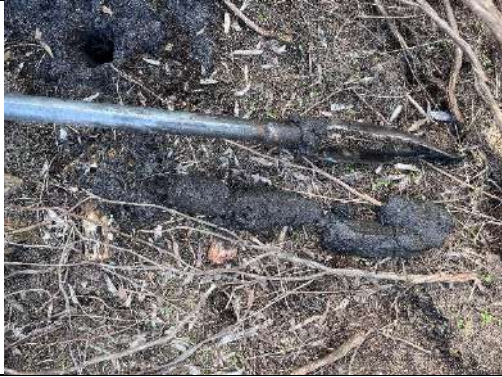
| SAP | Location description | Vegetation | Soils | Other notes | Habitat type | Photo(s) |
|---|---|---|---|---|---|---|
| 31 | North of SAP 30 towards the permanently saturated wetland | Renosterbos; Nidorella and Senecio halimifolius | 0-35cm: grey sands (10YR 2/1)<br>35-50cm: grey sands (10YR 3/1) | Bleaching at 30/35cm; Water ingress at 40cm | Seasonal wetland | |

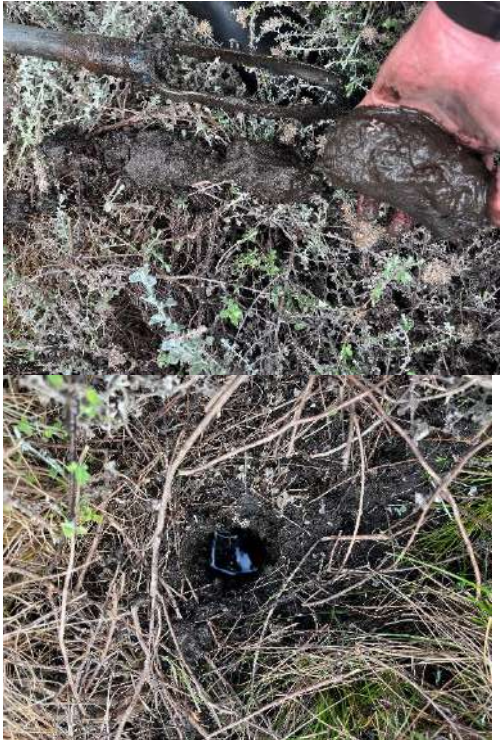
| SAP | Location description | Vegetation | Soils | Other notes | Habitat type | Photo(s) |
|---|---|---|---|---|---|---|
| 32 | within permanently saturated wetland | Nidorella; Helichrysum; <i>Seriphium plumosum</i> ; renosterbos; Juncus krausii | 0-8cm: organic roots etc<br>8-20cm: dark grey sands (10YR 2/1) (damp)<br>20-50cm: dark grey sands (10YR 2/1) (saturated) | Strong egg smell; saturation from 20cm onwards; water ingress at 20cm; no streaking | Seasonal to permanently saturated wetland | |

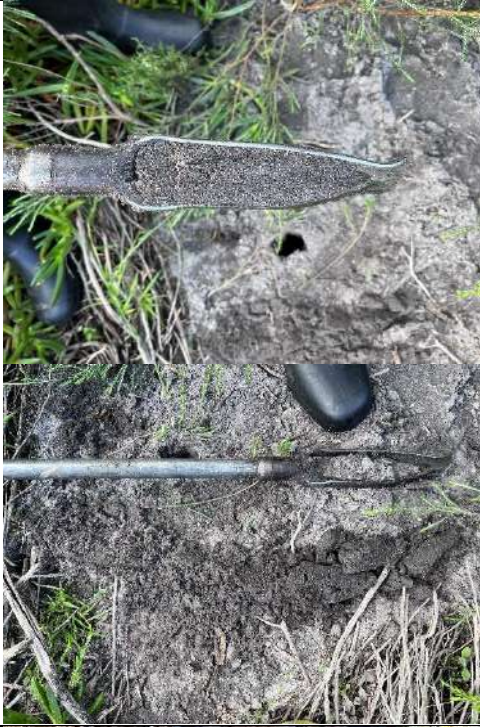
| SAP | Location description | Vegetation | Soils | Other notes | Habitat type | Photo(s) |
|---|---|---|---|---|---|---|
| 33 | Towards the western boundary of erf 1486 | Passerina; Helichrysum; <i>Seriphium plumosum</i> ; Vygie; also garden escapees | 0-40cm grey sands (10YR 2/1) (damp)<br>40-50cm: grey sands (10YR 2/1) (saturation) | Subtle streaking between 30 and 40cm | Seasonal wetland | |

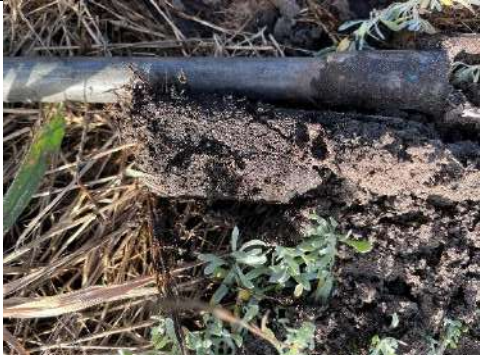
| SAP | Location description | Vegetation | Soils | Other notes | Habitat type | Photo(s) |
|---|---|---|---|---|---|---|
| 34 | On reserve (transect from wet to dry dunes) | <i>Juncus krausii</i> ; <i>Senecio halimifolius</i> ; grassy sedge; <i>cotula</i> ; <i>Cyperus spp</i> | 0-10cm organics and sand<br>10-50cm: bleached grey sands (10YR 3/1) | | permanently saturated wetland | |

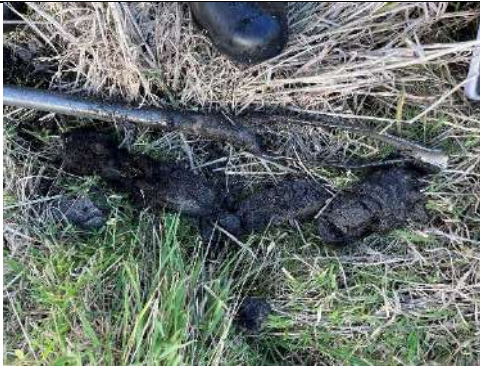
| SAP | Location description | Vegetation | Soils | Other notes | Habitat type | Photo(s) |
|---|---|---|---|---|---|---|
| 35 | On reserve (transect from wet to dry dunes) | <i>Cyperus spp</i> ; Nidorella; light grey/green pioneer grass | 0-15cm: organics<br>15-50: grey sands (10YR 2/1) | Damp: 0-20/25cm)<br>Saturated from 25cm onwards; water ingress at 25cm; strong egg smell | permanently saturated wetland | |

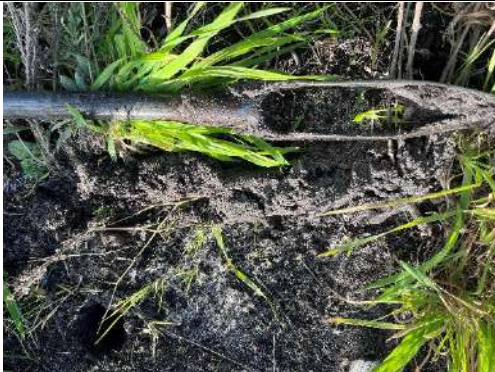
| SAP | Location description | Vegetation | Soils | Other notes | Habitat type | Photo(s) |
|---|---|---|---|---|---|---|
| 36 | On reserve (transect from wet to dry dunes) | <i>Erigeron sumatrensis</i> ; <i>Senecio halimifolius</i> ; light grey/green pioneer grass | 0-15cm: dark grey organic<br>15-50cm: light grey sands (10YR 3/1) | Damp: 0-25cm; saturated from 25cm onwards; egg smell | Seasonal to permanently saturated wetland | |

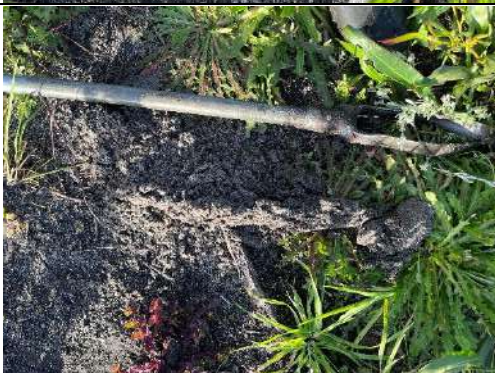
| SAP | Location description | Vegetation | Soils | Other notes | Habitat type | Photo(s) |
|---|---|---|---|---|---|---|
| 37 | On reserve (transect from wet to dry dunes) | <i>Erigeron sumatrensis</i> ; <i>Senecio halimifolius</i> ; <i>Cyperus spp</i> ; light grey/green pioneer grass; <i>helichrysum</i> | 0-8cm: organics<br>8-50cm: bleached grey sands (10YR 3/1) | Egg smell | Seasonal wetland | |

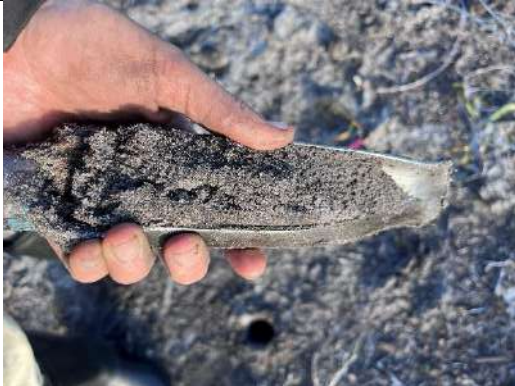
| SAP | Location description | Vegetation | Soils | Other notes | Habitat type | Photo(s) |
|---|---|---|---|---|---|---|
| 38 | On reserve (transect from wet to dry dunes) | Weedy plants; Acacia seedlings; <i>Erigeron sumatrensis</i> ; light grey/green pioneer grass | 0-50cm: bleached grey sands (10YR 3/1) | Damp throughout but not saturated. Seems like this is on higher ground. More terrestrial-looking plants. | Marginal edge of wetland | |

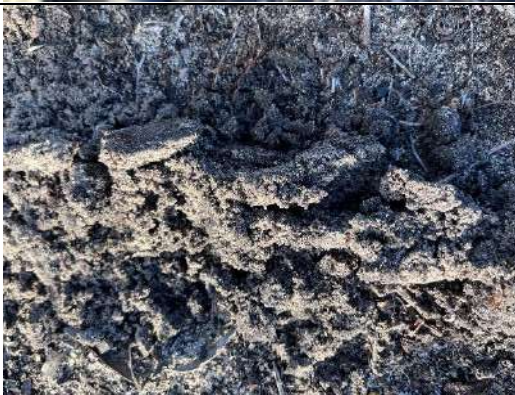
| SAP | Location description | Vegetation | Soils | Other notes | Habitat type | Photo(s) |
|---|---|---|---|---|---|---|
| 39 | On reserve (transect from wet to dry dunes) | Acacia seedlings and terrestrial-looking sedge | 0-50cm: bleached grey sands (10YR 3/1) | No egg smell; saturation at 35/40cm | Marginal edge of wetland | |

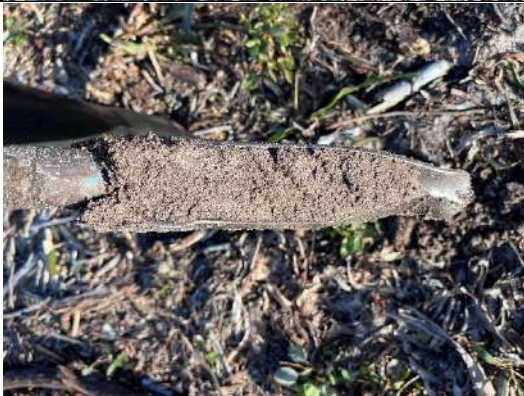
| SAP | Location description | Vegetation | Soils | Other notes | Habitat type | Photo(s) |
|---|---|---|---|---|---|---|
| 40 | On reserve (transect from wet to dry dunes) | Very recently cleared Eucalyptus; no plants | 0-50cm: bleached grey/brown sands (10YR 3/1) | Damp from 40cm onwards | Likely terrestrial | |

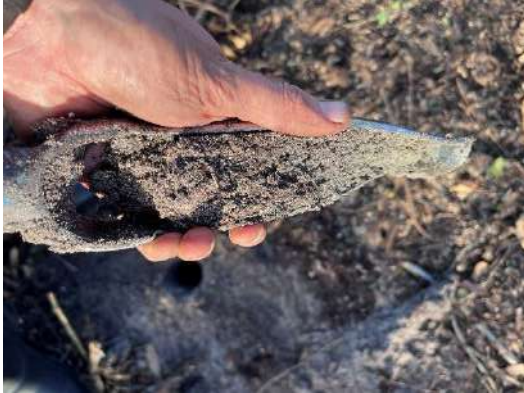
| SAP | Location description | Vegetation | Soils | Other notes | Habitat type | Photo(s) |
|---|---|---|---|---|---|---|
| 41 | On reserve (transect from wet to dry dunes) | Very recently cleared Eucalyptus; no plants | 0-50cm: bleached grey sands (10YR 3/1) | Dry until 30cm, after which damp | Likely terrestrial | |
