**WETLAND DELINEATION AND SPECIALIST COMMENT RELATING TO  
THE PROPOSED RESIDENTIAL DEVELOPMENT ON ERF 1486,  
VERMONT, WESTERN CAPE**

**FINAL REPORT**

**20 July 2025**

Freshwater Consulting

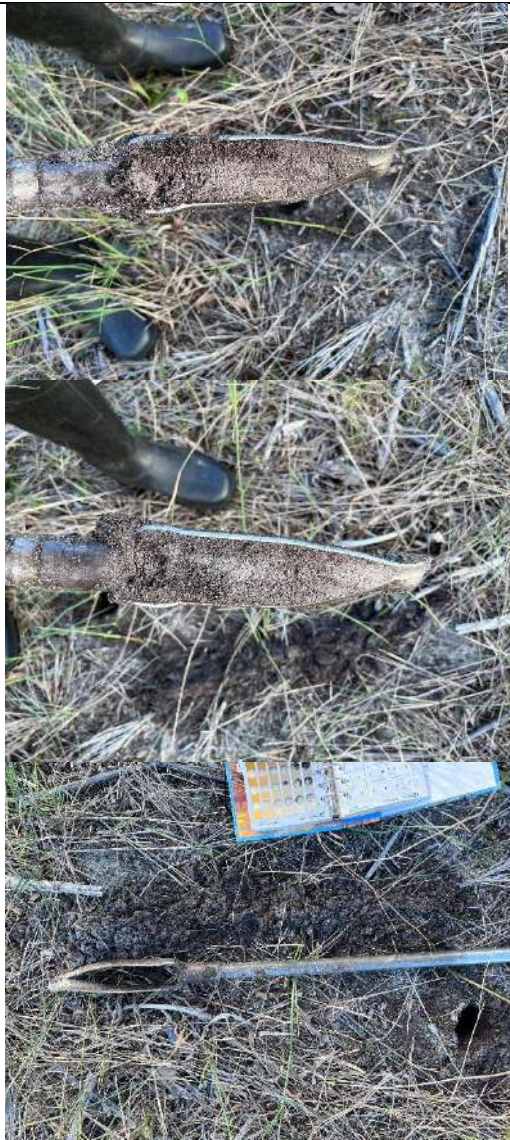
| 42 | On reserve (transect from wet to dry dunes) | Ehrharta; <i>Thamnochortus</i> ; terrestrial sedge spp ( <i>Schoenus compar</i> ); small <i>restio</i> | 0-40cm dark grey sands (10YR 2/1)<br>40-50cm: bleached grey sands (10YR 3/1) | Possible streaking from 20cm onwards but could also be fire residue; dry soils throughout | Likely terrestrial | |

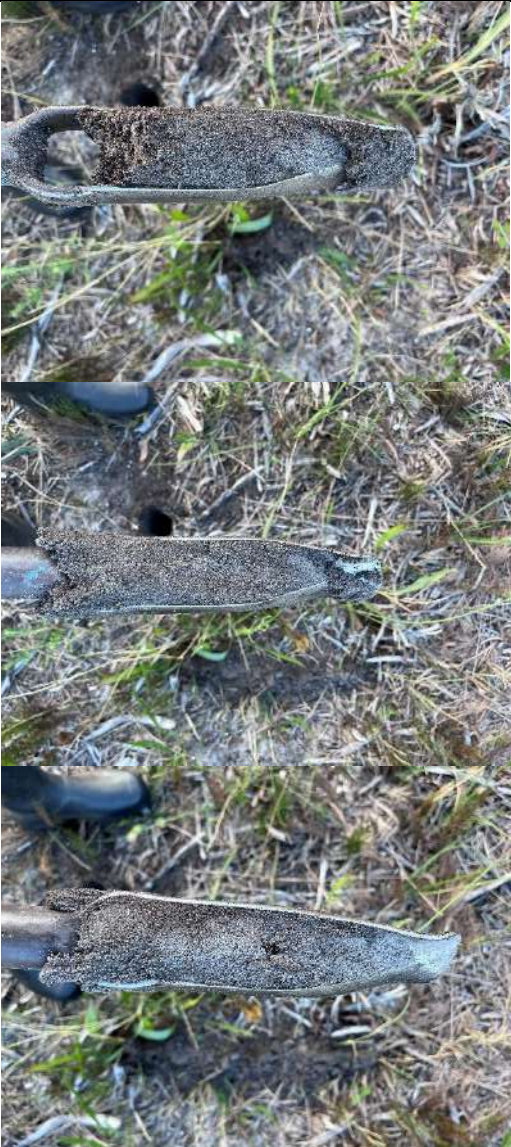
| 43 | On reserve (transect from wet to dry dunes) | Ehrharta; <i>Thamnochortus</i> ; terrestrial sedge spp ( <i>Schoenus compar</i> ); <i>Acacia</i> seedlings | 0-50cm dark grey sands (10YR 2/1) | Possible streaking between 35 and 50cm but could also be fire residue; dry soils throughout | Likely terrestrial | |

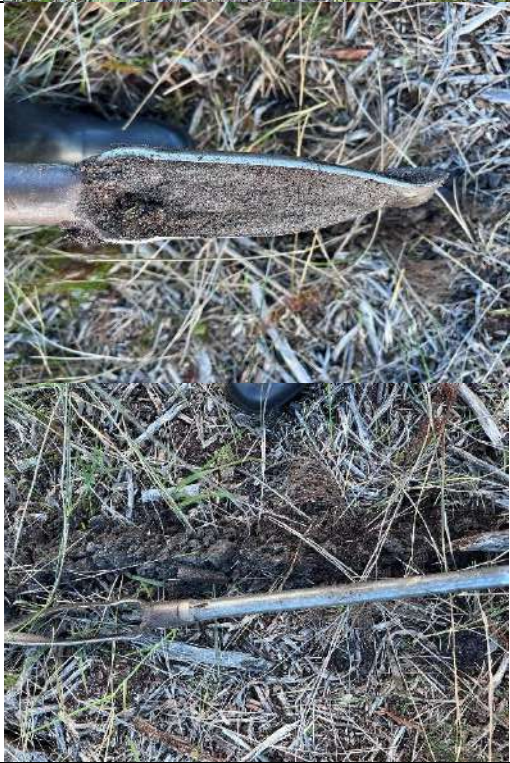
| 44 | On reserve (transect from wet to dry dunes) | Ehrharta; small restio; <i>Colpoon compressum</i> | 0-5cm: organics<br>5-50cm: grey sands (10YR 2.5/1) | | Likely terrestrial | | |

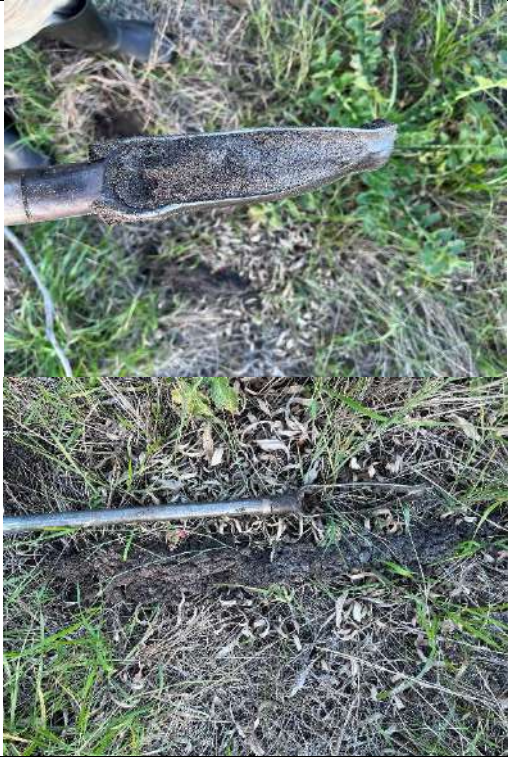
| 45 | On reserve (transect from wet to dry dunes) (at the base of the dune) | Ehrharta;<br>Osteospermum moniliferum;<br>weedy grasses | Brown sands | | Likely terrestrial | |
