MAINTENANCE MANAGEMENT PLAN

Proposed Residential development and associated infrastructure on Erf 1486,
Vermont, Hermanus, Caledon RD

20 May 2026

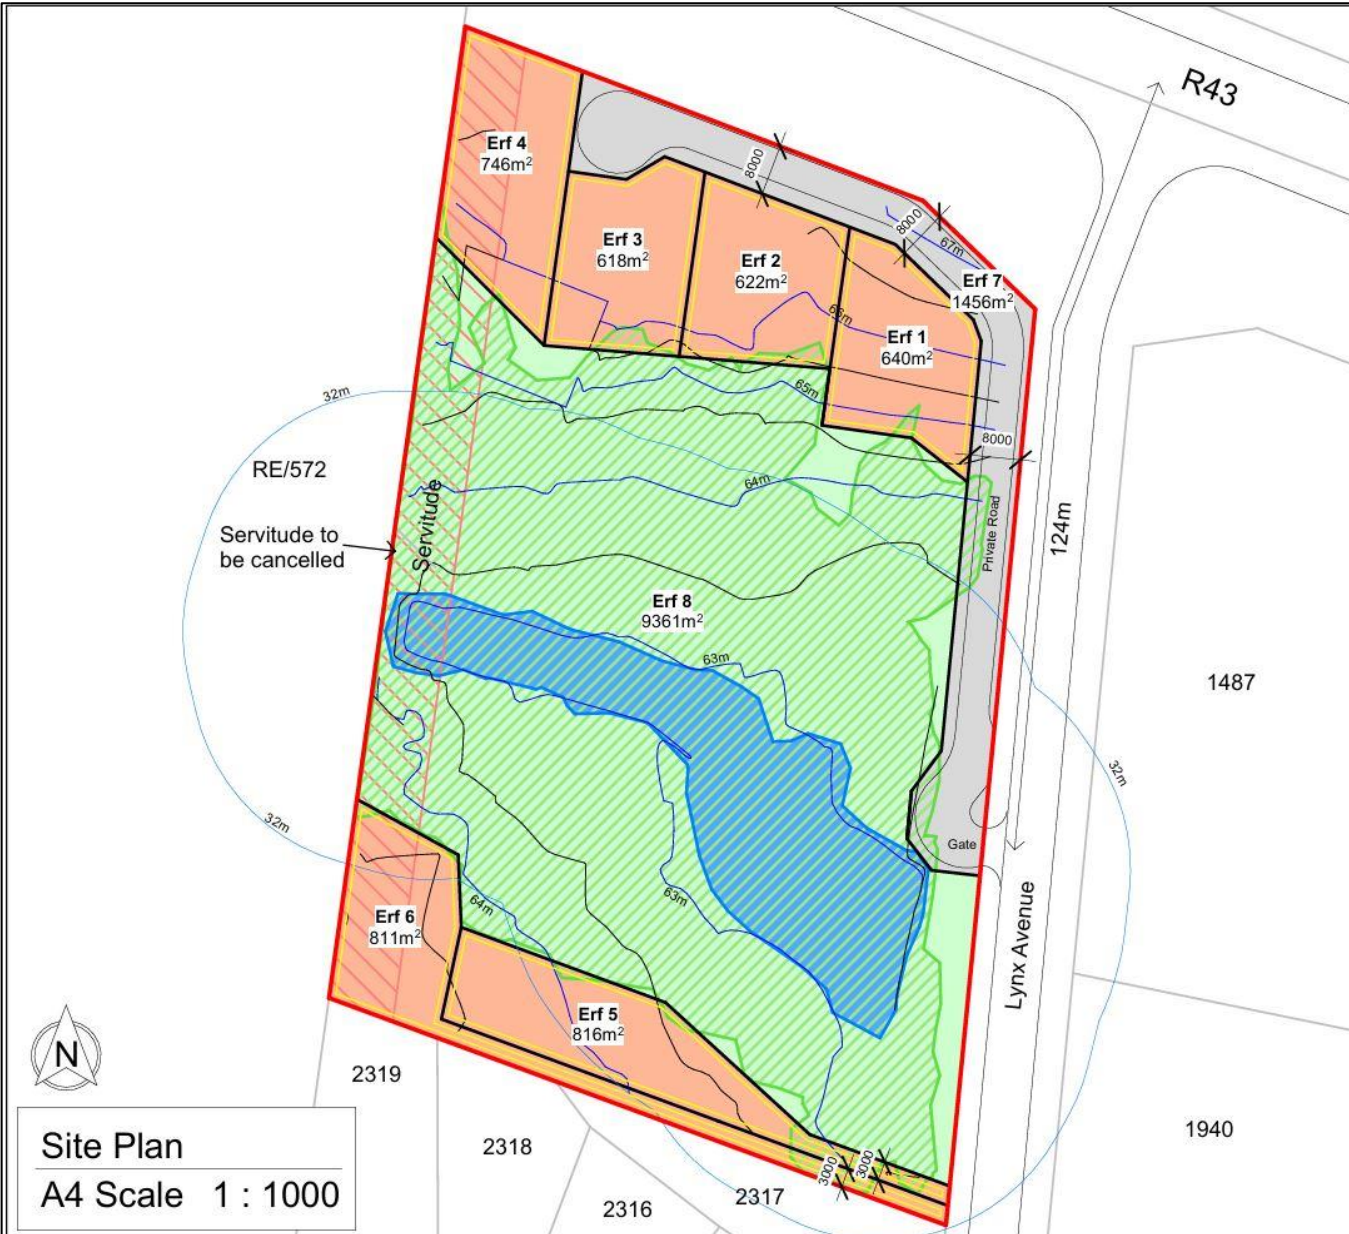
Site Plan
A4 Scale 1 : 1000

TITLE
Site Plan

- Application Area
- Permanent Wetland (depression)
- Seasonal Wetland
- Servitude (to be cancelled)
- Zoning Scheme Building Lines

- Six (6) residential erven (Erven 1-6) for town housing in the northern and southern portions of the property;
- One (1) private access road erf (Erf 7, 1 456 m²) along the eastern and southern boundaries; and
- One (1) large private open space erf (Erf 8, 9 361 m²) comprising the central portion of the property.

The private open space erf (Erf 8) will remain undeveloped and will accommodate the delineated wetland together with the offset, rehabilitation, and management area.
