# Aquatic Biodiversity Impact Assessment

## Remainder of Erf 1489, Vermont, Western Cape Province

For: Lornay Environmental Consulting

September 2026

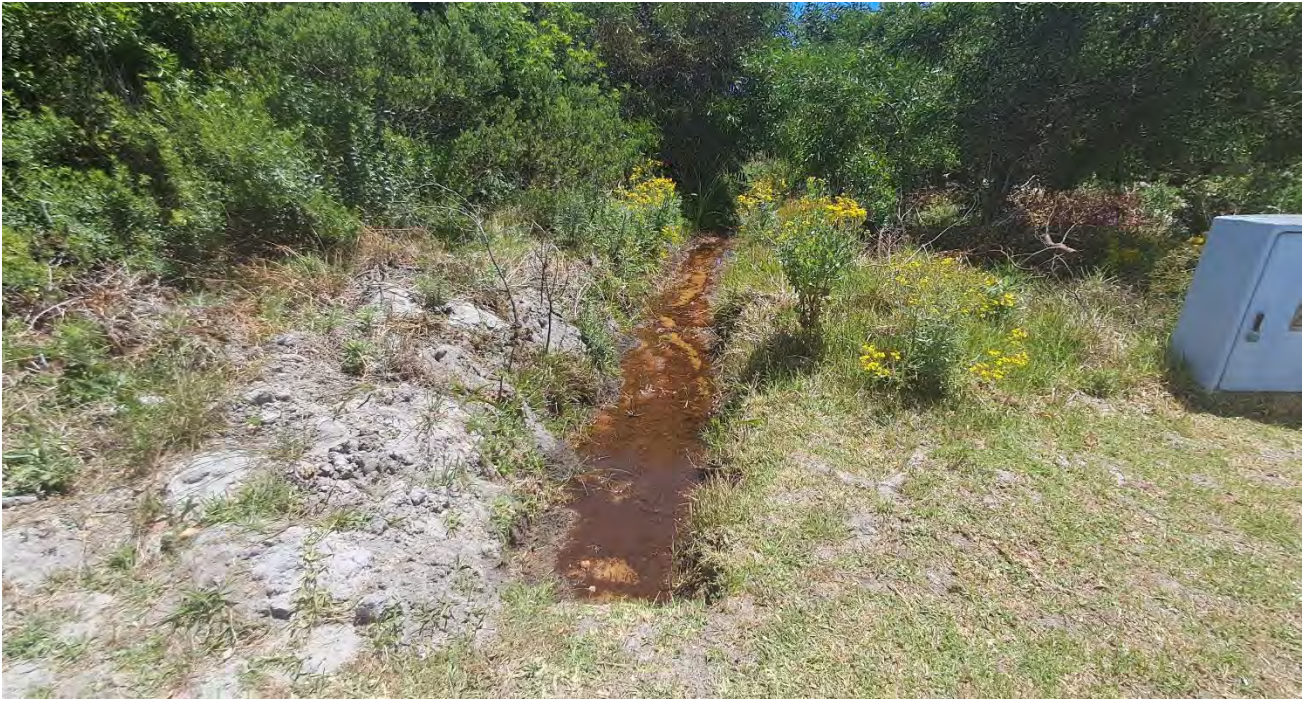
**Figure 5-7: Channel within the UVB wetland, adjacent to the entrance / access road.**

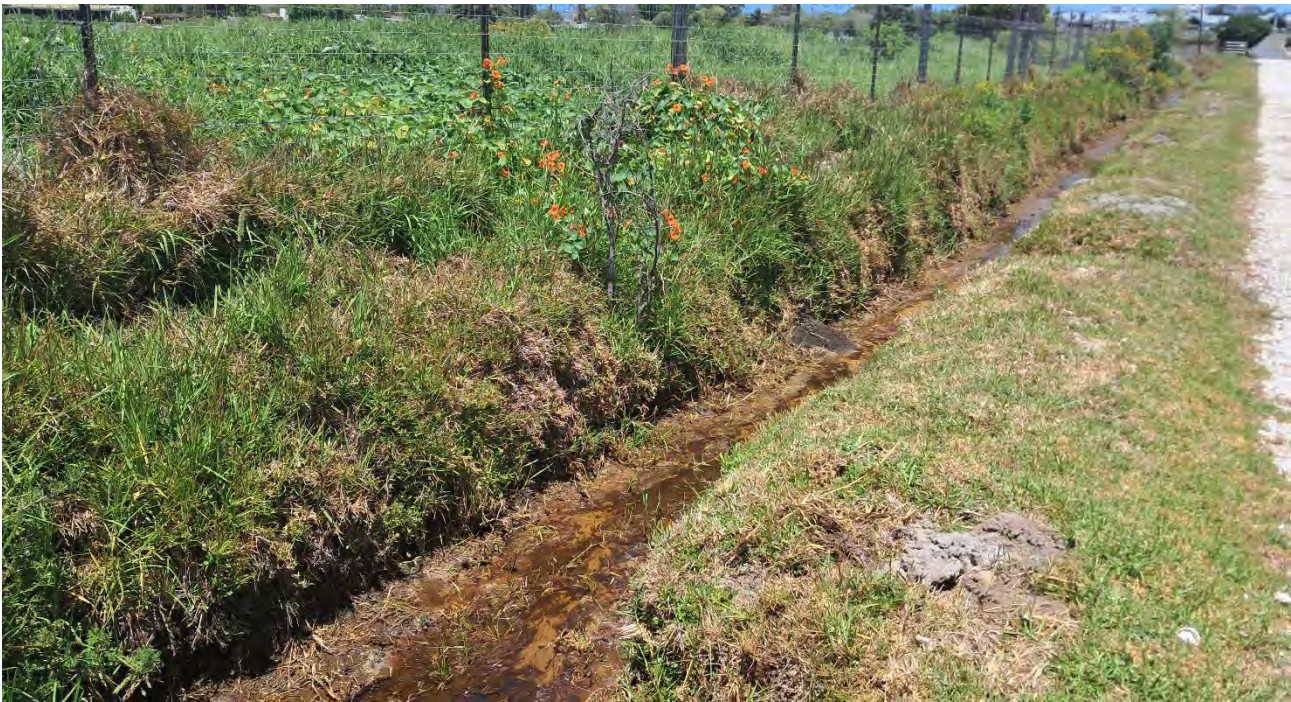
**Figure 5-8: Stormwater channel along the access road which will be upgraded, within the UVB wetland.**

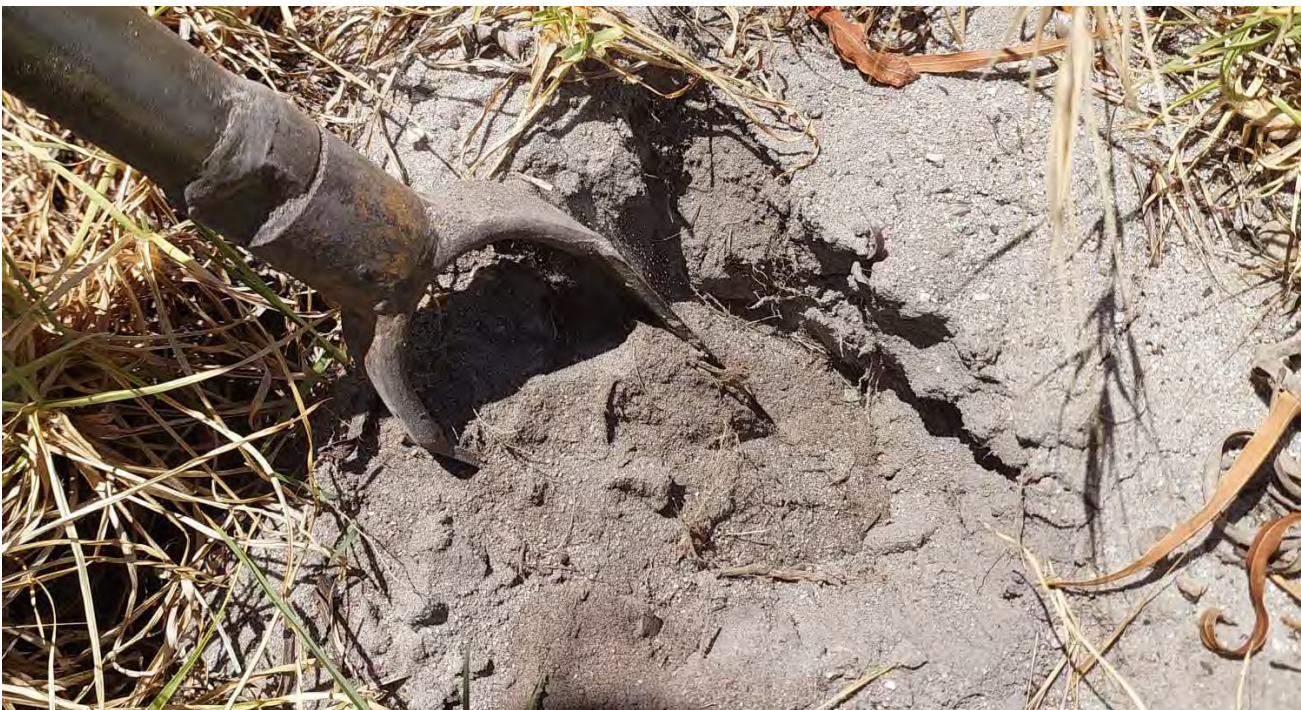
**Figure 5-10: Majority of the soils sampled within the study area consisted of greyish brown, deep, sandy terrestrial soils.**

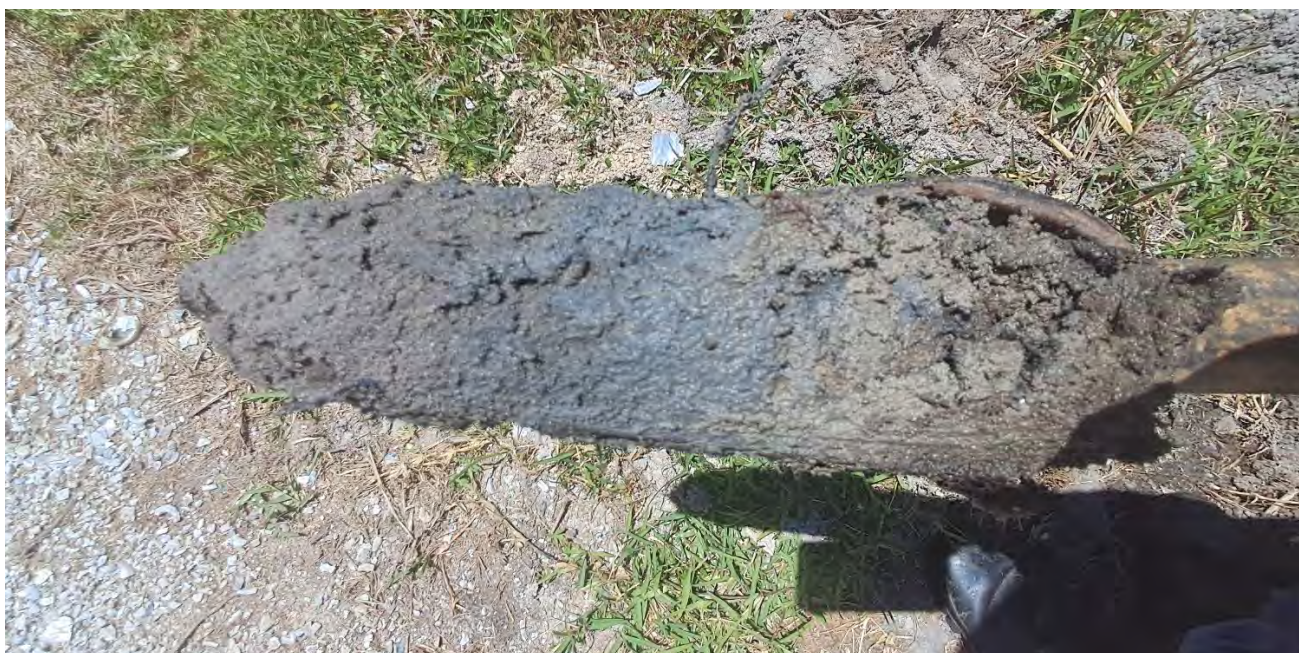
**Figure 5-11: Soil sample from the functional UVB wetland.**

Soils that were sampled in the functional UVB wetland did not differ markedly from terrestrial soils, aside from appearing darker and with a higher organic content than the terrestrial baseline (**Figure 5-11**).
